Stream Restoration Inventory, Phase 1 Final Report

Prepared for Chicago Wilderness by the Northeastern Illinois Planning Commission

October 2002

Stream Restoration Inventory / Phase 2 Report of Restoration Field Verification

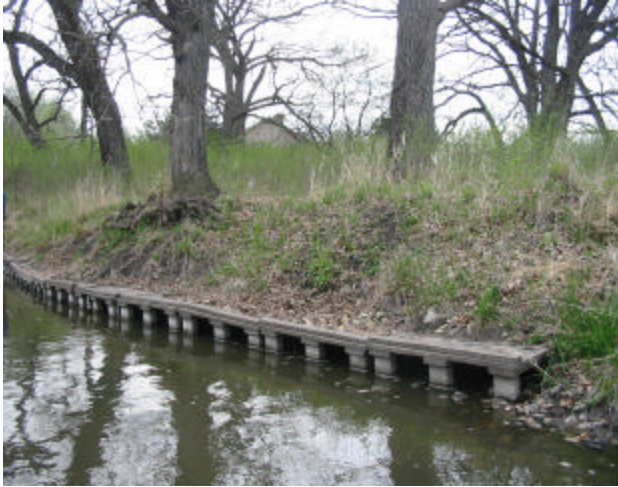
Lunkers were originally developed for trout streams to provide in-stream habitat and reinforce the toe of eroding banks, especially on the outside of meander bends. Lunkers are similar to wooden pallets in design except the top and back are covered while both ends and the front are open to water flow. Lunkers are interlocked along the streambed at the toe of the bank with rebar. Rip rap is placed above and behind the lunkers. Situations were observed in the field where the rip rap or bed material placed above and behind the lunkers was too small and therefore easily eroded away. Situations were also observed where wooden lunkers were not placed on the streambed, but were higher on the stream bank. In small urban streams with intermittent flow, this lead to intermittent exposure of the wood to air causing deterioration of the wooden planks. It also lead to the tilting of lunkers when the bank beneath them was undermined by erosion. In addition, lunkers that are not placed at the level of the streambed have limited habitat value for desirable

Lunkers installed high on the bank

aquatic species. Lunkers should be installed on the streambed at the deepest level of the pools. In streams where flow is intermittent recycled plastic planks should be used instead of wooden planks.

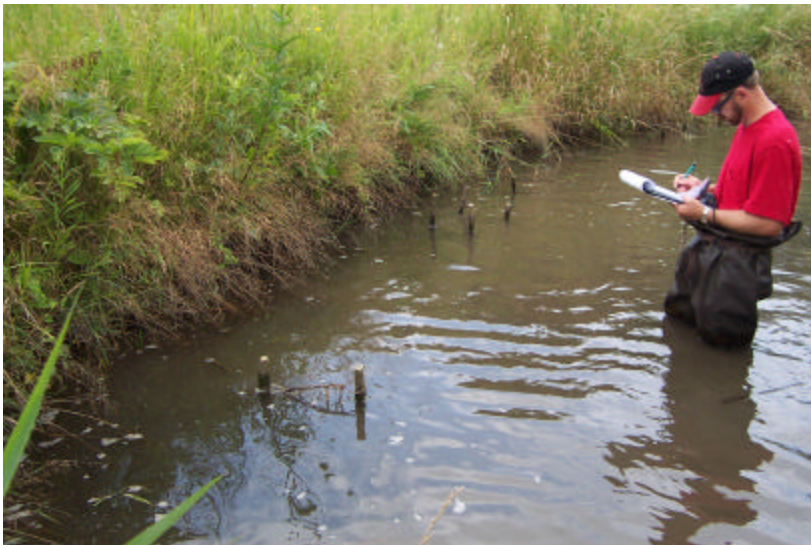
installed at a deep enough level to protect the toe area and erosion of bank soils occurred below the fiber rolls. Ultimately, the success of fiber rolls in stabilizing the bank depends on the root systems of installed plants becoming established to reinforce the degrading coir fabric and bank soil.

The fiber rolls originally held in place by these wooden stakes are missing

In cases where the vegetation did not survive, nearly empty nylon mesh was found along eroding banks with very few planted riparian species remaining. In areas of high velocity flow fiber rolls may not be the most appropriate stabilization technique. Where fiber rolls are installed a schedule for maintenance of plantings should be considered.

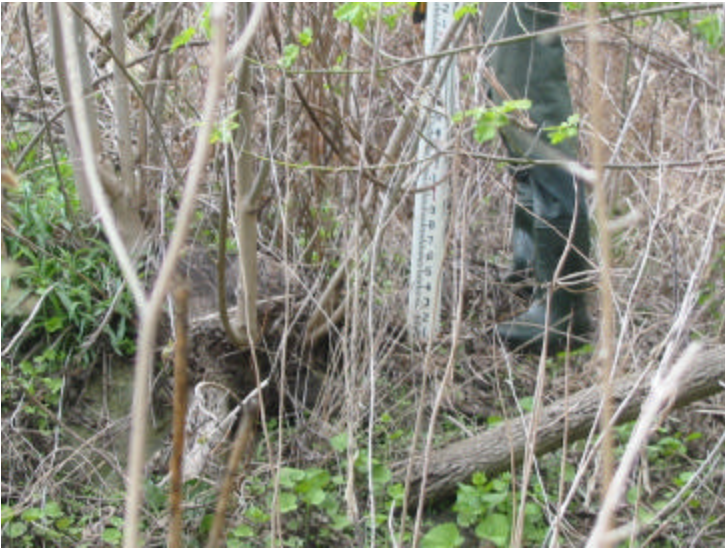
Regrowth of stumps after herbicide treatment

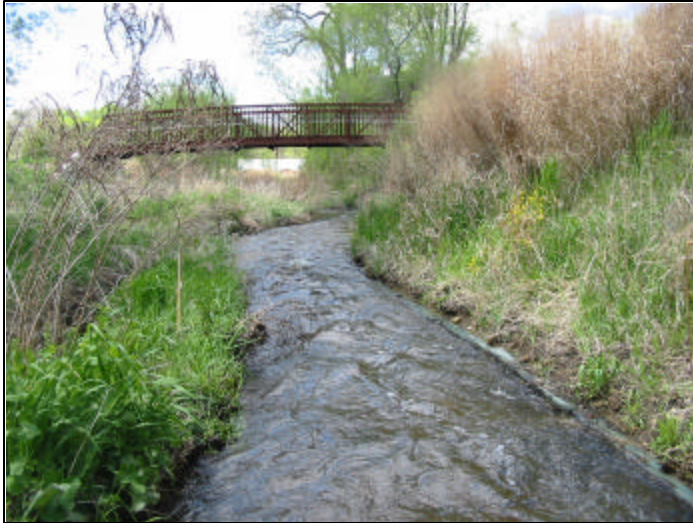
Lunkers:

The lunkers extend for about 100 feet along the right bank.

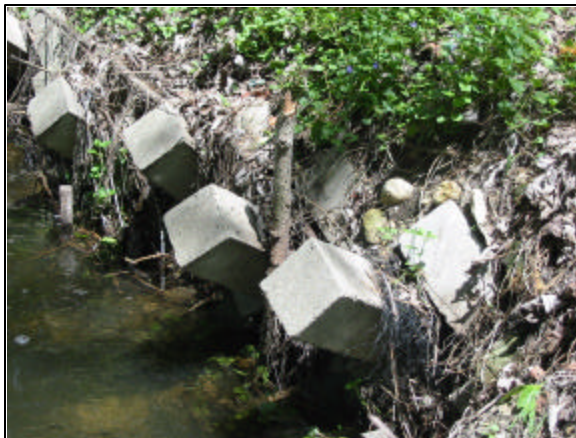
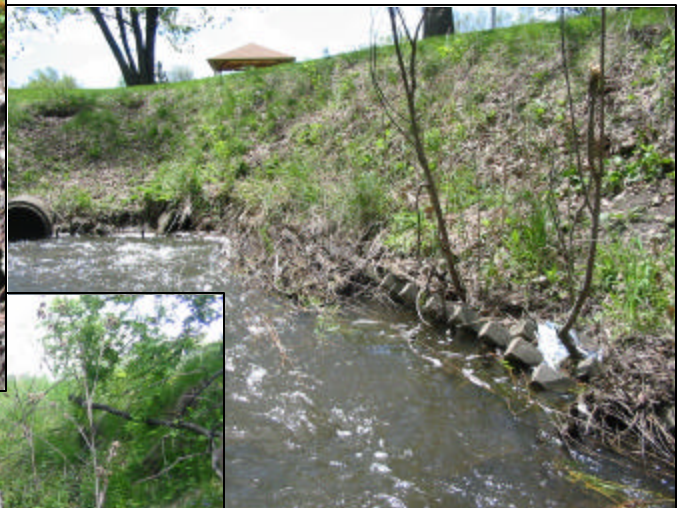
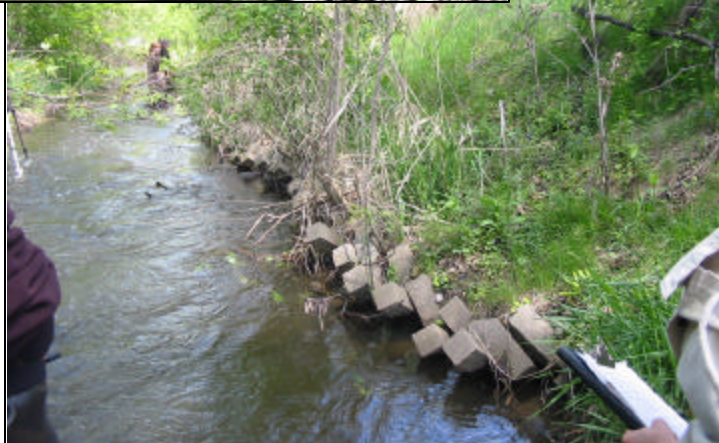
Ajacks:

Ajacks were found in four different locations in the project; some areas were aging better than others.

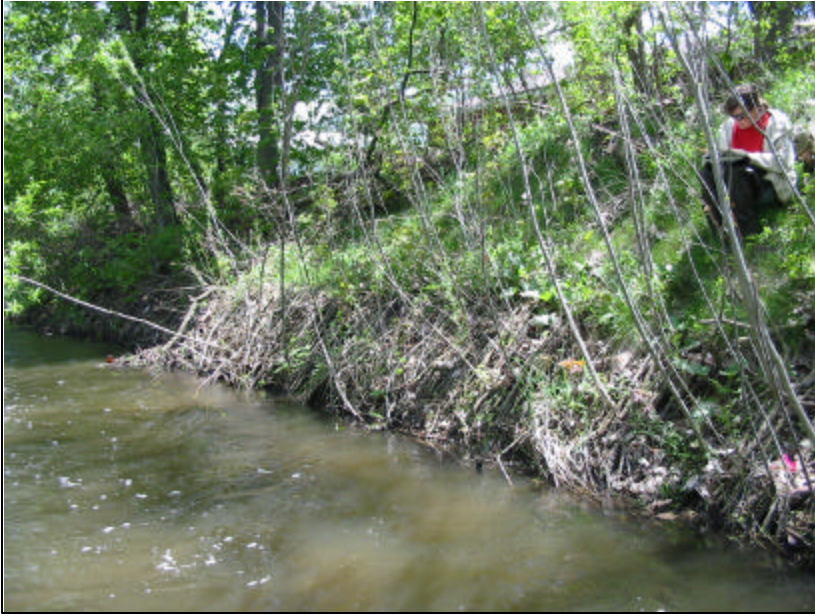
Brush mattress:

The brush mattress is held in place by willow stakes, and appears to be holding quite well.

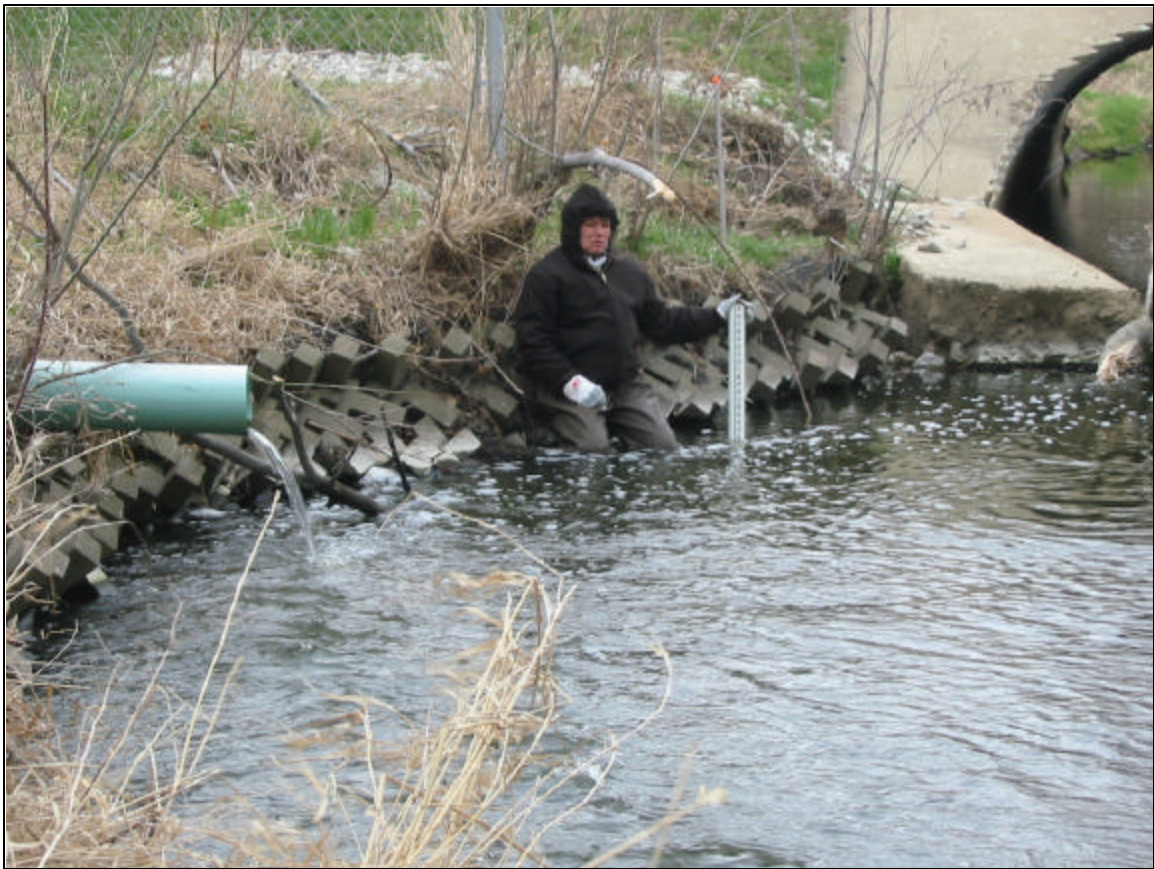
Note the depth of the stream here; the water level is higher than Cathy's knees. Pipes similar to the blue one in this photograph can be found all along the reaches both upstream and downstream of Raymond.

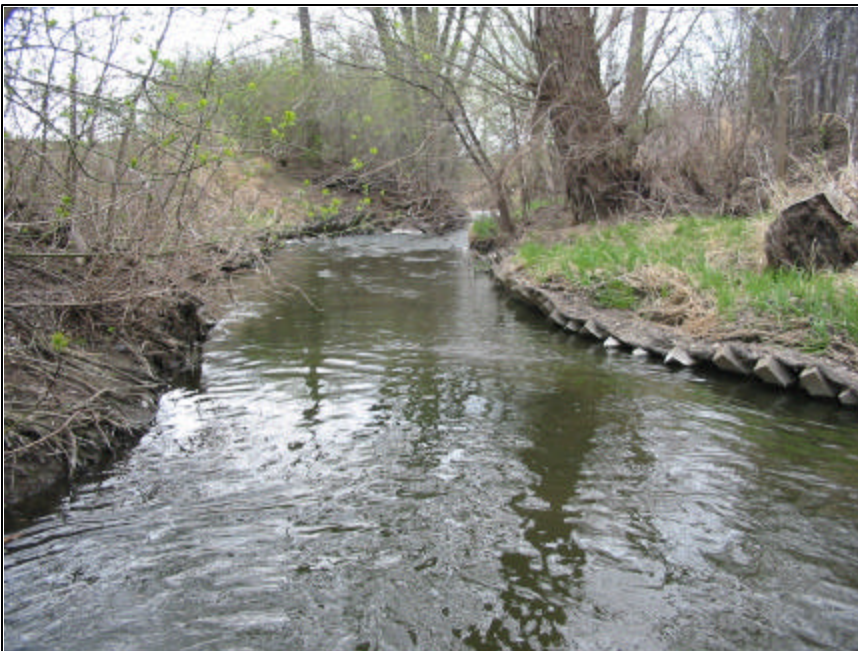
Ajacks with erosion control fabric above

The ajacks on the right bank appear very stable. Behind the ajacks, the erosion control fabric is loose and not holding soil at the edge of the stream.

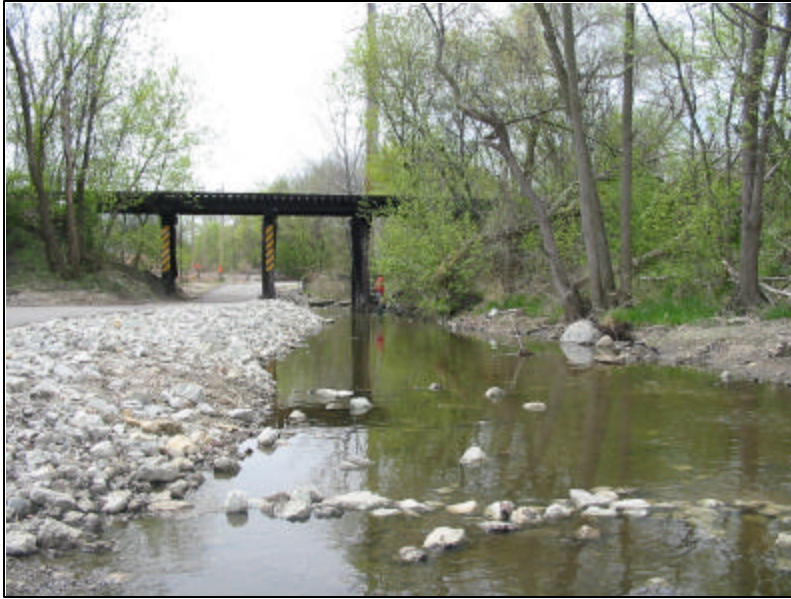
Installations upstream of Raymond Ave

This photograph, taken looking downstream, shows the mostly failed right bank installation as well as the heavy stone cover that has been installed on the left bank.

The report indicates that prairie plants were installed on the right bank, but on the day of the site visit mostly bare soil was visible.

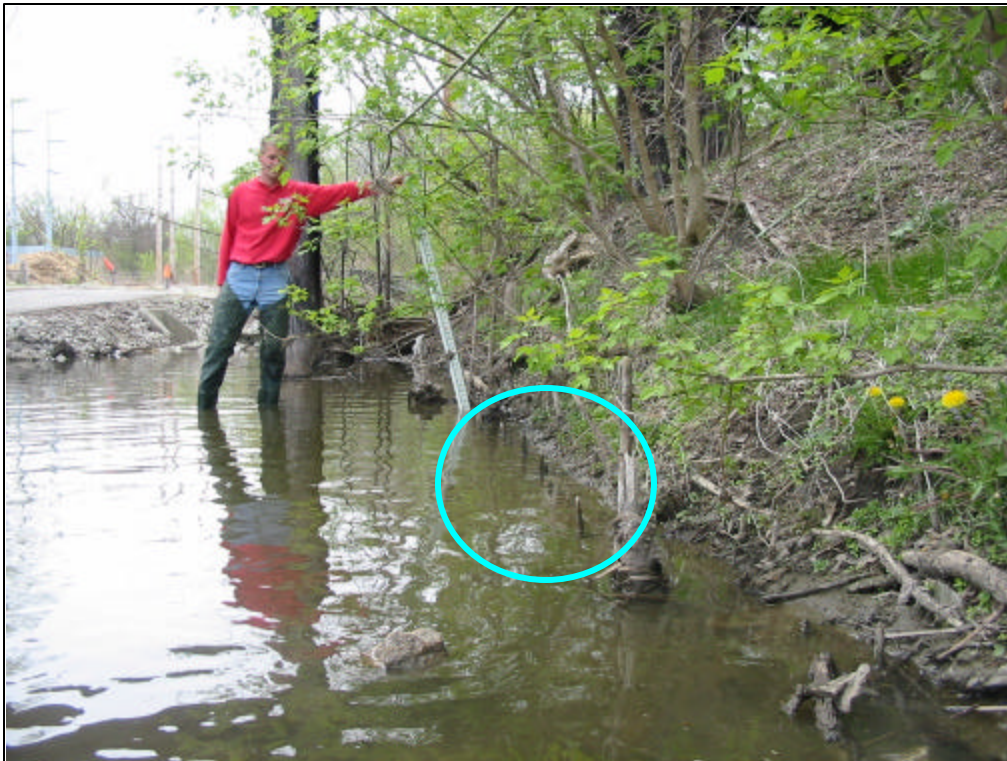
Detail of the right bank; a line of stakes is visible at the toe, though the fiber rolls that we expected to find were not apparent.

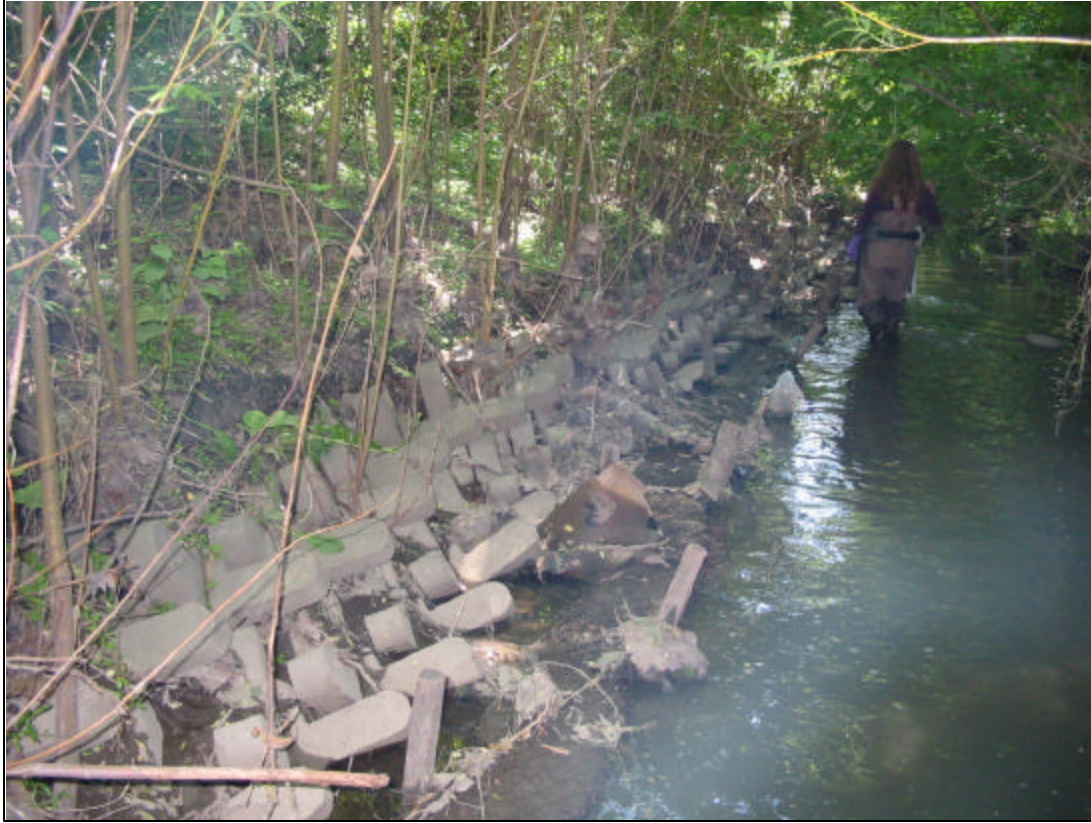
Another very typical example of the installations found on this reach. Note steep bank and shady conditions.

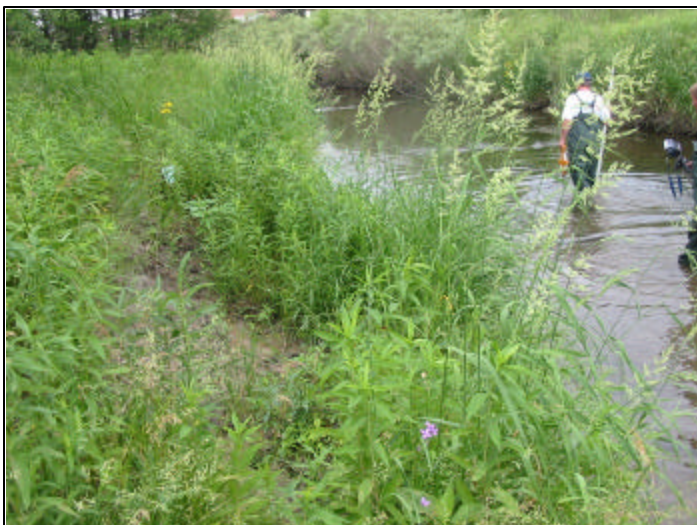
Slab failure; the slab toe was eaten away.

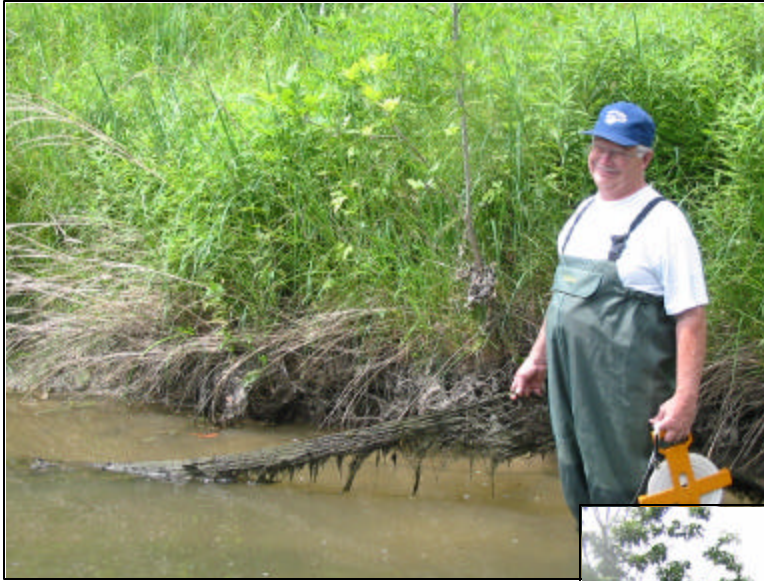
A biologist planted offshore (right bank) with water behind it – the coir fascine is empty (installation 8). This was the most eroded section.

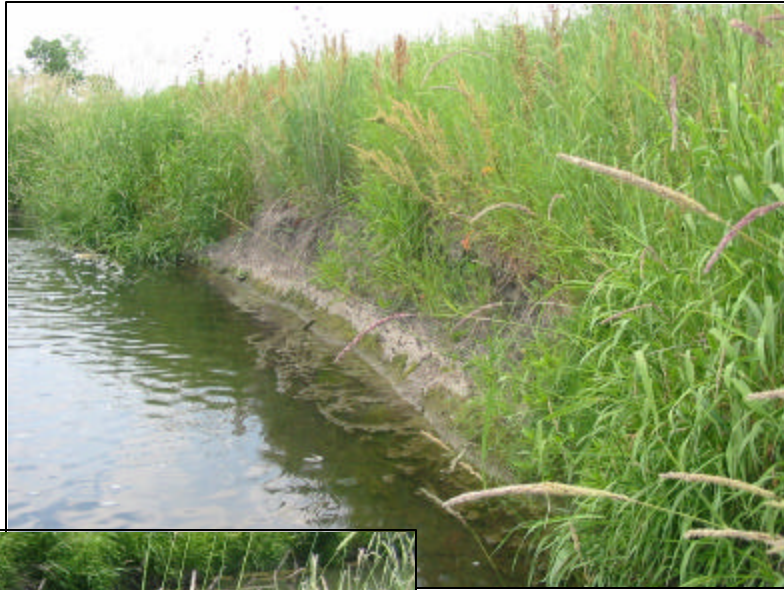
Scour on the left bank just below the first riffle. This scour is caused by the riffle.

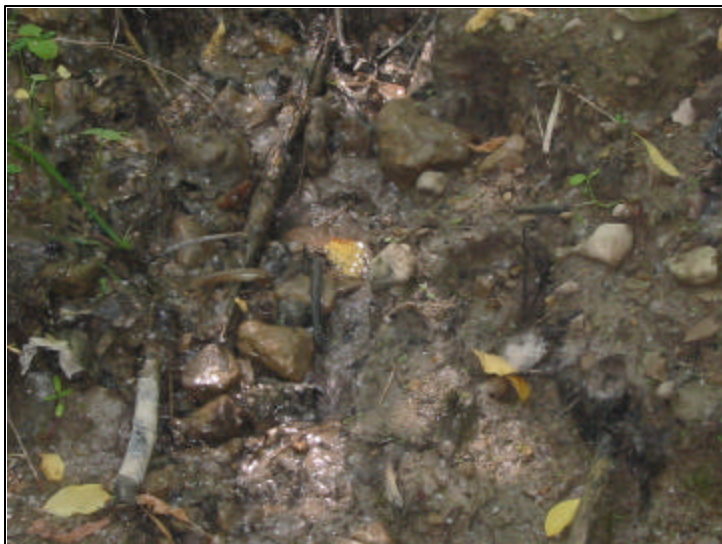
The remains of a biolog put in to stabilize the bank since the weir was not keyed into the bank.

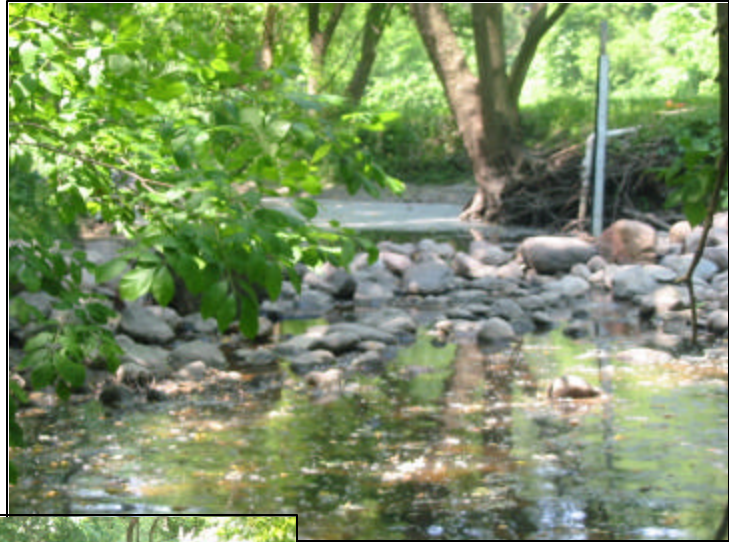
This photo was taken of a sliding seep area between the first and second weirs. The series of weirs installed along the southern channel were designed to reduce energy and sliding. A rebar was originally installed here to measure sliding, but was missing on the day of the site visit.

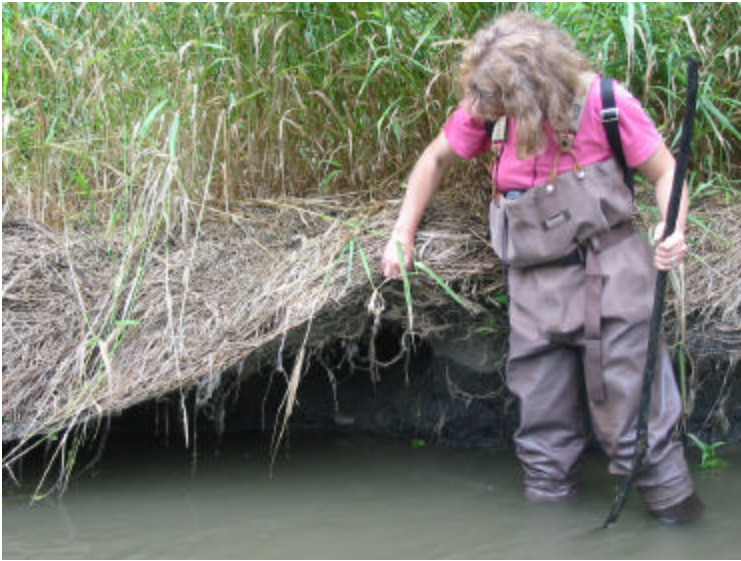
Don holding the remains of an empty fiber roll.

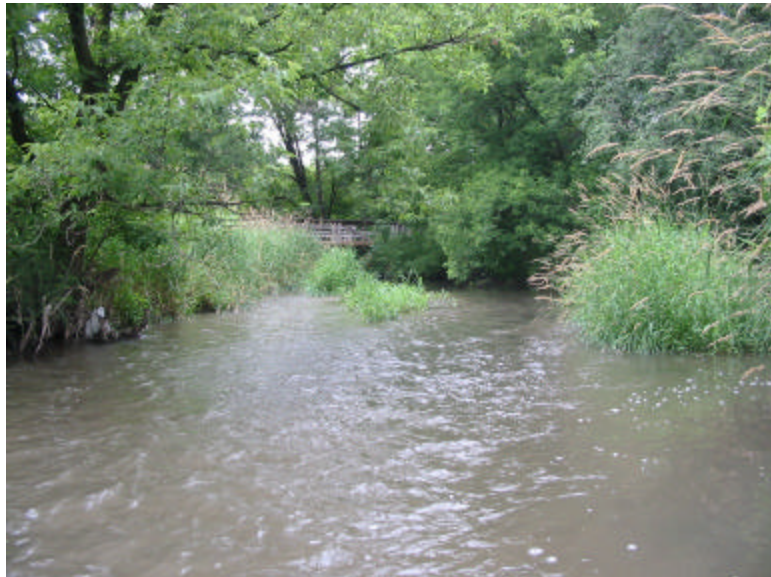
At installation 4, where bank grading and fabric were installed, 2 rolls of fabric were found, one overlaying the other. In some areas the bank was eroded and undercut behind the fabric.

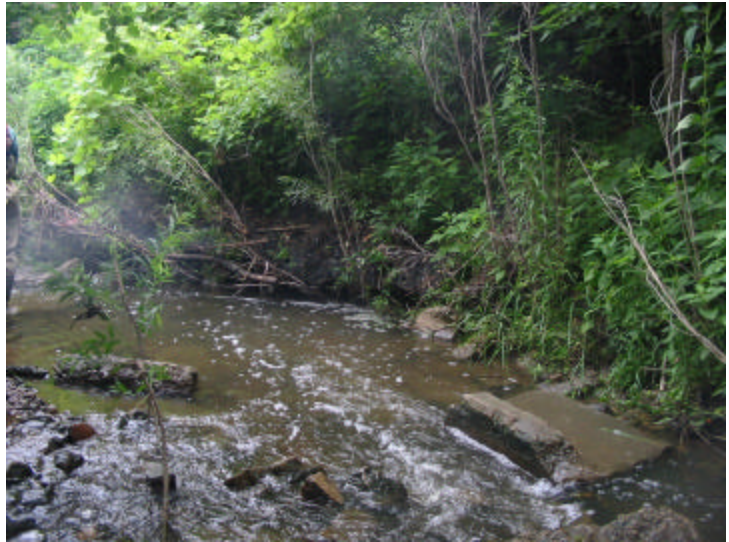
The outside meander bend where installation 1 is blown out and the bank is undercut. The pool depth in this area was 1 foot and bank stability was not very good.

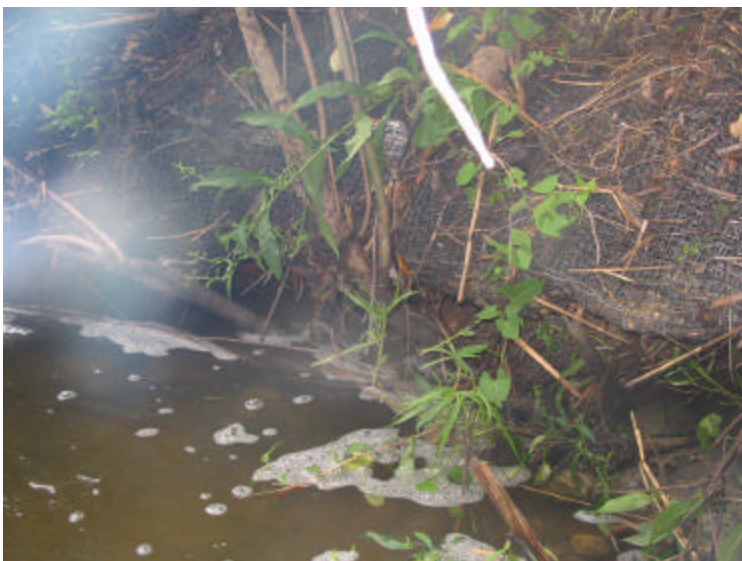
Close up of the bank undercutting on the outside of the meander bend.

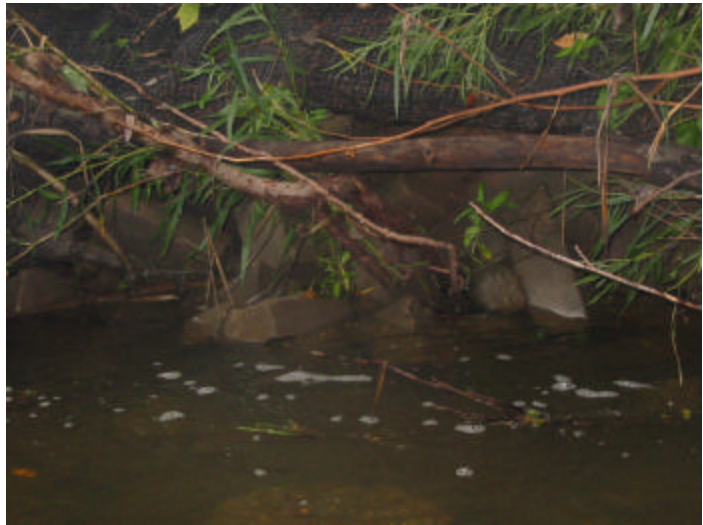
Ajacks from installation 1 with their outer legs cracked or broken off. A second row of ajacks was still holding the bank here.

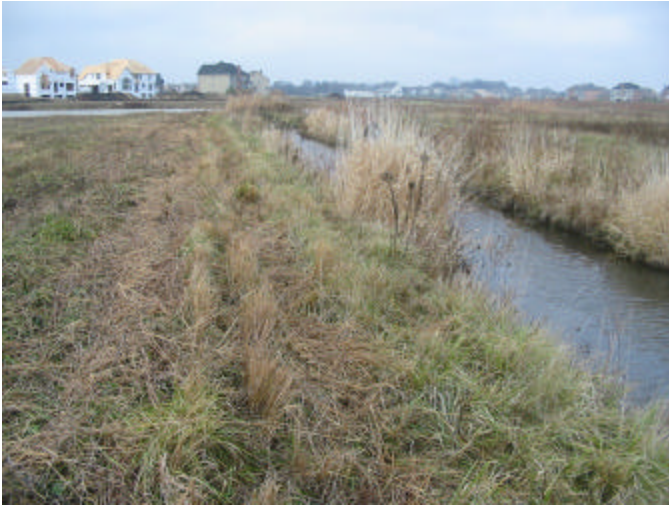
105 feet of erosion on the right bank at the apex of the meander bend (installation 10). Stability was generally good downstream of this area, with only a few relatively short erosional areas seen farther downstream.
