**CALUMET AREA HYDROLOGIC
MASTER PLAN (HMP)
EXECUTIVE SUMMARY
(VOLUME I)**

**CALUMET AREA
CITY OF CHICAGO, COOK COUNTY, ILLINOIS**

AUGUST 2006

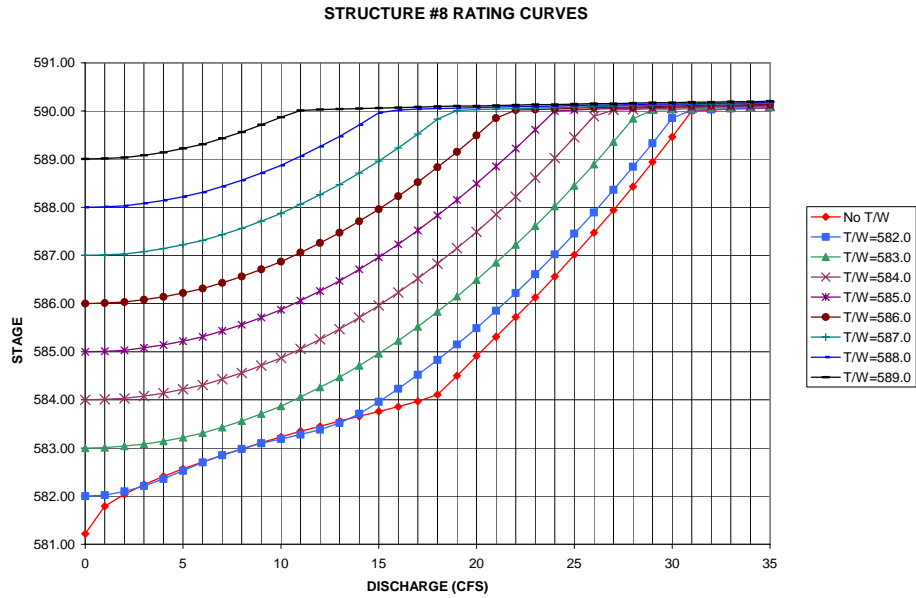
Figure 2: Structure #8 stage-discharge curve (Big Marsh)

V3's engineering investigation determined that there are three control structures that influence the hydrologic behavior at Big Marsh. From the north, Big Marsh is fed by Norfolk Southern Railroad Marsh. The connection structure is a 24" diameter non-adjustable culvert that conveys into a stream channel then into the Marsh itself (Figure 3; Structure #8; Vols II, IV). Resulting from stage-discharge modeling (Figure 2), structure #8 has an acceptable discharge capacity for storm events and V3 suggests that no improvements need to be made to this control; however an annual maintenance program should exist.

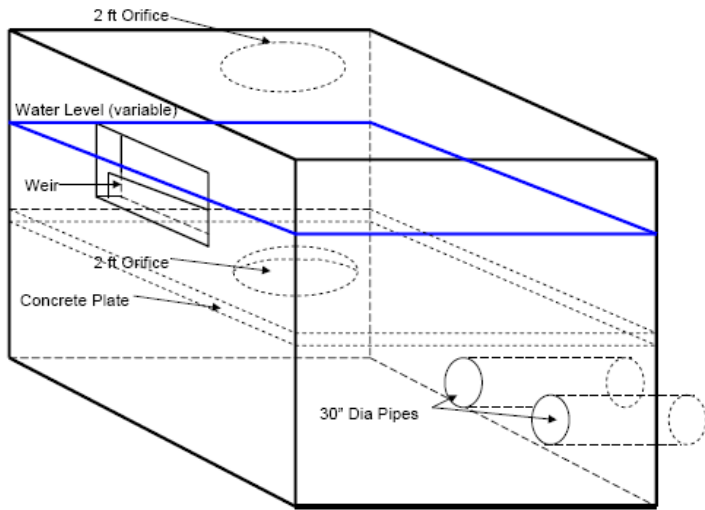
Figure 4: Structure #5, Hydraulic Geometry

The second control structure is the outlet structure which is composed of a rectangular concrete drop inlet with twin 30" outlet pipes that connect to Lake Calumet (Figure 4; structure #5; Vols II, IV). This control structure is adjustable; however it does not have an acceptable discharge capacity. It can take along extended period of time to release runoff from extreme events. Under this condition, the control structure promotes higher water levels for extended periods of time (Figure 6). In addition, the structure is susceptible to blockage from debris accumulation which may further increase the drawdown time of water levels following a storm event. V3 provides recommendations to construct a secondary outlet at this location and implement an annual maintenance program to reduce the blockage threat (Volume IV).

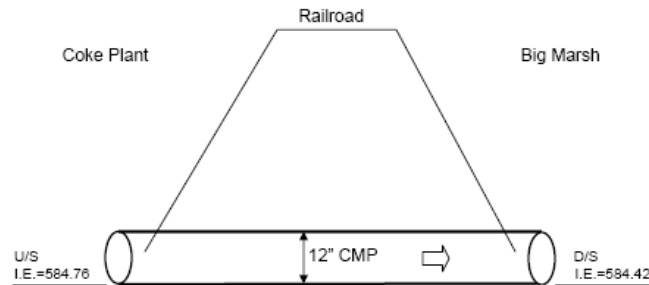
Figure 7: Structure #14, Hydraulic Geometry

The final control structure is #14 and is a single non-adjustable 12" diameter culvert that drains 62 acres and regulates discharge from the Coke Plant to Big Marsh (Figure 7). Stage discharge relationships were developed and determined that the structure functions as designed and has an acceptable discharge capacity, the only recommendation for structure # 14 is to designate an annual maintenance program of the culvert (Volume IV).

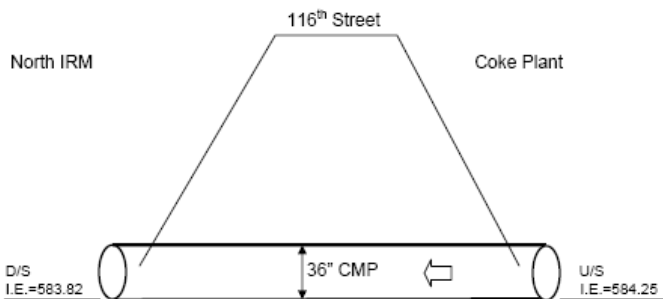
Figure 11: Structure #7, Hydraulic Geometry

V3's engineering investigation determined that there are two control structures that influence the hydrologic behavior at Indian Ridge Marsh North. From the north a culvert drains areas of the Coke plant into the marsh. The connection consists of a 36" non-adjustable culvert that conveys approximately 62 acres of drainage area into Indian Ridge Marsh North (Figure 11; Structure #7; Vols II, IV). A detailed drainage investigation of the coke plant was not conducted and it is unknown which areas of the coke plant drain to the culvert. Stage/discharge modeling indicated that this structure has an acceptable discharge capacity for storm events, and no improvement recommendations are made except for the implementation of an annual maintenance program. It is unknown whether this culvert is managed by the owners of the adjacent coke plant.

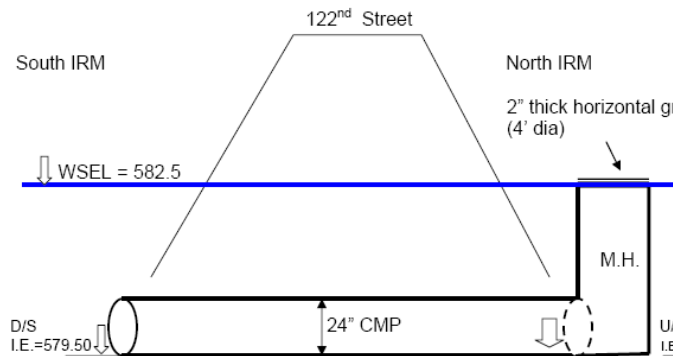
Figure 12: Structure #3 Hydraulic Geometry (Indian Ridge Marsh North)

The second control structure is the outlet which is an inlet box and attached 24" culvert (Figure 12; Structure #3, Vols II, and IV). The box rim sets the normal water level for the primary pool of Indian Ridge Marsh North. Through hydrologic modeling, V3 determined that this structure safely releases storm volumes; however, improvement recommendations are made due to the structure's tendency to become blocked, which restricts flows and influences water elevations (Volume IV). In 2001, Harza Inc. repaired the outlet and it was apparent that beaver levelers may be required at this location. In addition, the culvert pipe is believed to be from the 1920's and may be rusted and partially collapsed. V3 recommends inspecting and rehabilitating the

culvert, replacing the manhole with a water level control structure and installing a beaver leveler. Structure #3 should also have an annual maintenance program enacted.

- *An annual structure maintenance program should be enacted for all structures at Indian Ridge Marsh North (Structures #3, #7) (Volume IV).*
- *At Structure #3, V3 recommends inspecting and rehabilitating the culvert, replacing the manhole with a water level control structure and installing a beaver leveler.*
- *V3 recommends a hydrogeologic study of Indian Ridge Marsh North and its surroundings to investigate the influence of the Cluster Sites (West of IRM North) and the magnitude groundwater influences to the site.*

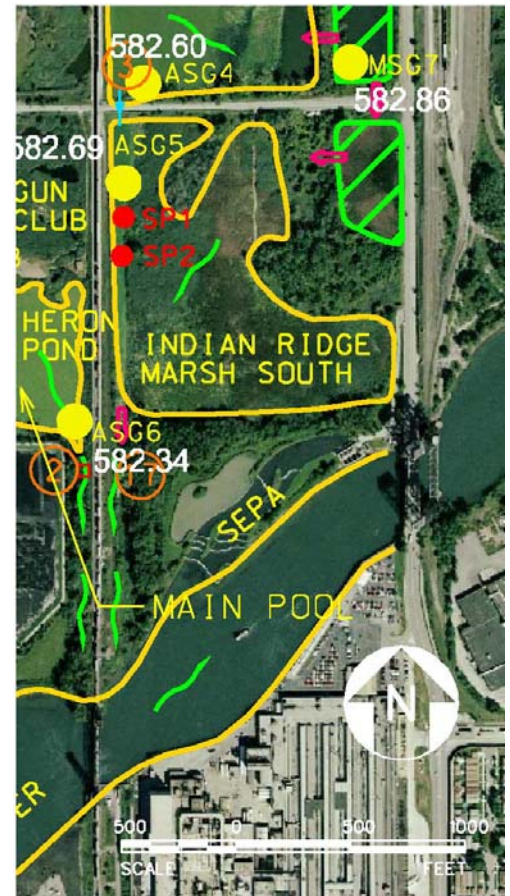
Figure 14: Structure #17, outlet channel from Indian Ridge Marsh South

The outlet of Indian Ridge Marsh South is simply an open channel with no control structure; hence the main control of water elevations in the marsh is the channel outlet bottom and the channel's ability to convey storm event discharges (Figures 14 & 15; Structure #17). Additionally, tail water of the Calumet River could play a role in water elevations during very significant storm events. The stage/discharge curves for this structure are provided in Figure 16. V3 recommends installing a concrete weir with stop logs at this outlet location, so that discharge and water levels can be better controlled to suit future ecological management decisions (Volumes II & IV).

- *An annual structure maintenance program should be enacted for all structures at Indian Ridge Marsh South (Structures #3, #17) (Volume IV).*
- *At Structure #3, V3 recommends inspecting and rehabilitating the culvert, replacing the manhole with a water level control structure and installing a beaver leveler (Volume IV).*
- *At Structure #17, V3 recommends installing a concrete weir with stop logs, so that discharge and water levels can be better controlled to suit future ecological management decisions.*

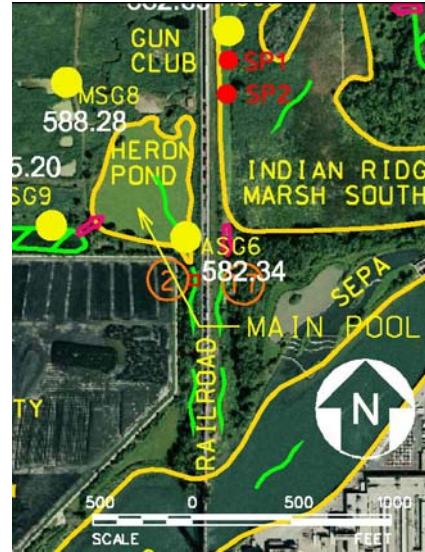
Figure 20: Structure #2, Channel Geometry (Heron Pond Outlet Channel)

V3's engineering investigation determined that the only control structure that influences the hydrologic behavior at Heron Pond is the outlet channel that conveys discharge into the Calumet River (Structure #2, Vols II,IV; Figure 20). Within this channel, a rudimentary man-made weir made of grass clippings and vegetation attempts to control water elevations in the pond (Figure 21), V3 determined that the man-made weir does not significantly restrict the rate of discharge exiting the pond. Modeling for the outlet channel indicated that tail water conditions from the Calumet River can influence water elevations within Heron Pond during significant storm events (Figure 22). The primary controls on water elevations in Heron Pond are the channel bottom elevation and the discharge capacity of the open outlet channel. V3 recommends installing a concrete weir with stop logs at the pond outlet in order to control discharge and water elevations at Heron Pond, this option allows for water elevations to be adjusted based on future ecological management decisions. Lastly, an annual maintenance program should be enacted for Structure #2 (Volume IV).

- *An annual structure maintenance program should be enacted for the structure at Heron Pond (Structure #2) (Volume IV).*
- *At Structure #2, V3 recommends installing a concrete weir with stop logs, so that discharge and water levels can be better controlled at Heron Pond to suit future ecological management decisions.*
- *V3 recommends a site specific hydrogeologic investigation to properly assess groundwater flow directions around Heron Pond, and evaluate possible influences with Cluster Sites located to the North of Heron Pond.*
- *V3 recommends a further detailed water quality study in order to further establish aquatic health conditions at Heron Pond.*

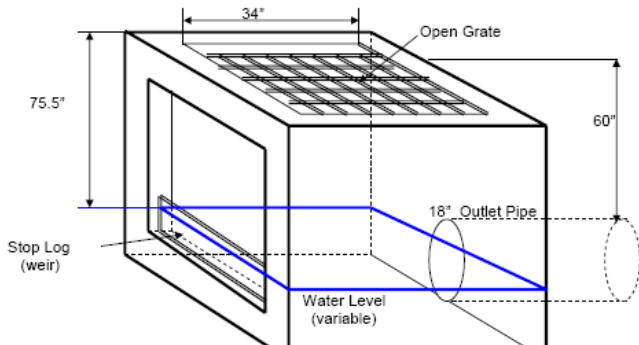
Figure 27: Structure #1, Hydraulic Geometry

V3's engineering investigation evaluated the outlet structure that regulates Deadstick Pond discharge into the Calumet River (Figure 27; Structure #1; Vols II, IV). The structure is an adjustable rectangular concrete box structure with adjustable stop logs (Figures 27 & 28). The box is connected to an 18" culvert that conveys discharge into the Calumet River. Under low flow conditions, the water elevations in Deadstick Pond are controlled by the stop logs. During higher flow conditions the water elevations are controlled by the discharge capacity of the outlet pipe and tail water conditions from the Calumet River. Figure 29 shows hydraulic stage/discharge modeling conducted by V3 suggests that this outlet control structure has an acceptable discharge capacity for large storm events and does not appear to be susceptible to blockage (Volume II, IV). V3 recommends clearing the outfall channel of structure #1 and stabilizing the banks with rip-rap in addition to an annual maintenance program for structure #1.

- *An annual structure maintenance program should be enacted for the outlet structure at Deadstick Pond (Structure #1) (Volume IV).*
- *At Structure #1, V3 recommends clearing the outfall channel and stabilizing the banks with rip-rap.*
- *V3 recommends a site specific surface water quality study in conjunction with a hydrogeologic investigation to assess potential sources of poor water quality and groundwater flow patterns at Deadstick Pond.*

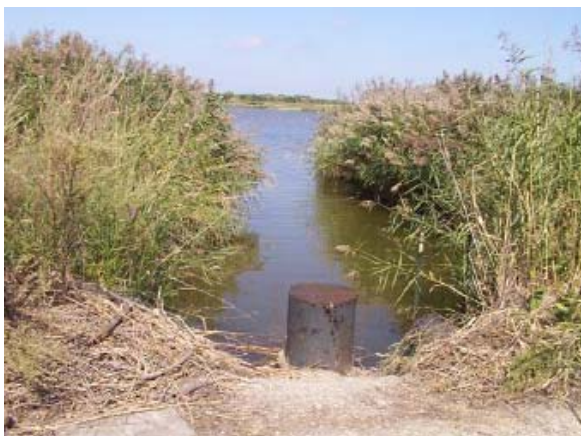
Figure 33: Structure #15, facing North (Conservation Area Outlet)

V3 evaluated the outlet control structure #15 that regulates flow from the Conservation Area into Lake Calumet (Figures 33 & 34; Vols II, IV). The structure consists of two ductile iron pipe culverts (24" and 18") which are equipped with stop logs to control water elevations in the Conservation Area. Hydraulic modeling indicated that the structure has an unacceptable discharge capacity and it may take up to 28 days to release large rainfall events (Figure 35). V3 recommends stabilizing the outlet area of structure #15 with rip-rap, constructing a secondary structure to convey flows from large storm events and enact an annual maintenance program for the structure(s).

- *An annual structure maintenance program should be enacted for the outlet structure at the Conservation Area (Structure #15) (Volume IV).*
- *At Structure #15, V3 recommends stabilizing the outlet area of structure #15 with rip-rap and constructing a secondary structure to convey flows from large storm events and reduce drawdown times of the Conservation Area waterbody (Volume IV).*

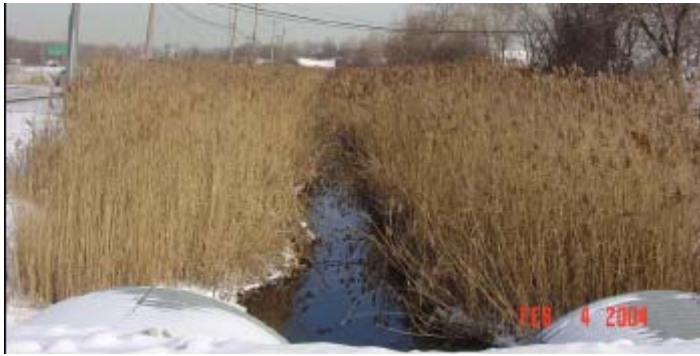
Figure 37: Pullman Creek at Harborside Golf Course Entrance

Volume III provides the study in which V3 conducted a detailed Pump station analysis and evaluated the hydraulic capabilities of the Pullman Creek stream channel. The stream channel collects flows from a series of six culverts that drain sources such as the IDOT right of way and Harborside Golf Course. Hydraulic modeling indicated that the stream channel could not effectively convey floods for a 50 year storm event, which would result in pavement flooding. Additionally, sediment accumulation is a concern in the stream channels as it reduces the capacity to convey large flood flows.

Multiple recommendations are provided to improve the hydraulic functions of Pullman Creek. Recommendations include re-configuring the pump station, changing invert elevations of culverts, constructing an overpass bridge to remove culverts and dredging the Pullman Creek channel. The recommendations will improve reduce stage heights, and improve flood conveyance capacity and likely eliminate flooding issues associated with large storm events.
