Flood of September 2008 in Northwestern Indiana

Open-File Report 2010–1098

By Kathleen K. Fowler, Moon H. Kim, Chad D. Menke, and Donald V. Arvin

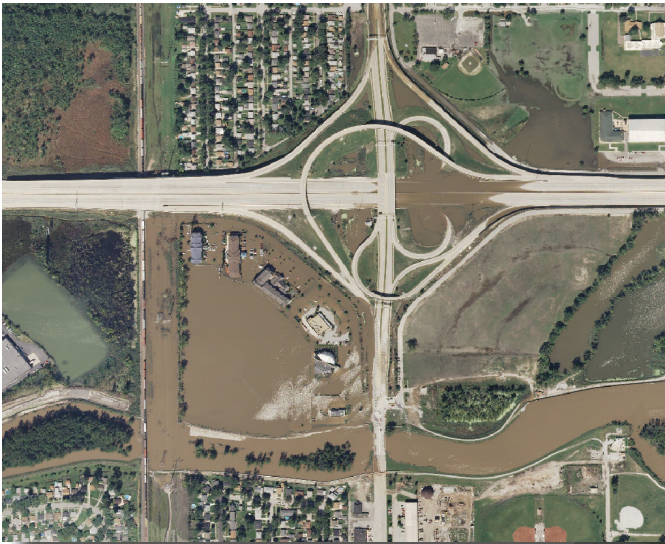
Left—Little Calumet River south of Interstate 80 and the Kennedy Avenue Interchange at Hammond, Ind., September 16, 2008. (Aerial photo, at 1:14,000 scale, courtesy of the U.S. Army Corps of Engineers.)

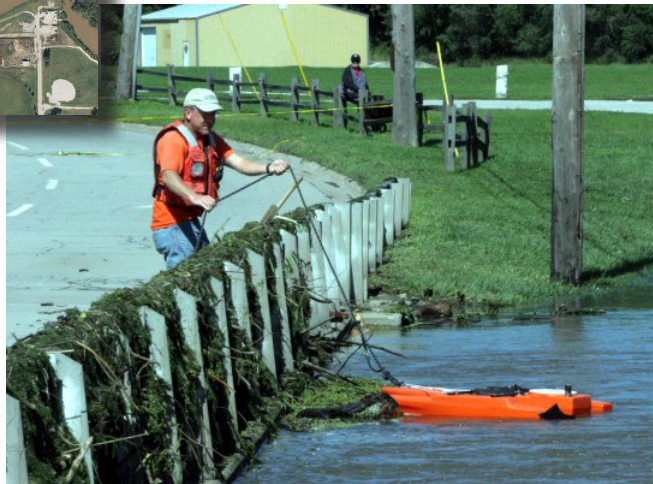
Right—Discharge measurement made by Acoustic Doppler Current Profiler on Deep River at Lake George Outlet at Hobart, Ind., U.S. Geological Survey station 04093000. (Photograph by Ron G. Knapp, U.S. Geological Survey.)

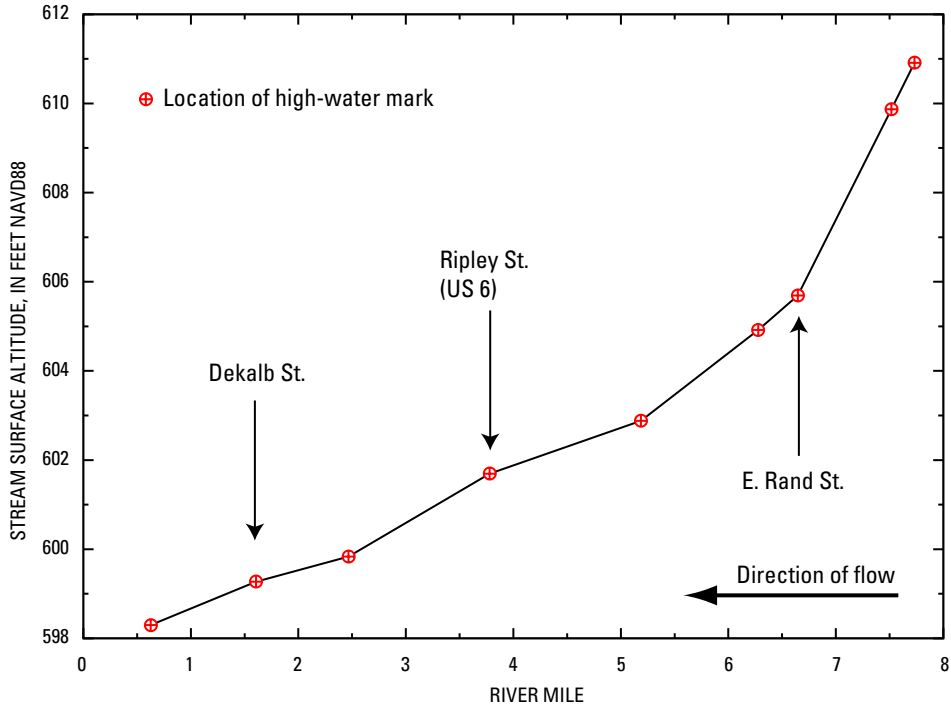
Flood-peak elevation profile, flood of September 2008, for Deep River near Hobart, Indiana.

Water surfaces were estimated by linear interpolation between high-water marks. A linear interpolation between high-water marks is an approximation of the actual water surface; the actual water surface may have substantially departed from the water surface depicted in the profiles in some locations. For example, it is common for the water surface to drop between the upstream and downstream face of a bridge or culvert; potential water-surface elevation drops may not be reflected in the profiles. In some plots, a rise in the profile in the downstream direction can indicate a backwater condition caused by an obstruction. Water-surface elevations are referenced to the North American Vertical Datum of 1988 (NAVD 88).

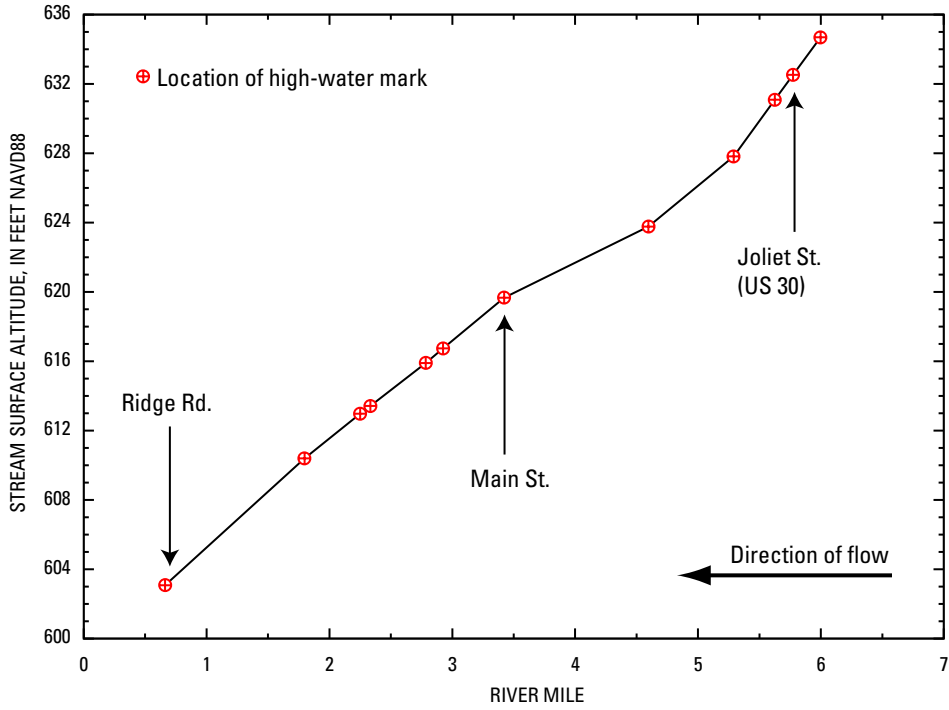
Flood-peak elevation profile, flood of September 2008, for Hart Ditch/Plum Creek near Dyer, Indiana.

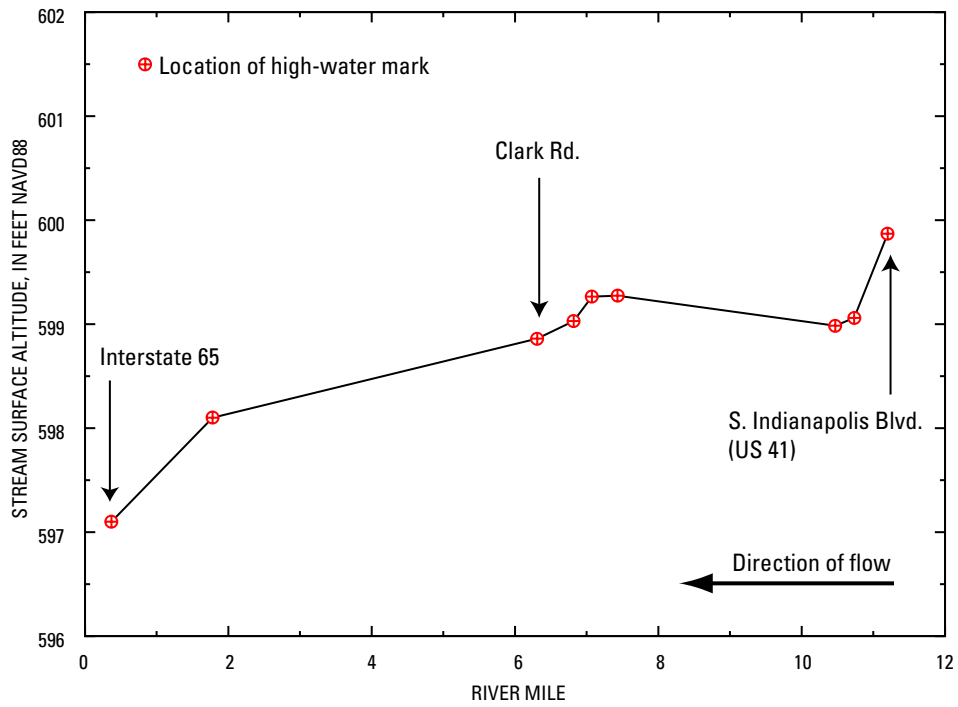
Flood-peak elevation profile, flood of September 2008, for Little Calumet River near Highland, Indiana.

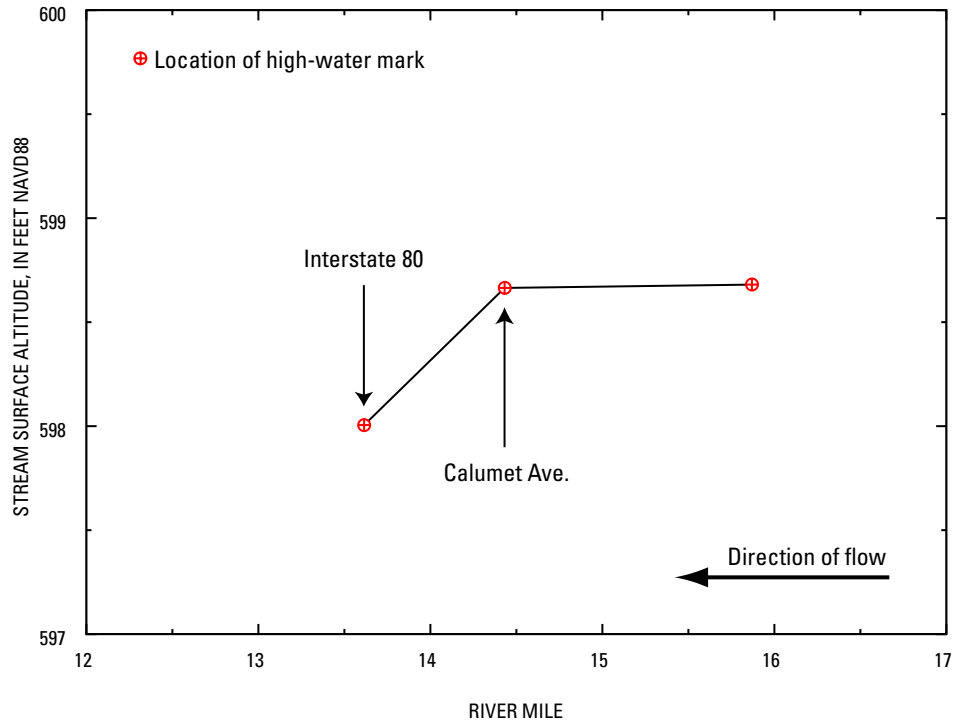
Flood-peak elevation profile, flood of September 2008, for Little Calumet River near Munster, Indiana.

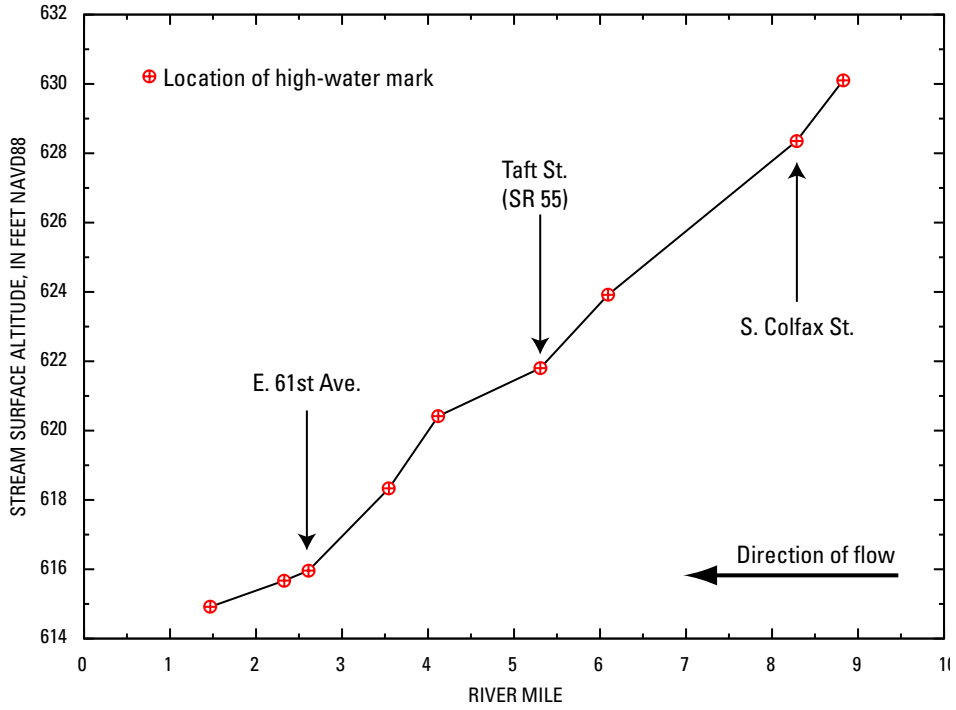
Flood-peak elevation profile, flood of September 2008, for Turkey Creek near Schererville, Indiana.

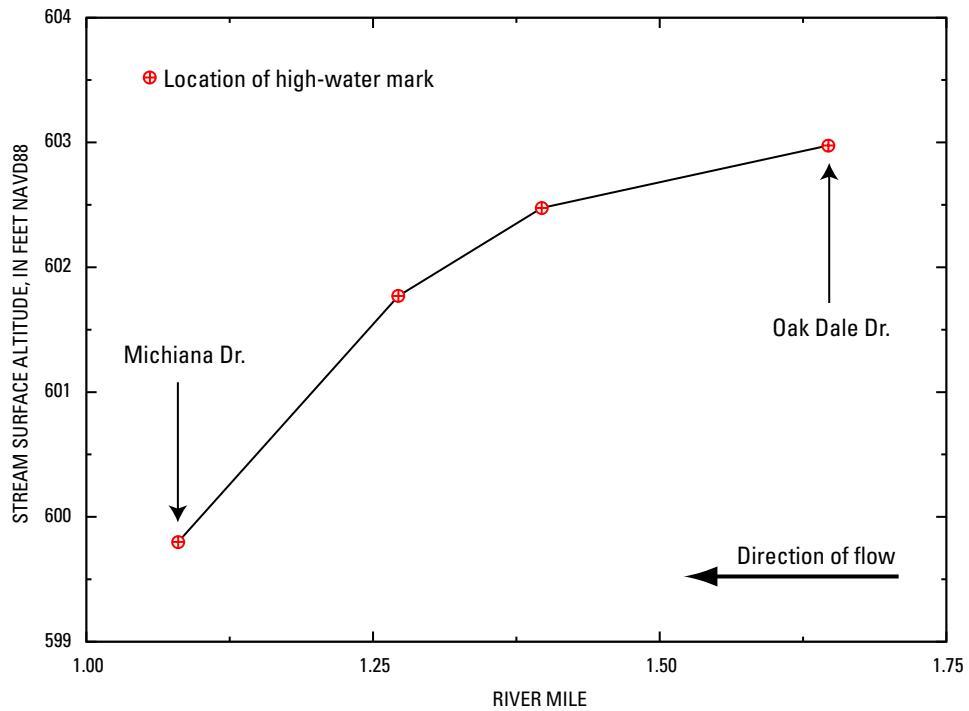
Flood-peak elevation profile, flood of September 2008, for White Ditch at Michiana Shores, Indiana.
