**VOLUME V
WATER LEVEL MONITORING,
GROUNDWATER SEEPS AND
WATER QUALITY MONITORING
REPORT**

**CALUMET AREA
CITY OF CHICAGO, COOK COUNTY, ILLINOIS**

(DATA: JULY 2003 - JULY 2004)

AUGUST 2006

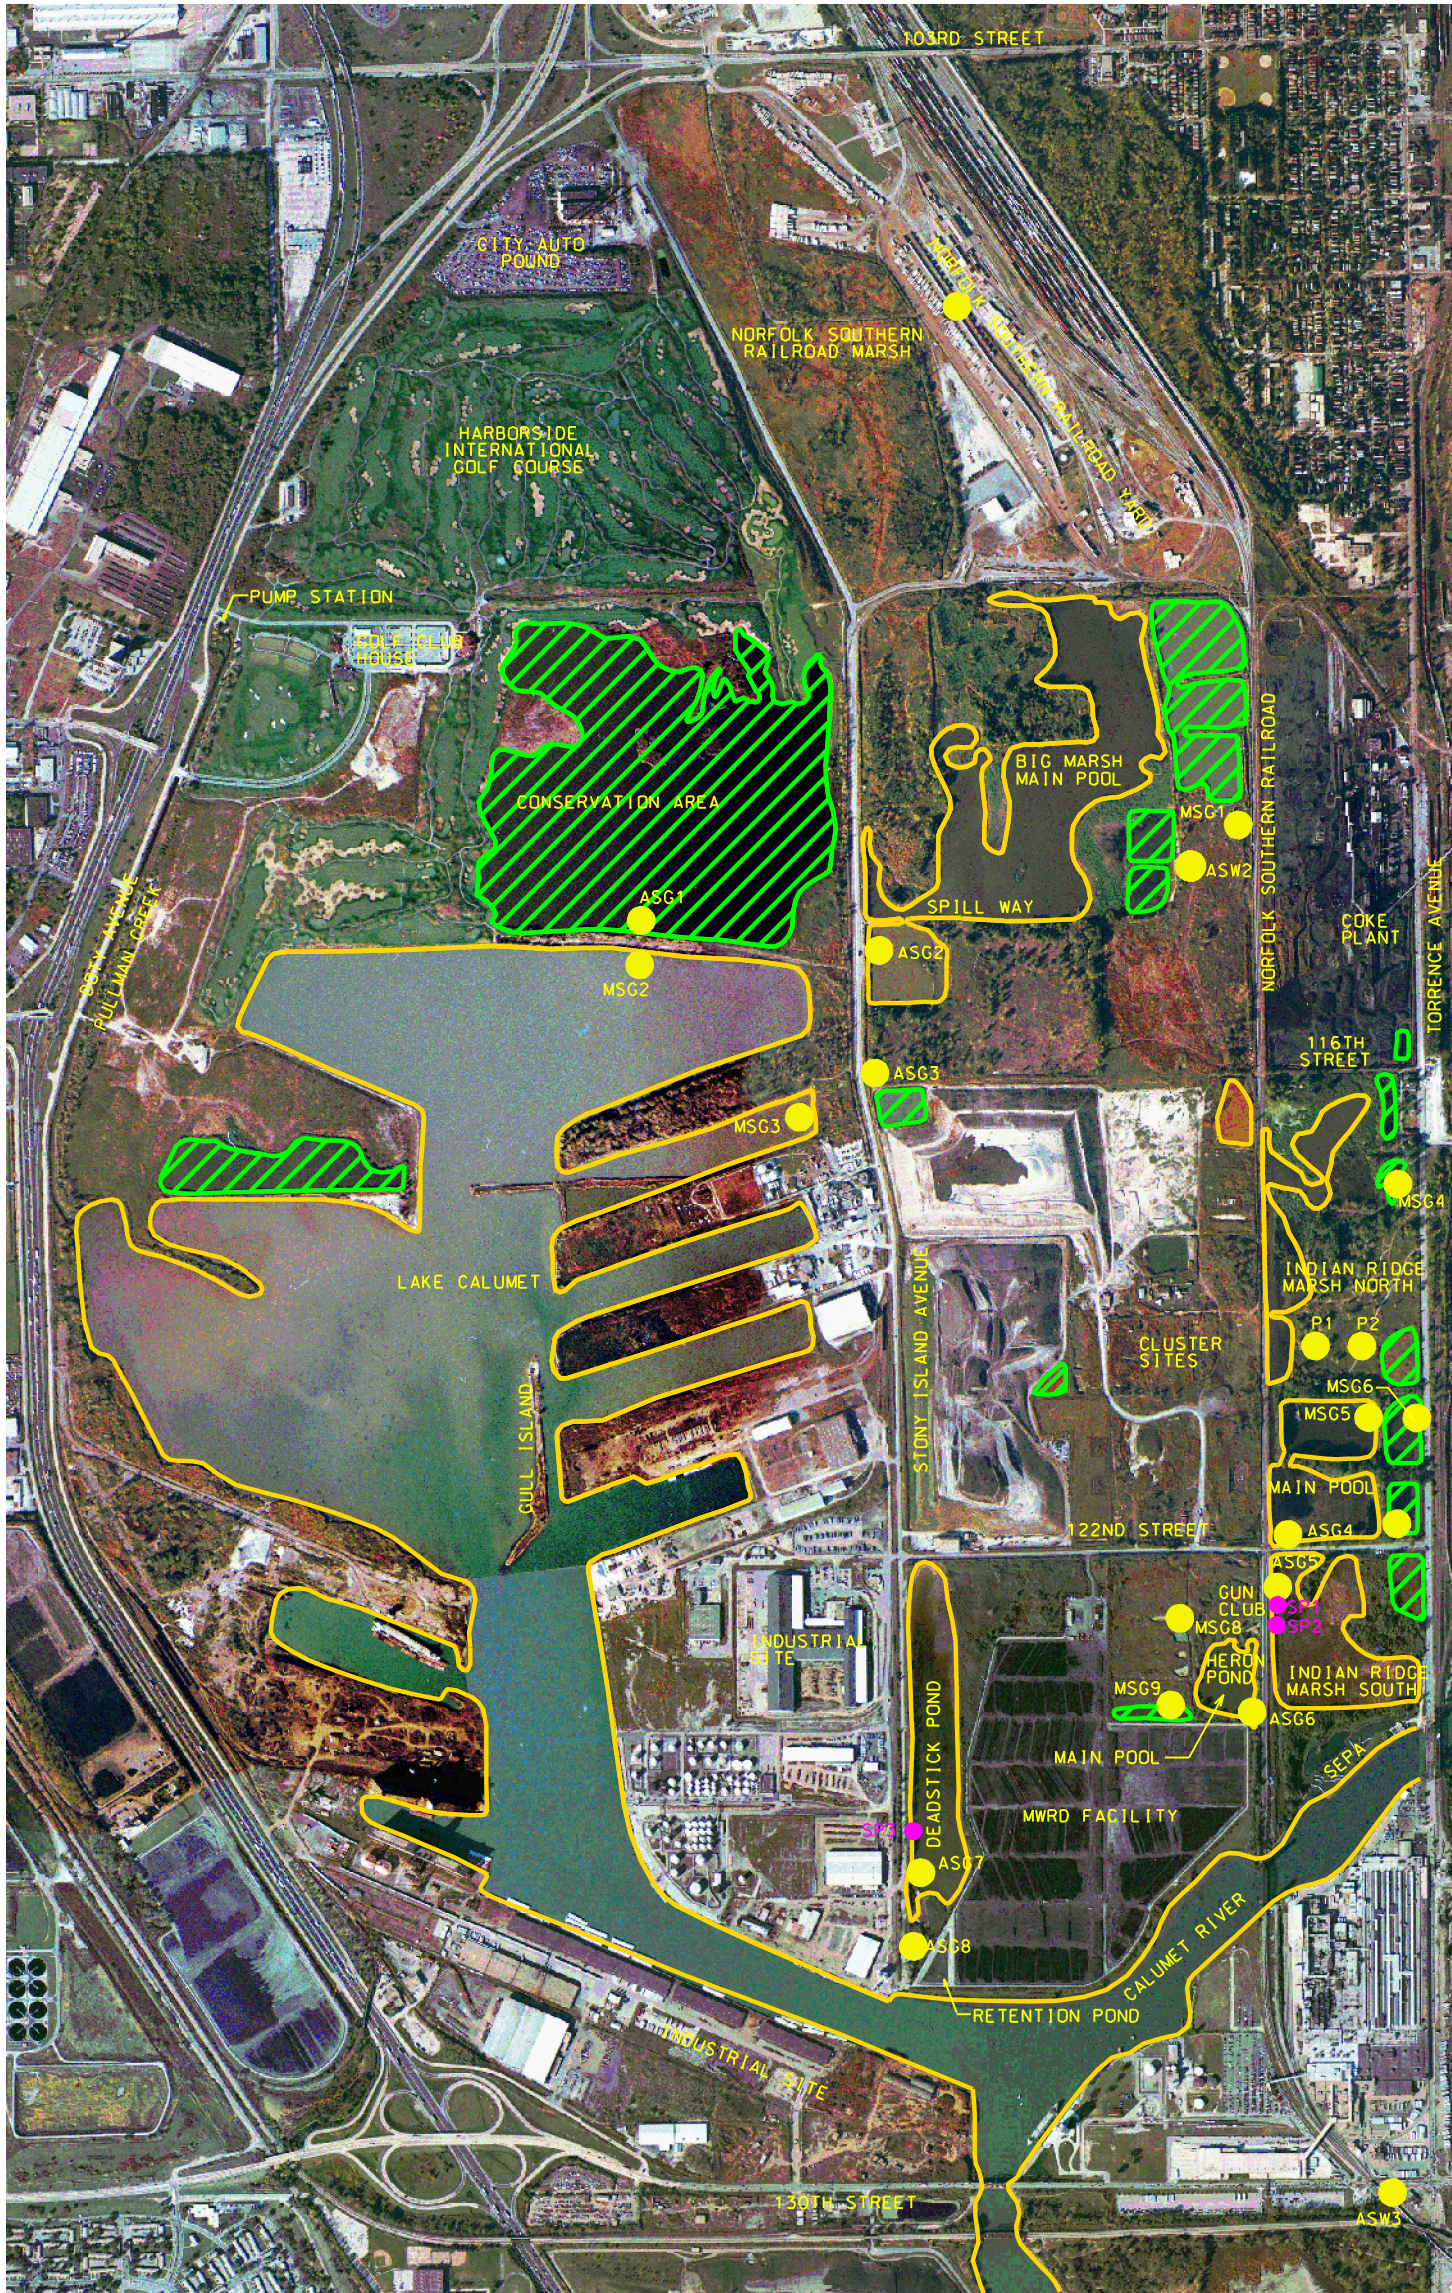
DRAWING NO.
1

HMP MONITORING NETWORK & SEEP LOCATIONS
CALUMET AREA HYDROLOGIC MASTER PLAN
 CHICAGO ILLINOIS

Data collected as a result of this network (see Figure 1) includes:

Two (2) automatic staff gages were installed to evaluate Big Marsh. ASG 2 was installed along Stony Island Avenue to monitor water level fluctuations in the main pool for Big Marsh (Figure 1). ASG 3 was installed immediately upstream of the outlet from Big Marsh to Lake Calumet (Figure 1). The necessity of this second installation was driven by the observed channel gradient from the main pool to the Big Marsh outlet. Several additional monitoring stations were established at Big Marsh:

Two automatic staff gages (ASG 7, ASG 8) were installed in Deadstick Pond (Figure 1). ASG 7 was installed to monitor representative water level fluctuations within the main pool of the pond. ASG 8 was installed immediately upstream of the outlet to the Calumet River at the water control structure. ASG 8 was installed due to the observed channel gradient from the primary pool to the outlet control structure. The combined installations provide the data necessary to correlate conditions within the main pool and outlet channel in association with any temporal changes in site conditions and during runoff events.

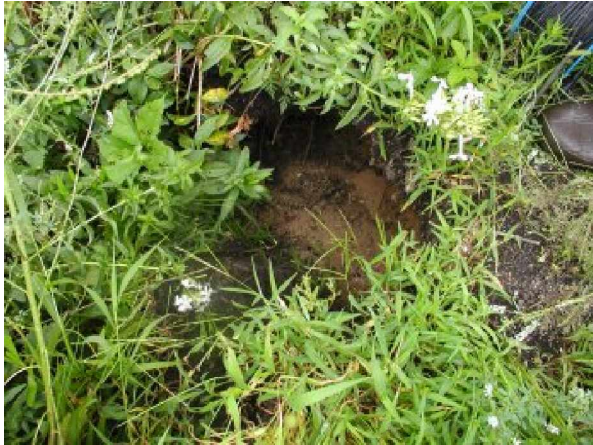
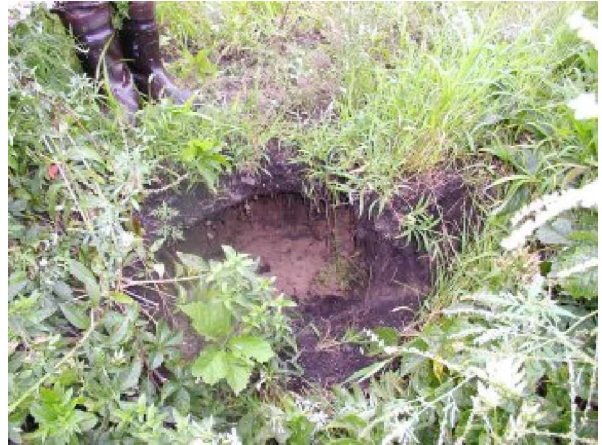
Seep#1 (SP1) located along the southwest bank of South Indian Ridge Marsh. Seep appears to be about 2-2½ feet in diameter.
(Located at 7th T-pole from 122nd street)

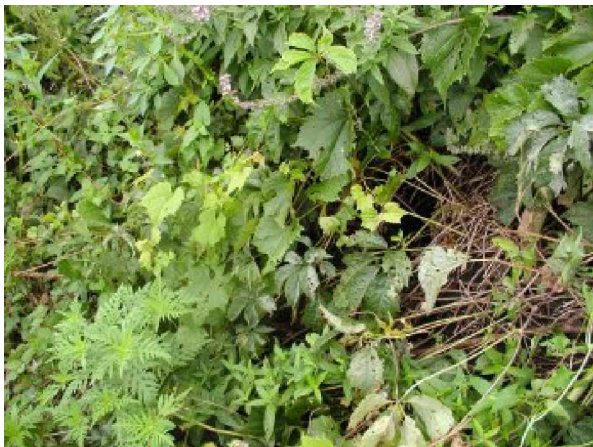
Seep#2 (SP2) located along the southwest bank of South Indian Ridge Marsh. Possible seep (Located at 10th T-pole from 122nd street)

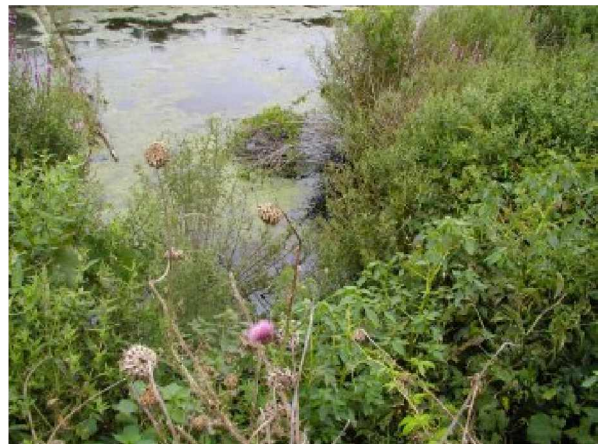
View of path from possible seep to marsh.

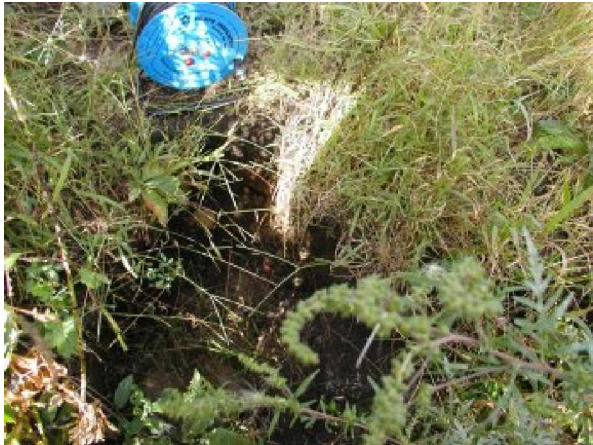
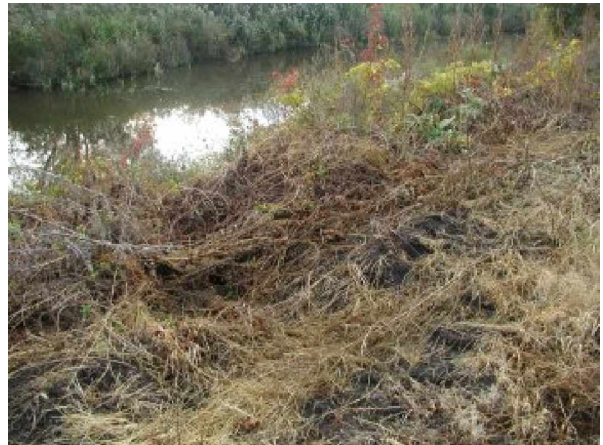
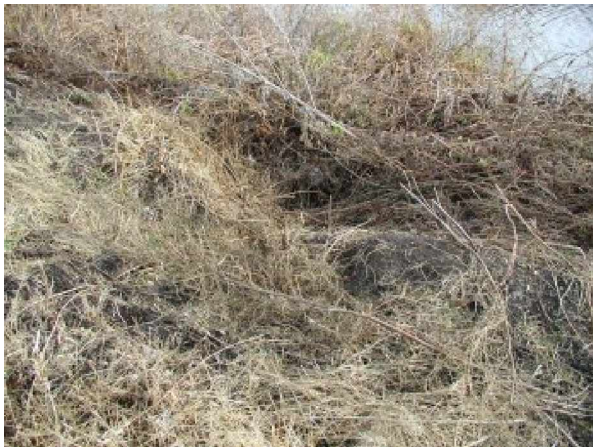
Seep #1 possibly more erosion has occurred, but basically the same.

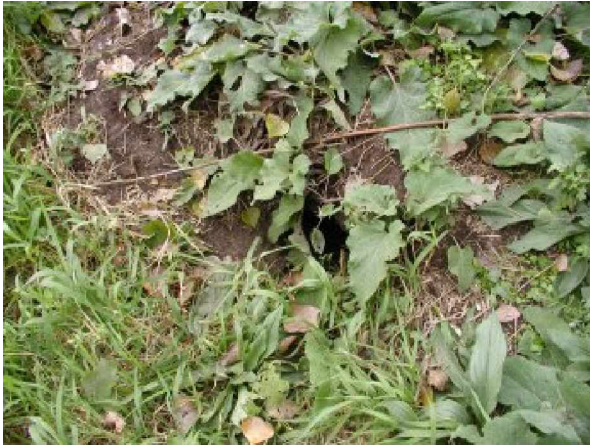
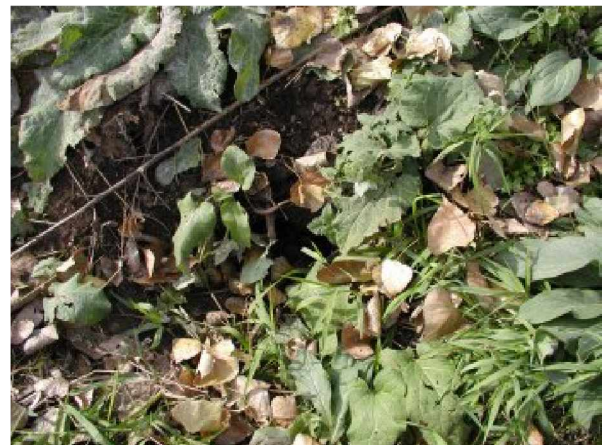
Seep #3 (SP 3) located along the west bank of South Indian Ridge Marsh. Seep appears to be about 1 foot in diameter.
(Located just north of ASG 7)
