**CALUMET AREA HYDROLOGIC
MASTER PLAN (HMP)
EXECUTIVE SUMMARY
(VOLUME I)**

**CALUMET AREA
CITY OF CHICAGO, COOK COUNTY, ILLINOIS**

AUGUST 2006

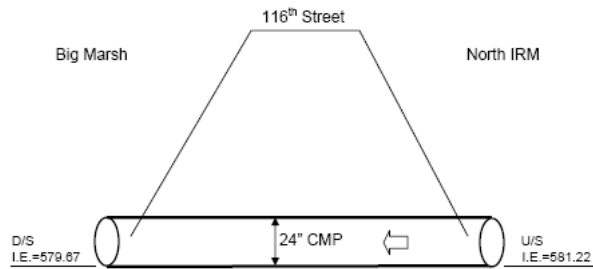
Figure 3: Structure #8, Hydraulic Geometry

V3's engineering investigation determined that there are three control structures that influence the hydrologic behavior at Big Marsh. From the north, Big Marsh is fed by Norfolk Southern Railroad Marsh. The connection structure is a 24" diameter non-adjustable culvert that conveys into a stream channel then into the Marsh itself (Figure 3; Structure #8; Vols II, IV). Resulting from stage-discharge modeling (Figure 2), structure #8 has an acceptable discharge capacity for storm events and V3 suggests that no improvements need to be made to this control; however an annual maintenance program should exist.

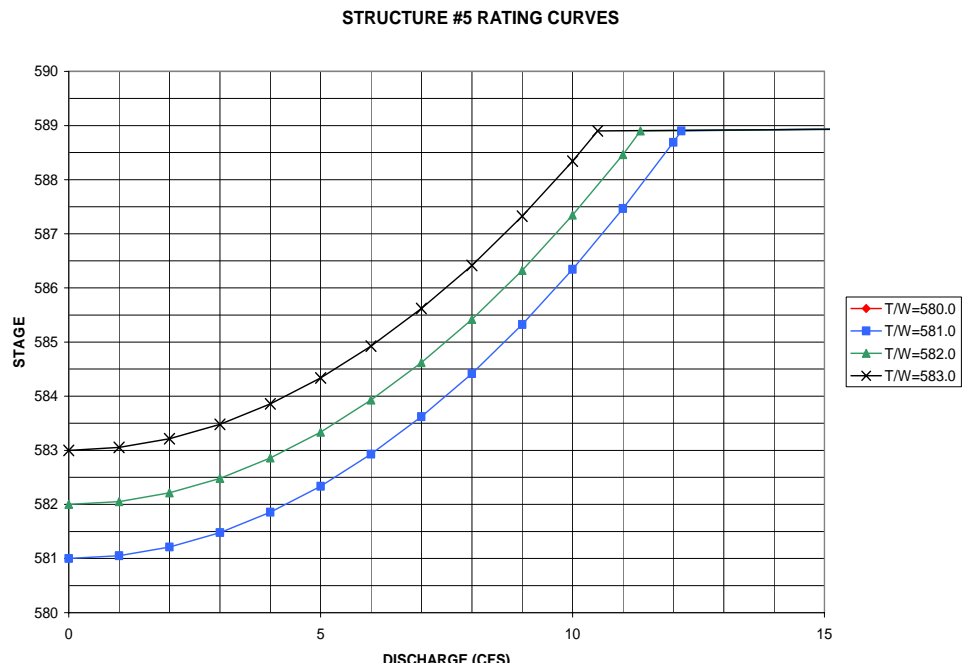
Figure 6: Structure #5, stage-discharge curve (Big Marsh)

The second control structure is the outlet structure which is composed of a rectangular concrete drop inlet with twin 30" outlet pipes that connect to Lake Calumet (Figure 4; structure #5; Vols II, IV). This control structure is adjustable; however it does not have an acceptable discharge capacity. It can take along extended period of time to release runoff from extreme events. Under this condition, the control structure promotes higher water levels for extended periods of time (Figure 6). In addition, the structure is susceptible to blockage from debris accumulation which may further increase the drawdown time of water levels following a storm event. V3 provides recommendations to construct a secondary outlet at this location and implement an annual maintenance program to reduce the blockage threat (Volume IV).

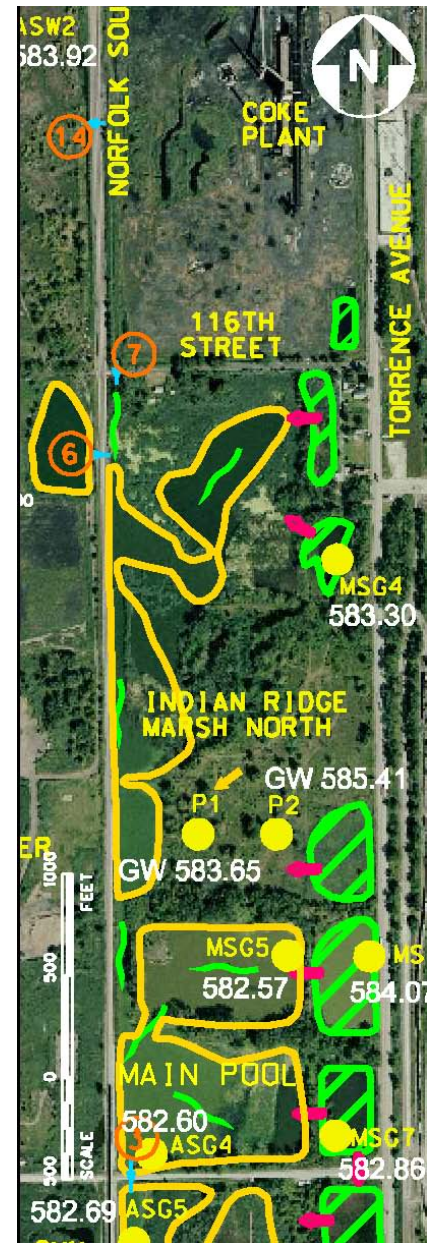
Figure 12: Structure #3 Hydraulic Geometry (Indian Ridge Marsh North)

The second control structure is the outlet which is an inlet box and attached 24" culvert (Figure 12; Structure #3, Vols II, and IV). The box rim sets the normal water level for the primary pool of Indian Ridge Marsh North. Through hydrologic modeling, V3 determined that this structure safely releases storm volumes; however, improvement recommendations are made due to the structure's tendency to become blocked, which restricts flows and influences water elevations (Volume IV). In 2001, Harza Inc. repaired the outlet and it was apparent that beaver levelers may be required at this location. In addition, the culvert pipe is believed to be from the 1920's and may be rusted and partially collapsed. V3 recommends inspecting and rehabilitating the

culvert, replacing the manhole with a water level control structure and installing a beaver leveler. Structure #3 should also have an annual maintenance program enacted.

- *An annual structure maintenance program should be enacted for all structures at Indian Ridge Marsh North (Structures #3, #7) (Volume IV).*
- *At Structure #3, V3 recommends inspecting and rehabilitating the culvert, replacing the manhole with a water level control structure and installing a beaver leveler.*
- *V3 recommends a hydrogeologic study of Indian Ridge Marsh North and its surroundings to investigate the influence of the Cluster Sites (West of IRM North) and the magnitude groundwater influences to the site.*

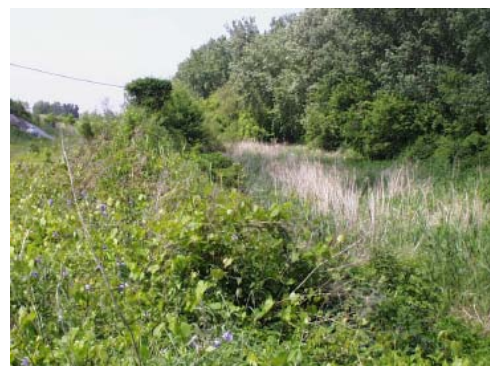
Figure 15: S. Indian Ridge Marsh Outlet Channel, facing North

The outlet of Indian Ridge Marsh South is simply an open channel with no control structure; hence the main control of water elevations in the marsh is the channel outlet bottom and the channel's ability to convey storm event discharges (Figures 14 & 15; Structure #17). Additionally, tail water of the Calumet River could play a role in water elevations during very significant storm events. The stage/discharge curves for this structure are provided in Figure 16. V3 recommends installing a concrete weir with stop logs at this outlet location, so that discharge and water levels can be better controlled to suit future ecological management decisions (Volumes II & IV).

- *An annual structure maintenance program should be enacted for all structures at Indian Ridge Marsh South (Structures #3, #17) (Volume IV).*
- *At Structure #3, V3 recommends inspecting and rehabilitating the culvert, replacing the manhole with a water level control structure and installing a beaver leveler (Volume IV).*
- *At Structure #17, V3 recommends installing a concrete weir with stop logs, so that discharge and water levels can be better controlled to suit future ecological management decisions.*

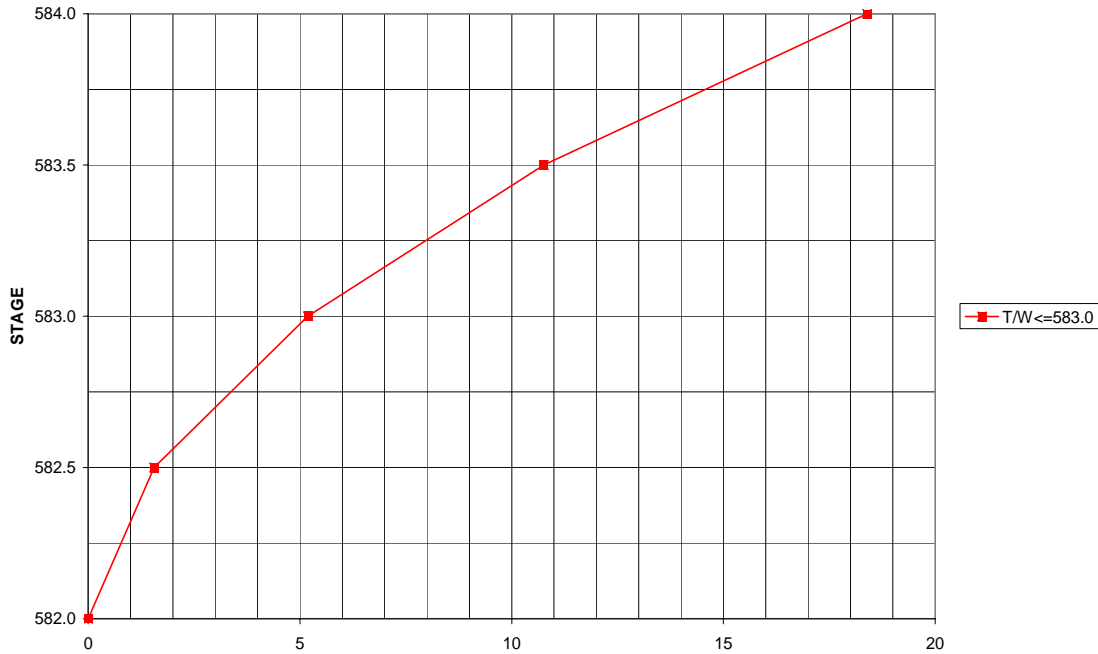
Figure 22: Structure #2, stage-discharge curve (Heron Pond Outlet Channel)

V3's engineering investigation determined that the only control structure that influences the hydrologic behavior at Heron Pond is the outlet channel that conveys discharge into the Calumet River (Structure #2, Vols II,IV; Figure 20). Within this channel, a rudimentary man-made weir made of grass clippings and vegetation attempts to control water elevations in the pond (Figure 21), V3 determined that the man-made weir does not significantly restrict the rate of discharge exiting the pond. Modeling for the outlet channel indicated that tail water conditions from the Calumet River can influence water elevations within Heron Pond during significant storm events (Figure 22). The primary controls on water elevations in Heron Pond are the channel bottom elevation and the discharge capacity of the open outlet channel. V3 recommends installing a concrete weir with stop logs at the pond outlet in order to control discharge and water elevations at Heron Pond, this option allows for water elevations to be adjusted based on future ecological management decisions. Lastly, an annual maintenance program should be enacted for Structure #2 (Volume IV).

- *An annual structure maintenance program should be enacted for the structure at Heron Pond (Structure #2) (Volume IV).*
- *At Structure #2, V3 recommends installing a concrete weir with stop logs, so that discharge and water levels can be better controlled at Heron Pond to suit future ecological management decisions.*
- *V3 recommends a site specific hydrogeologic investigation to properly assess groundwater flow directions around Heron Pond, and evaluate possible influences with Cluster Sites located to the North of Heron Pond.*
- *V3 recommends a further detailed water quality study in order to further establish aquatic health conditions at Heron Pond.*

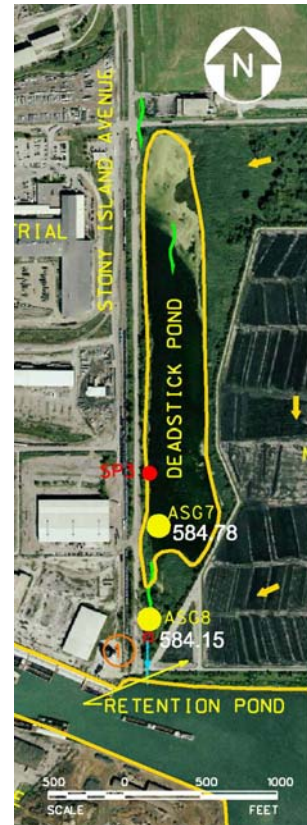
Figure 27: Structure #1, Hydraulic Geometry

V3's engineering investigation evaluated the outlet structure that regulates Deadstick Pond discharge into the Calumet River (Figure 27; Structure #1; Vols II, IV). The structure is an adjustable rectangular concrete box structure with adjustable stop logs (Figures 27 & 28). The box is connected to an 18" culvert that conveys discharge into the Calumet River. Under low flow conditions, the water elevations in Deadstick Pond are controlled by the stop logs. During higher flow conditions the water elevations are controlled by the discharge capacity of the outlet pipe and tail water conditions from the Calumet River. Figure 29 shows hydraulic stage/discharge modeling conducted by V3 suggests that this outlet control structure has an acceptable discharge capacity for large storm events and does not appear to be susceptible to blockage (Volume II, IV). V3 recommends clearing the outfall channel of structure #1 and stabilizing the banks with rip-rap in addition to an annual maintenance program for structure #1.

- *An annual structure maintenance program should be enacted for the outlet structure at Deadstick Pond (Structure #1) (Volume IV).*
- *At Structure #1, V3 recommends clearing the outfall channel and stabilizing the banks with rip-rap.*
- *V3 recommends a site specific surface water quality study in conjunction with a hydrogeologic investigation to assess potential sources of poor water quality and groundwater flow patterns at Deadstick Pond.*

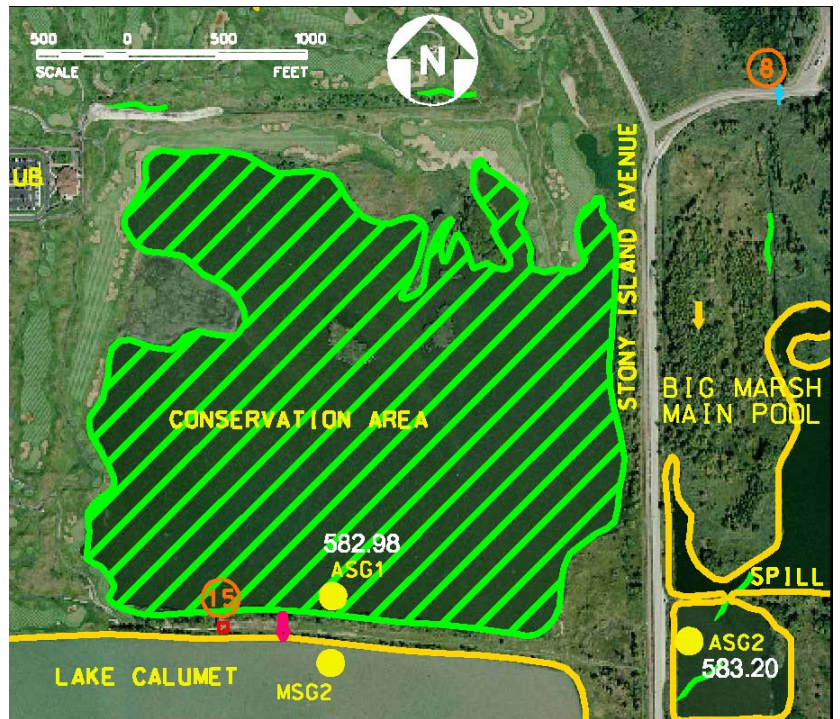
Figure 33: Structure #15, facing North (Conservation Area Outlet)

V3 evaluated the outlet control structure #15 that regulates flow from the Conservation Area into Lake Calumet (Figures 33 & 34; Vols II, IV). The structure consists of two ductile iron pipe culverts (24" and 18") which are equipped with stop logs to control water elevations in the Conservation Area. Hydraulic modeling indicated that the structure has an unacceptable discharge capacity and it may take up to 28 days to release large rainfall events (Figure 35). V3 recommends stabilizing the outlet area of structure #15 with rip-rap, constructing a secondary structure to convey flows from large storm events and enact an annual maintenance program for the structure(s).

- *An annual structure maintenance program should be enacted for the outlet structure at the Conservation Area (Structure #15) (Volume IV).*
- *At Structure #15, V3 recommends stabilizing the outlet area of structure #15 with rip-rap and constructing a secondary structure to convey flows from large storm events and reduce drawdown times of the Conservation Area waterbody (Volume IV).*

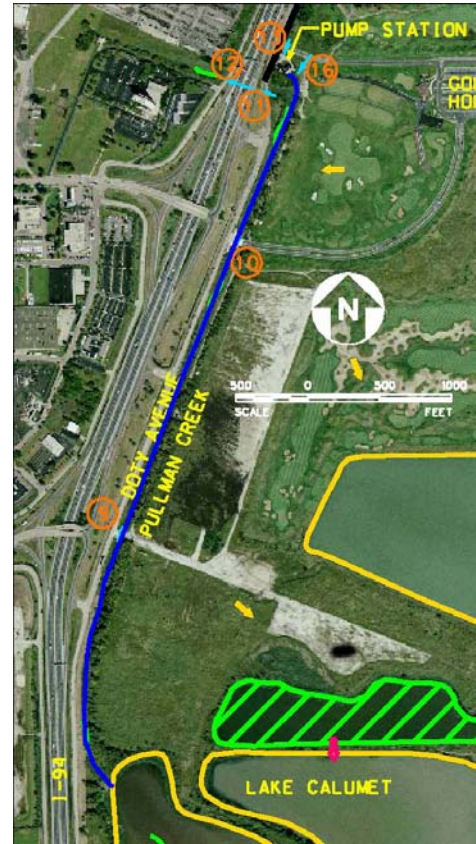
Volume III provides the study in which V3 conducted a detailed Pump station analysis and evaluated the hydraulic capabilities of the Pullman Creek stream channel. The stream channel collects flows from a series of six culverts that drain sources such as the IDOT right of way and Harborside Golf Course. Hydraulic modeling indicated that the stream channel could not effectively convey floods for a 50 year storm event, which would result in pavement flooding. Additionally, sediment accumulation is a concern in the stream channels as it reduces the capacity to convey large flood flows.

Multiple recommendations are provided to improve the hydraulic functions of Pullman Creek. Recommendations include re-configuring the pump station, changing invert elevations of culverts, constructing an overpass bridge to remove culverts and dredging the Pullman Creek channel. The recommendations will improve reduce stage heights, and improve flood conveyance capacity and likely eliminate flooding issues associated with large storm events.
