Stream Restoration Inventory, Phase 1 Final Report

Prepared for Chicago Wilderness by the Northeastern Illinois Planning Commission

October 2002

Stream Restoration Inventory / Phase 2 Report of Restoration Field Verification

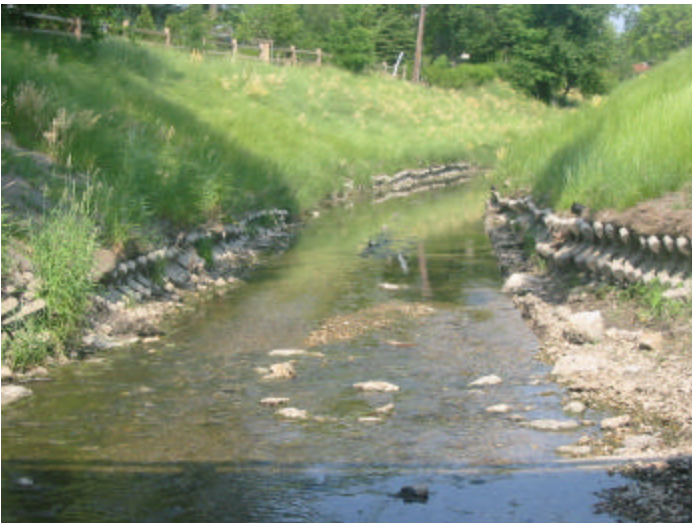
A-jacks are concrete jacks which are nested together in an interlocking pattern to reinforce the toe of eroding banks, generally on the outer bank of a meander. The jacks are buried in the bank and bed, and vegetation is planted through them. Normally only the more severe channel erosion sections are treated with a-jacks. In projects where a-jacks had become unstable over time, either the a-jacks were not interlocked below the streambed or streambed erosion had undermined the jacks so they fell apart. This instability can result from the installation of the a-jacks on both sides of the channel so

that a constricted stream flow may increase stream velocity and streambed erosion, which undermines the a-jacks. This problem may be avoided by installing a-jacks on one side of the channel only and using softer practices, which allow for some scour in the stream channel, on the other side. Installing a-jacks or other hardened bank practices on both banks is a technique that requires careful engineering analysis.

A-jacks installed on both sides of a stream

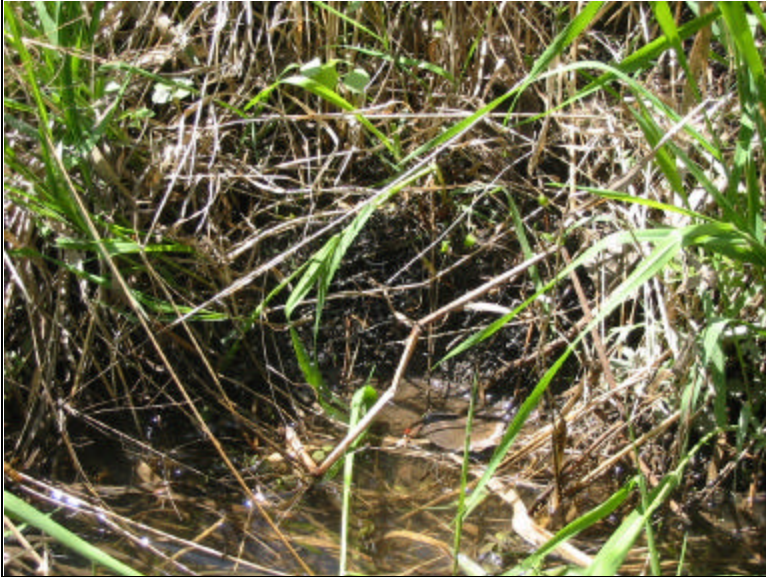
In this case, fiber roll is holding soil well.

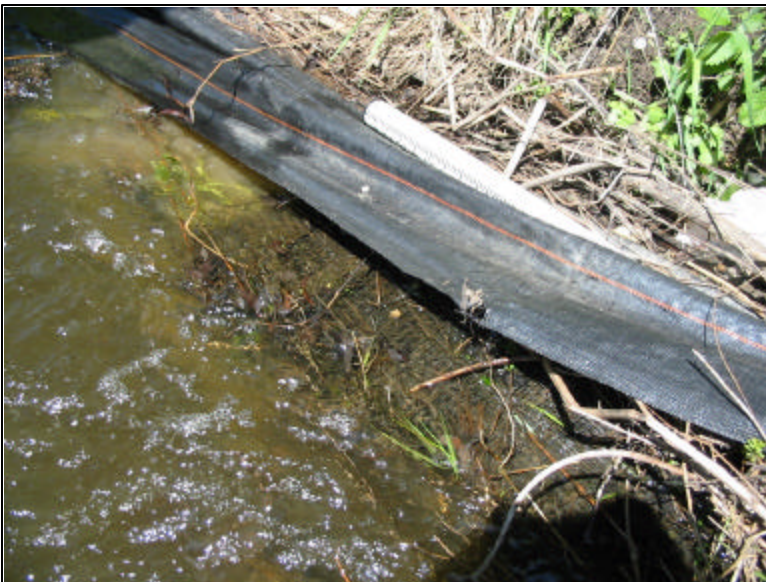
In contrast, this photograph shows a case where the fiber roll is not holding soil.

Pool depth in this location is ~1.8 feet on this very high water day.

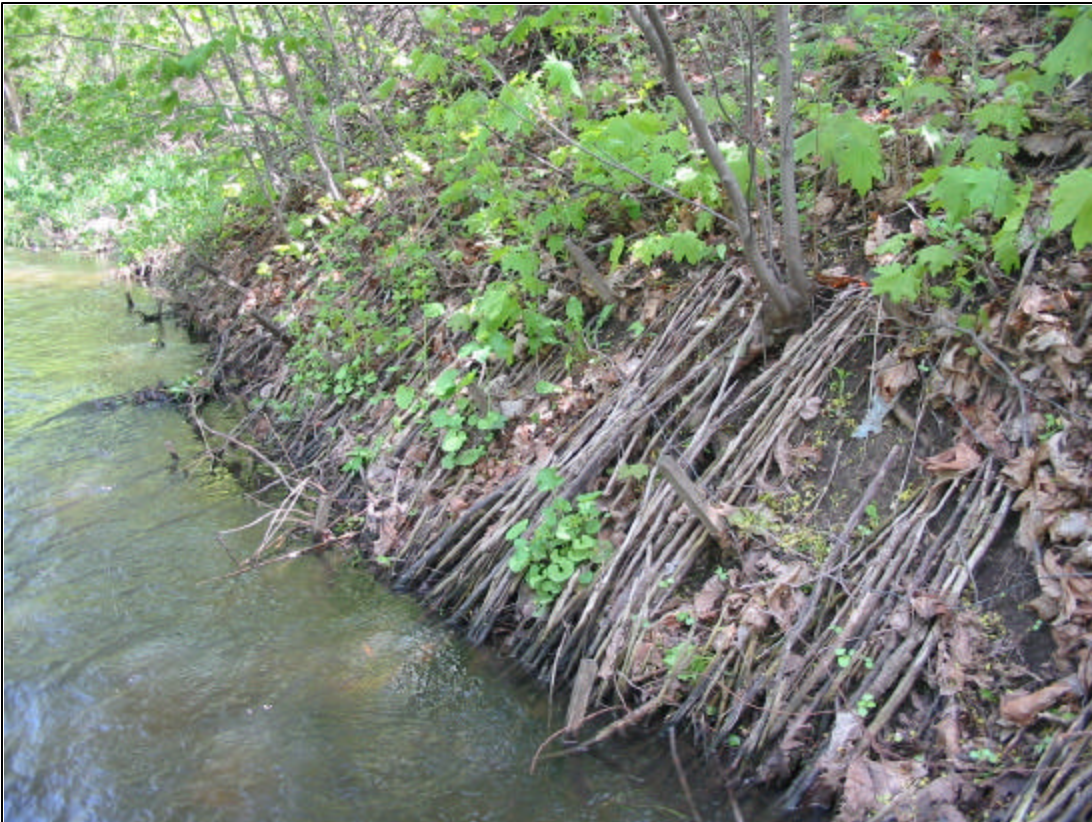
The brush mattress is held in place by willow stakes, and appears to be holding quite well.

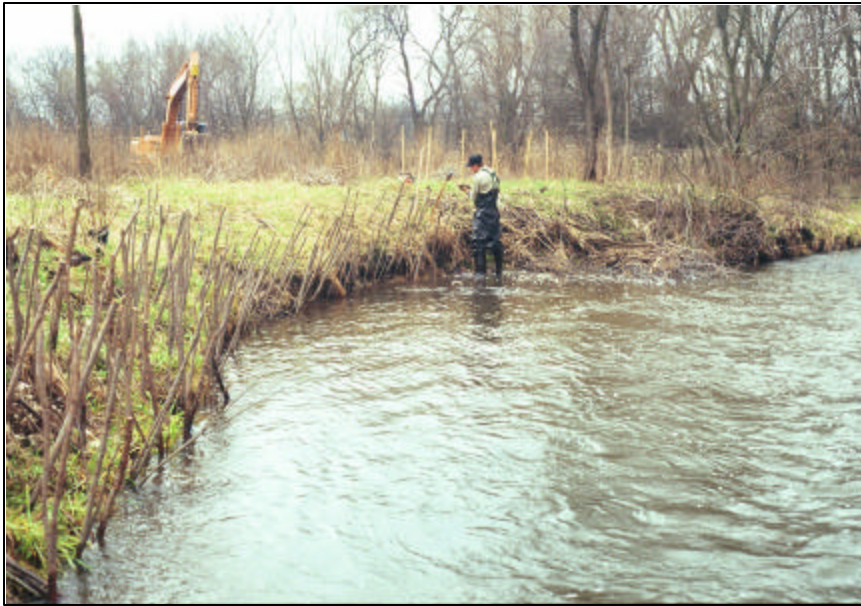
**BEFORE /
DURING**

Willow posting
installation.

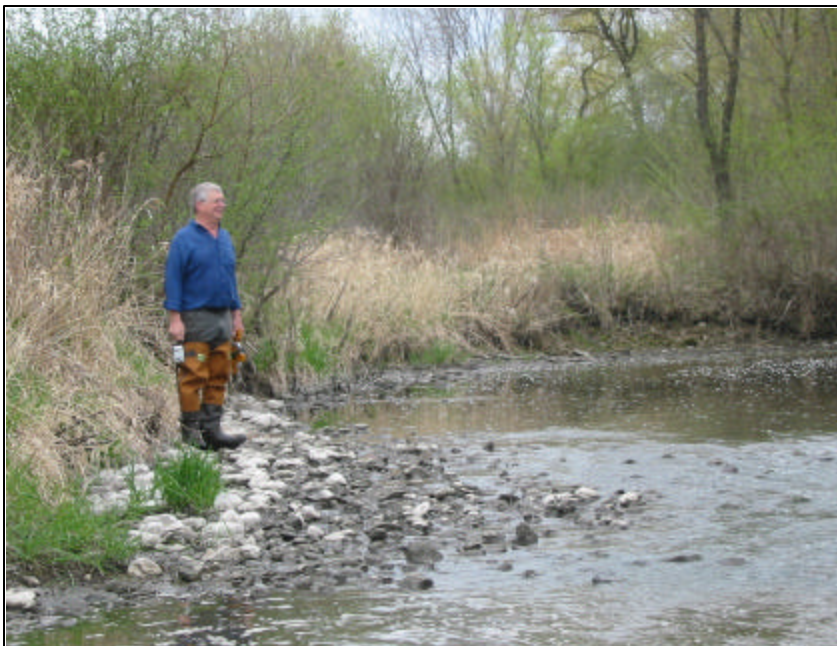
AFTER

This photograph was taken on the day of the site visit from a similar angle to the one above. The willow posts are barely visible, though the brush layers can still be seen.

Although the initial project notes do not mention stone toe protection, we saw this practice as well.

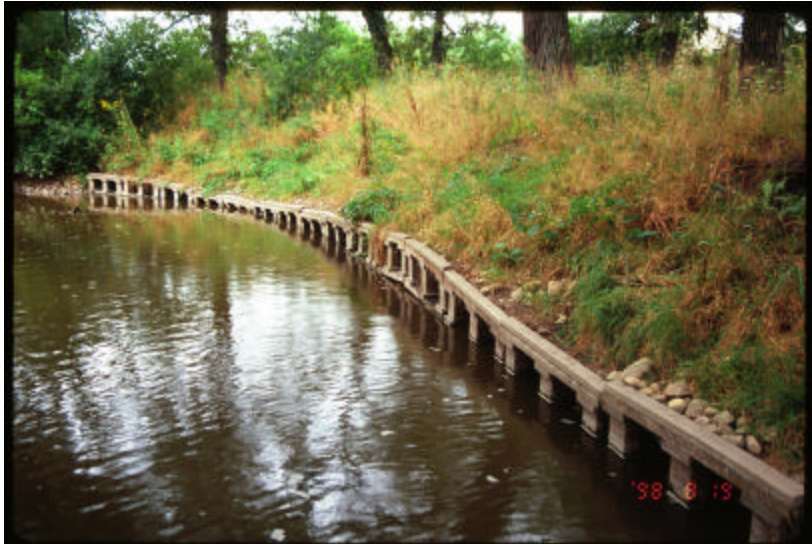
BEFORE

Lunker structure with established vegetation. The bank shows no signs of erosion, the lunkers look fairly uniform.

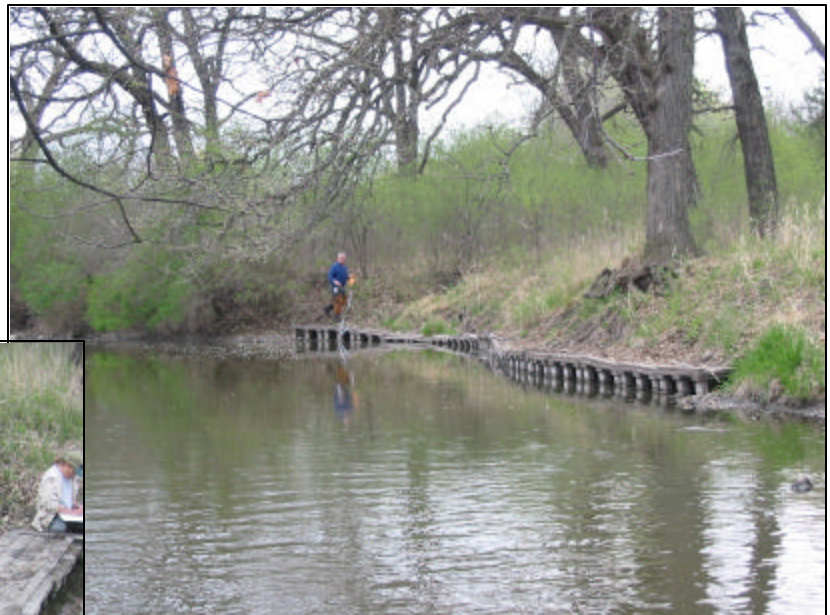
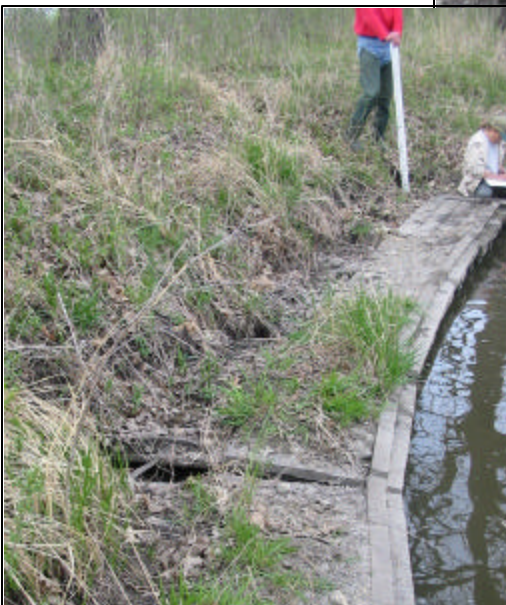
On the day of the site visit, the water level was well below the top of the lunkers. Bank shows erosion and few plant species were visible on the bank.

There is a good deal of erosion BEHIND the lunker structures. In this photograph, Tim shows how the measuring stick drops quite deeply into the eroded area behind the stick.

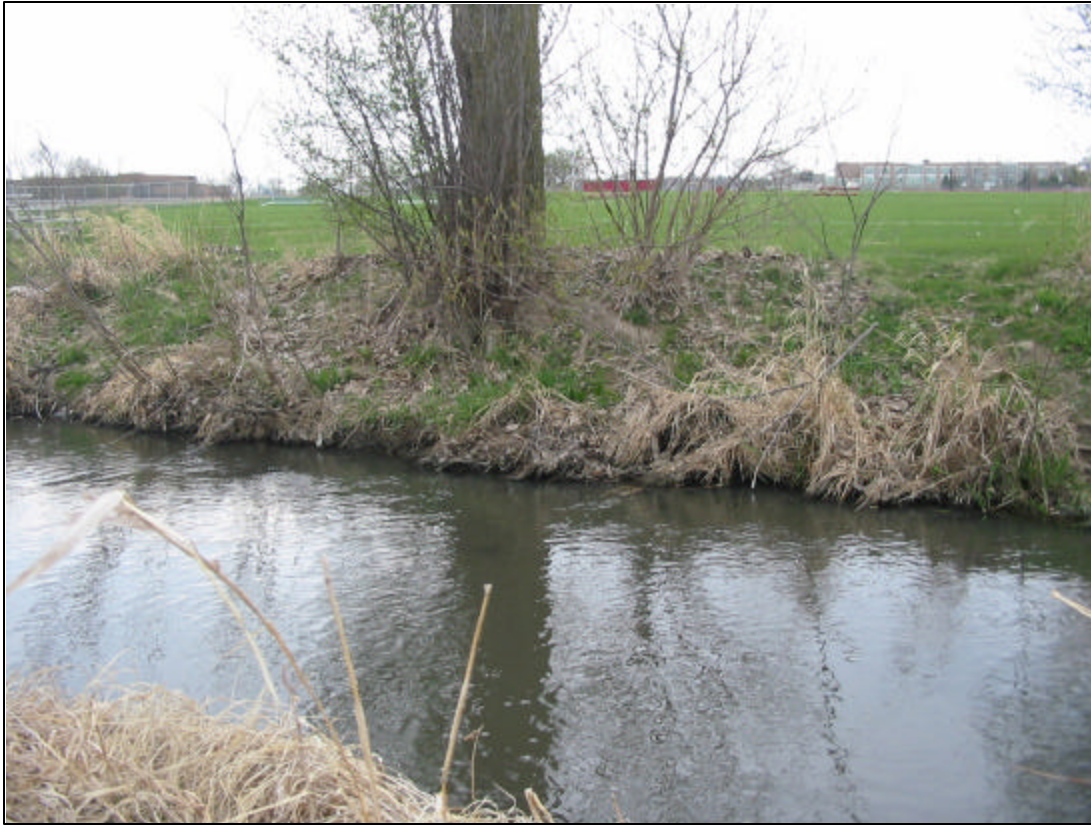
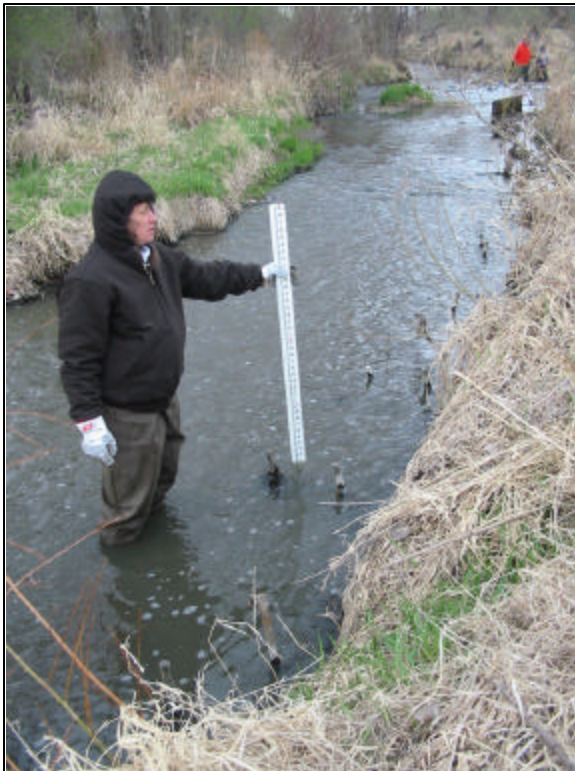
Above, on the right bank, biologs at the toe have survived will and appear to be holding the bank.

Left, a line of stakes is visible which once held biologs, but where the biologs are no longer in place.

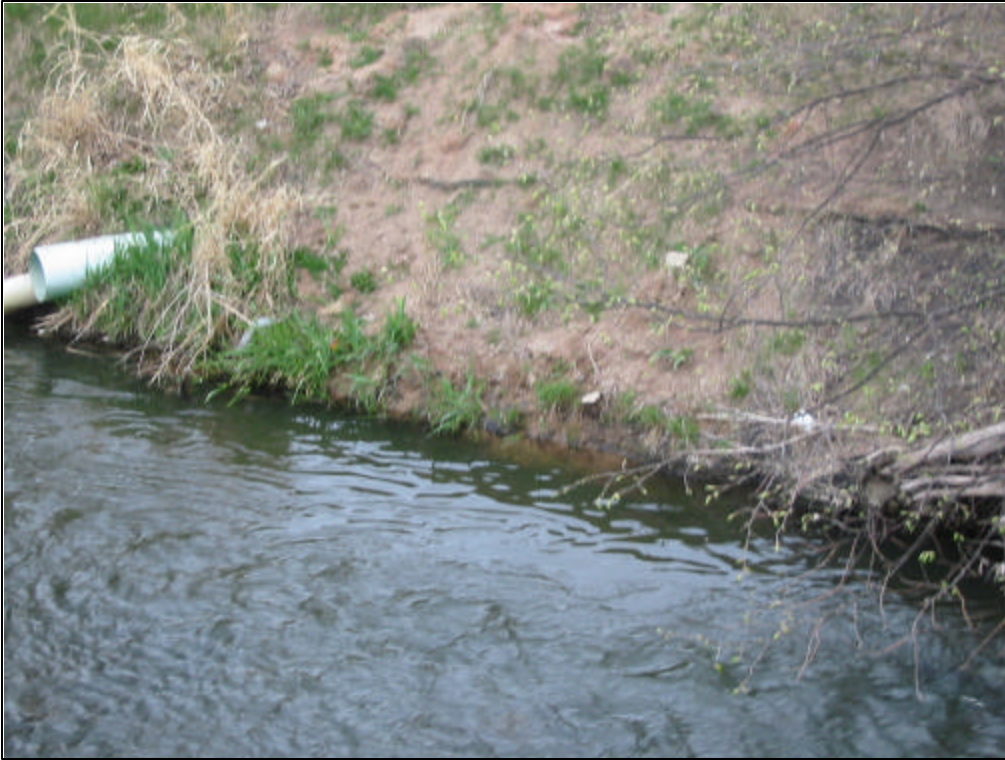
Lunkers and erosion control blanket on right bank

The lunkers are beneath the surface of the water; the erosion control blanket extends up the bank. (Note additional drainage pipes in left of photo.)

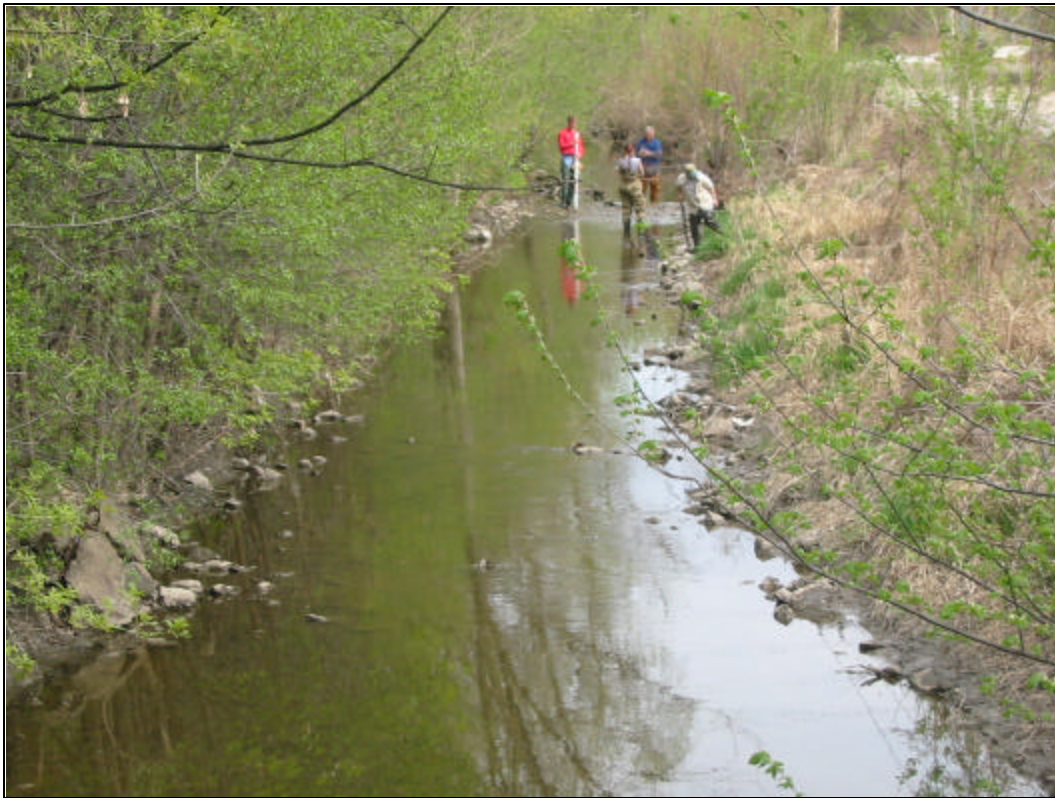
Long
view

looking upstream from the Raymond Avenue bridge.

The above photograph gives a general sense of the nature of this stream; brush removal was completed on the left, but without ongoing maintenance, much of the brushy growth is returning.

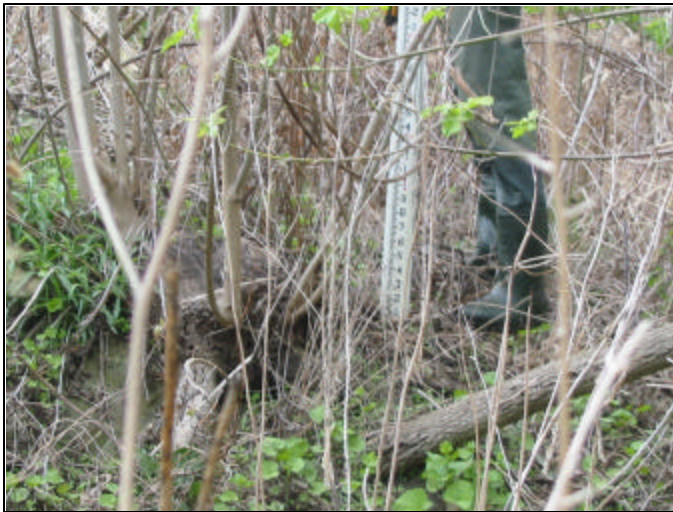
To the left, a stump of a tree that was removed during the brush clearance. The herbicide used did not fully kill the stump, and now the stump is vigorously sprouting.

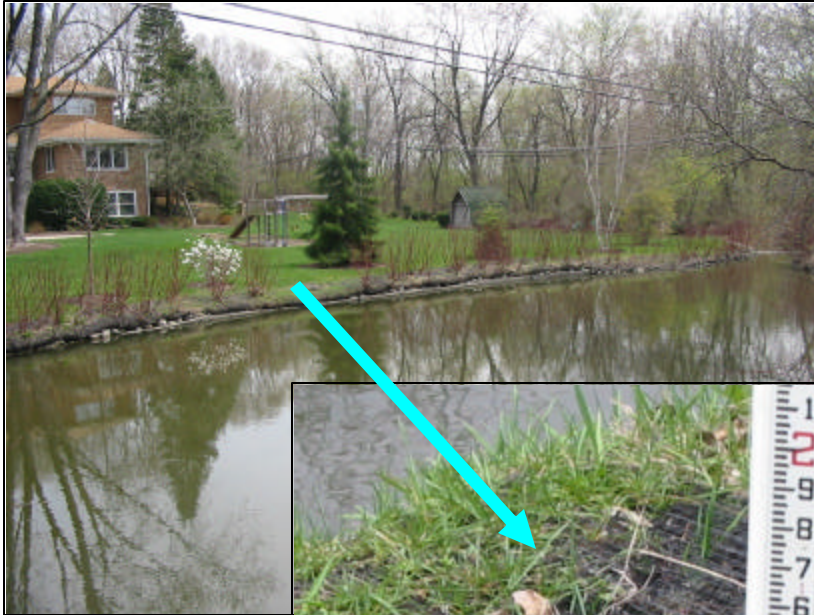
Installation 1: Pool area (continued)

Lunkers on left bank;
the right bank
stabilization is
primarily ajacks.

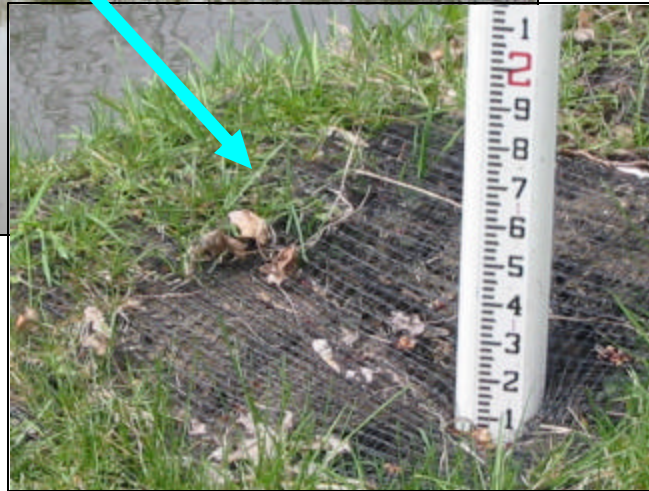
Lunker either
was not sealed
or has a hole
in it; area
behind lunker
has sunk
significantly.

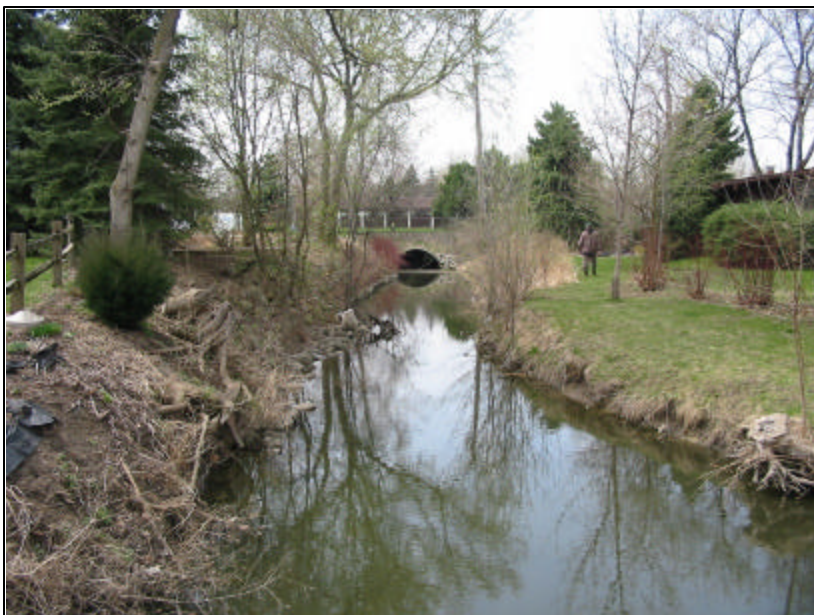
Installation 2: Bank stabilization and buffer revegetation

This image, taken
looking upstream
from the bridge at
the top of the
pool area, shows
eroded banks in
the foreground,
with the left and
right bank
stabilization
projects in the
background, just
below the culvert.
Presumably
without those
projects the banks
would look much
like those in the
foreground of
this photo.

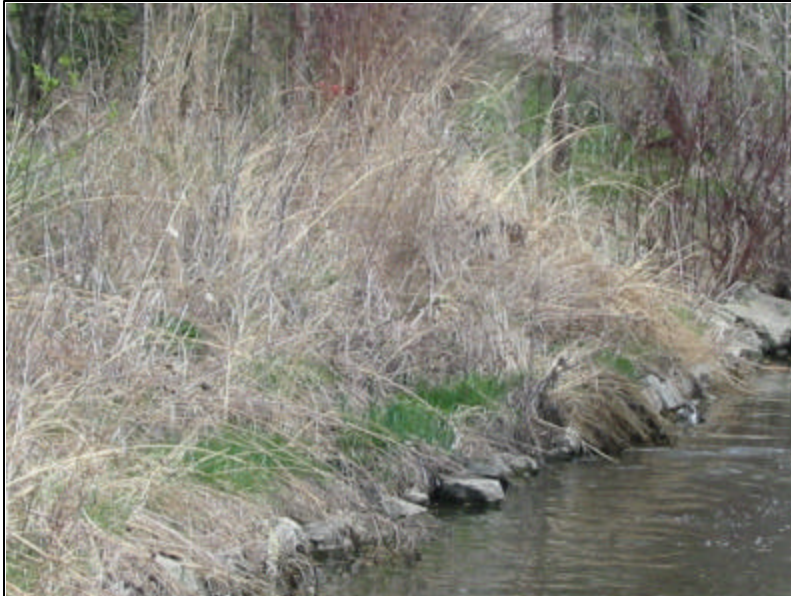
Installation 2: Left bank

On the day of the site visit, new grasses were just sprouting in this native prairie buffer planting area.

The lunkers are all open.

The D-50 is coarse sand.

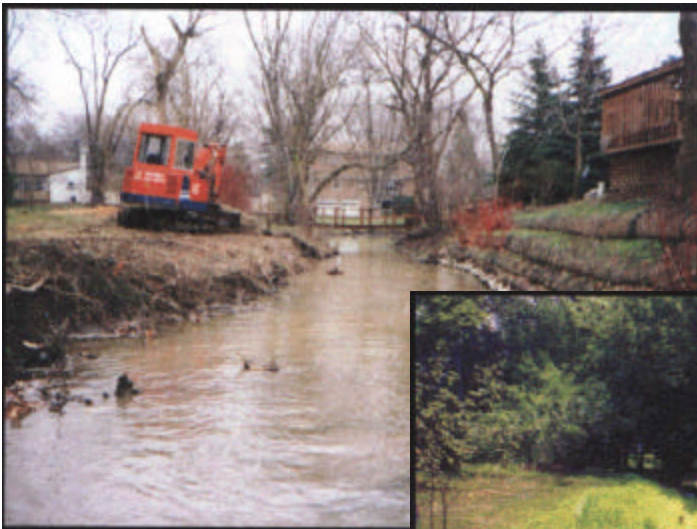
BEFORE

The left bank was badly eroded before the stabilization project was undertaken.

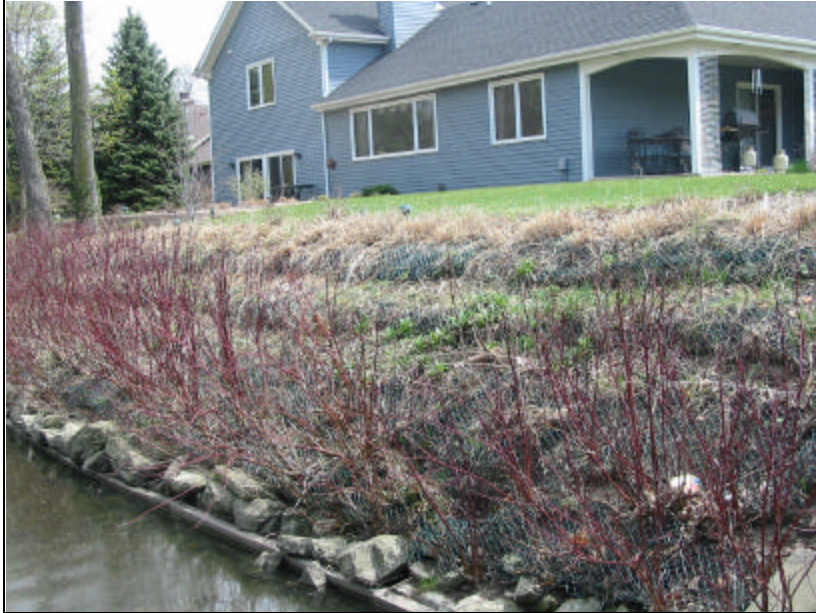
Installation 2: Right bank

Lunkers on the right bank are about 1/2 open.

Dogwoods are growing well.

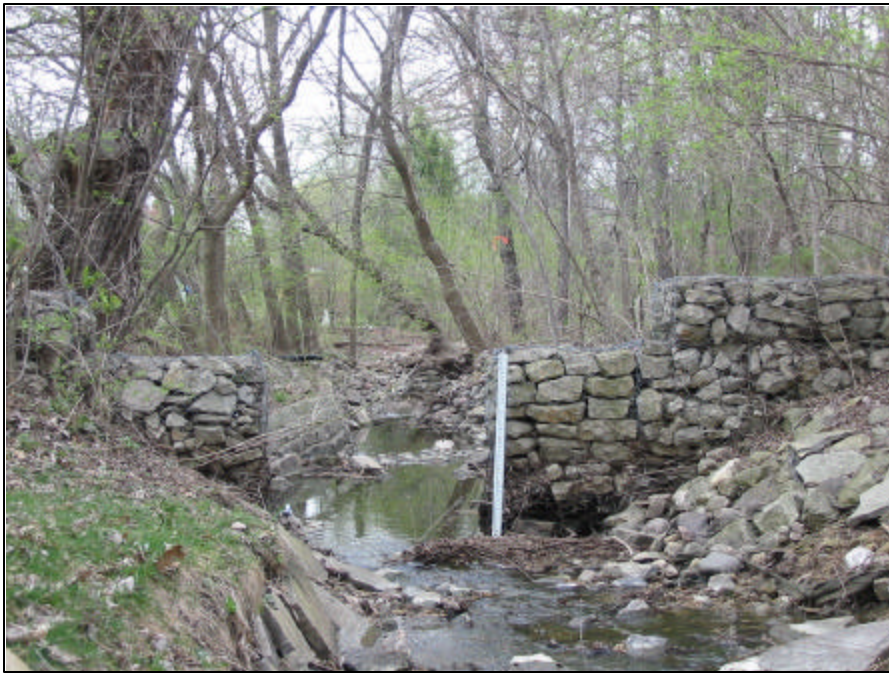
Installation 1: Gabion Dam

Pool depth here is just under 1 foot.

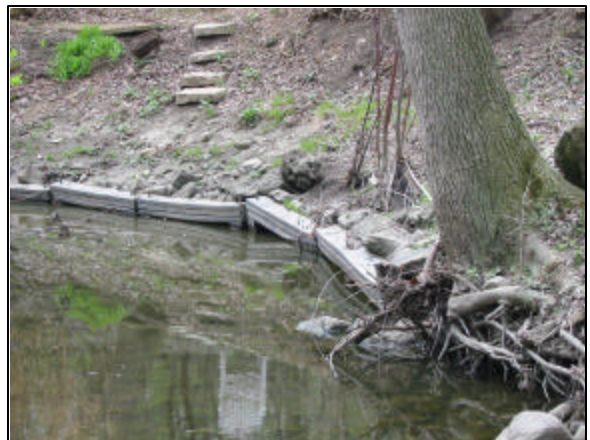
Downstream end of lunkers – note heavy erosion below roots of tree.

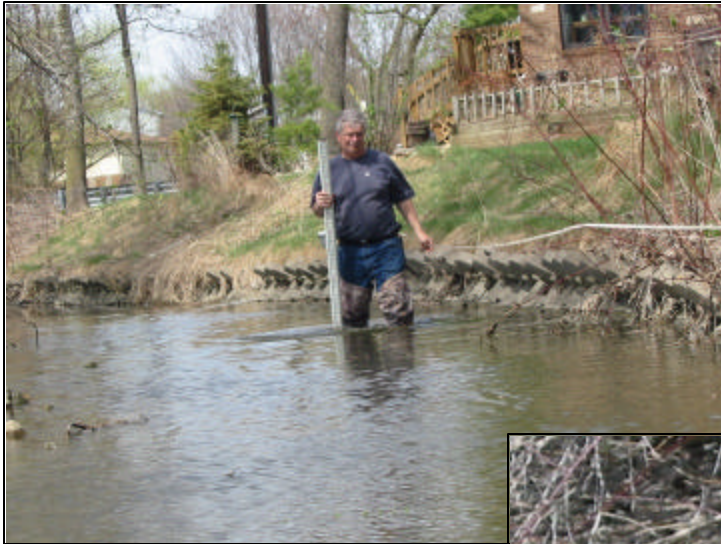
Pool depth is about 1 foot here.

Ajacks have sunk into bank until barely visible.

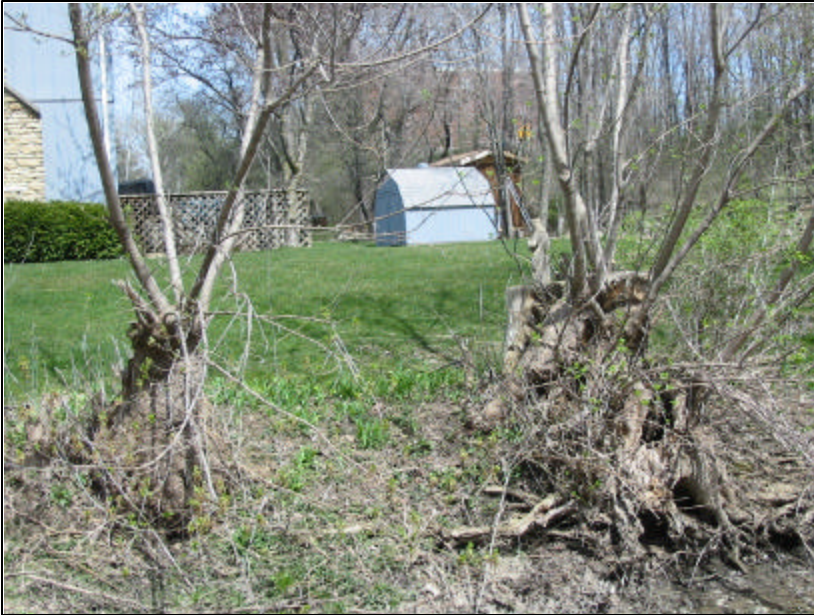
These trees were removed during the stabilization, but were not killed by herbicide.

Notice vigorous sprouting from stumps.

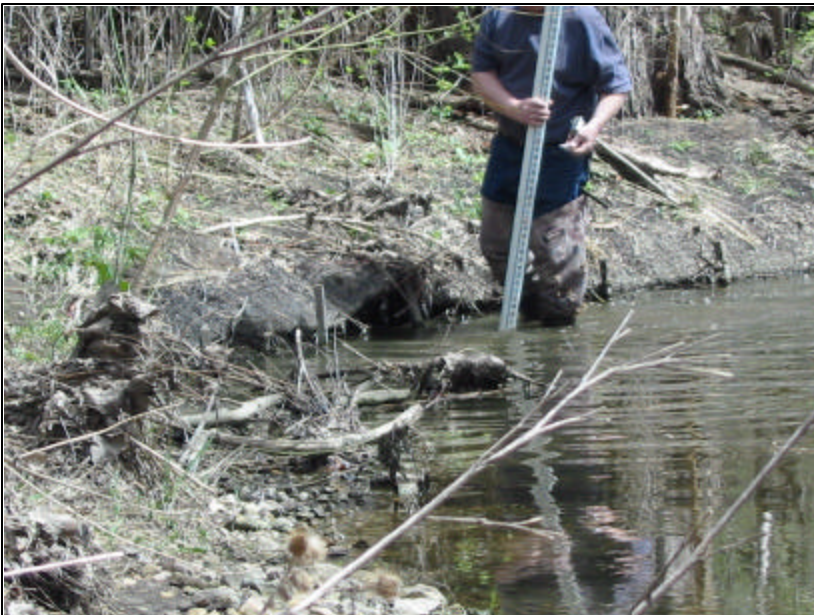
Here the vegetated geogrid has been unsuccessful; the grid is not holding soil and few plants have taken root.

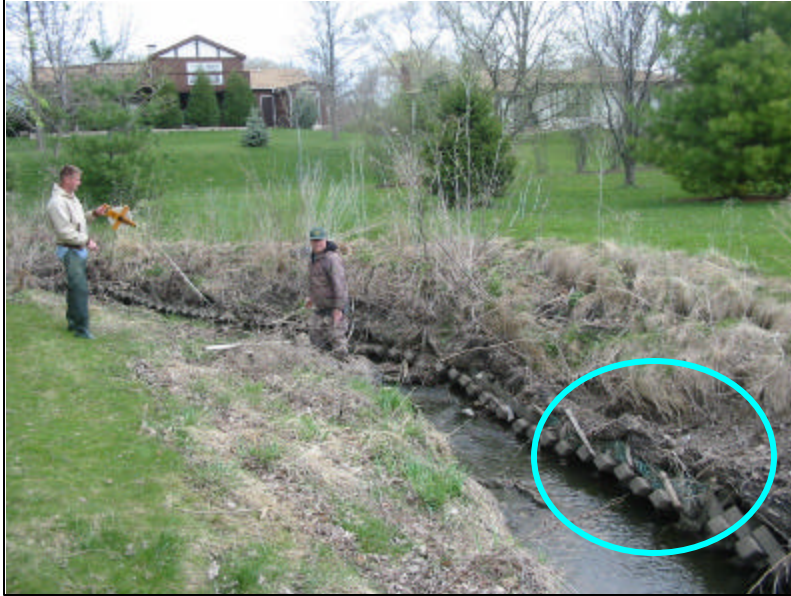
The ajacks, some installed as long ago as 1992, have settled into the bank in some areas, but in other places are still very visible.

Note visible fabric above ajacks.

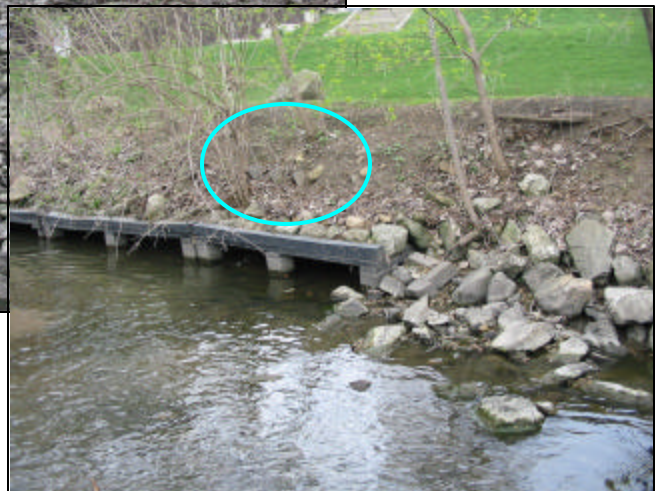
Circled below are the tips of several ajacks which are buried well behind the lunkers.

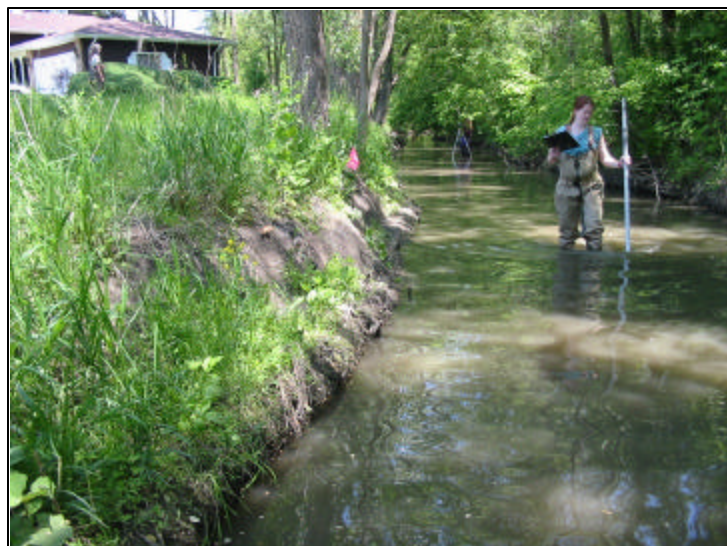
Photo is taken looking upstream; biolog and vegetated geo-grid can be seen on the right bank.

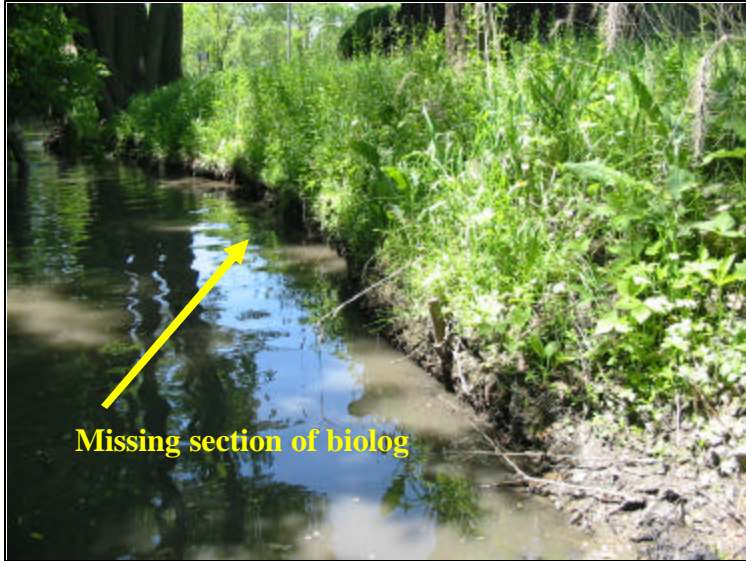
1: Biologs above Clarendon Hills Road (continued)

Biolog on the left bank. Note muddy condition of the water.

Midway along this installation a section of the biolog is missing. It looks like it might have washed away.

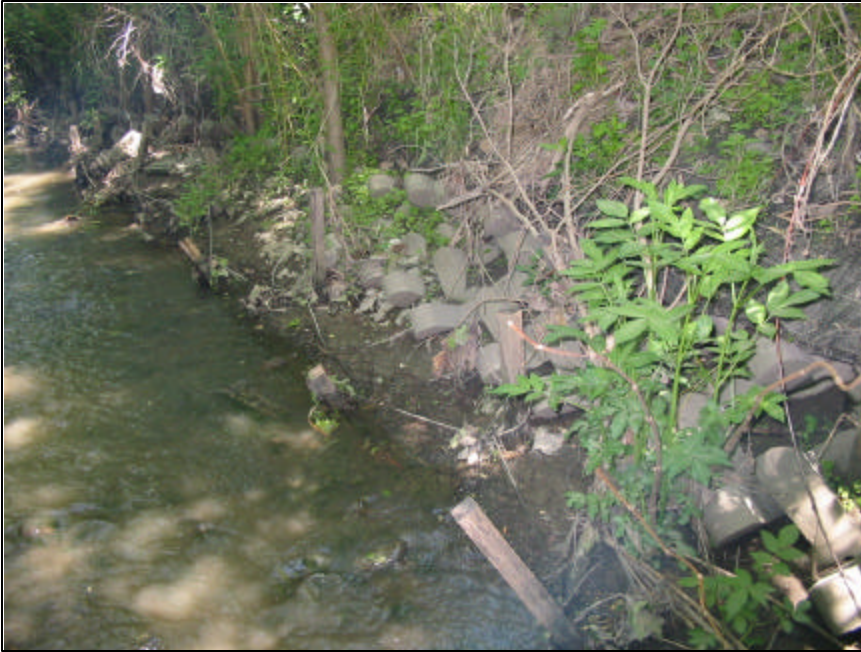
Closer view of ajacks embedded in the toe. Substrate is very soft, with material ranging from silt to small gravel.

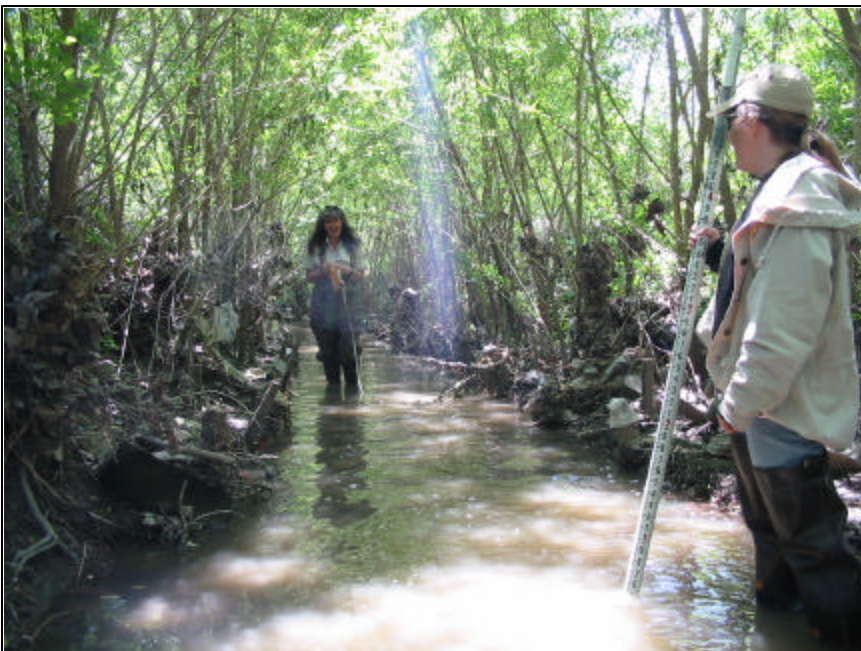
In some places, vigorously growing willows almost completely shade the stream.

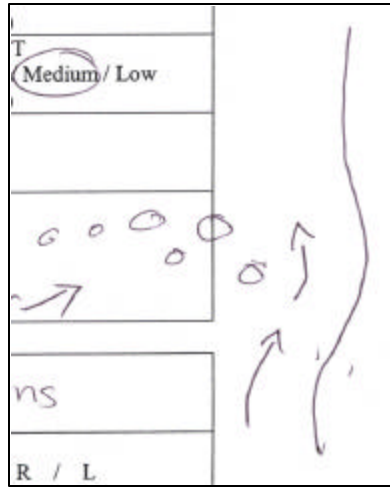
Left:
Illustration of the stream flowing around the inverted vortex weir (installation 11). Circles indicate the rocks of the weir, arrows indicate water flow.

Right: Illustration of the C shaped biologs (installation 21) used to meander the stream. The one on the right bank (labeled #2 in the picture) has held up well.

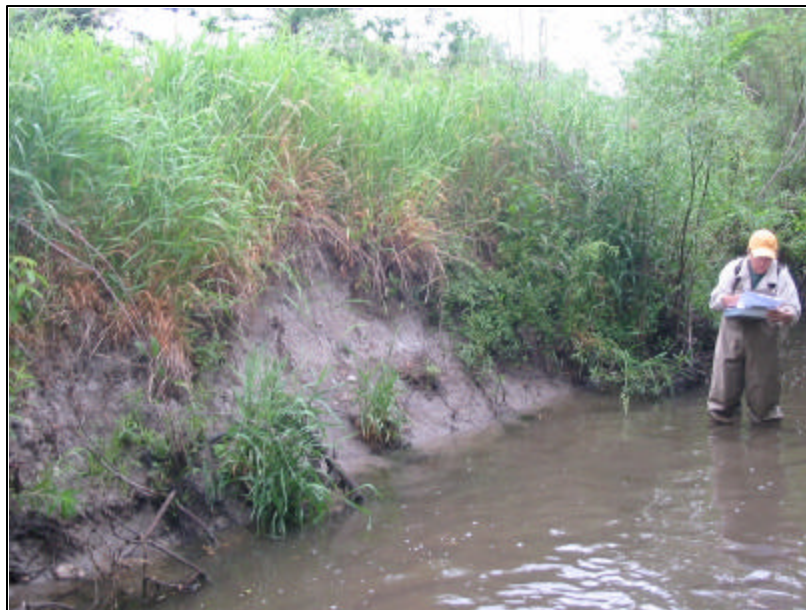
Scour on the right bank between installations 1 (willow stakes) and 2 (brush layer with willow stakes).

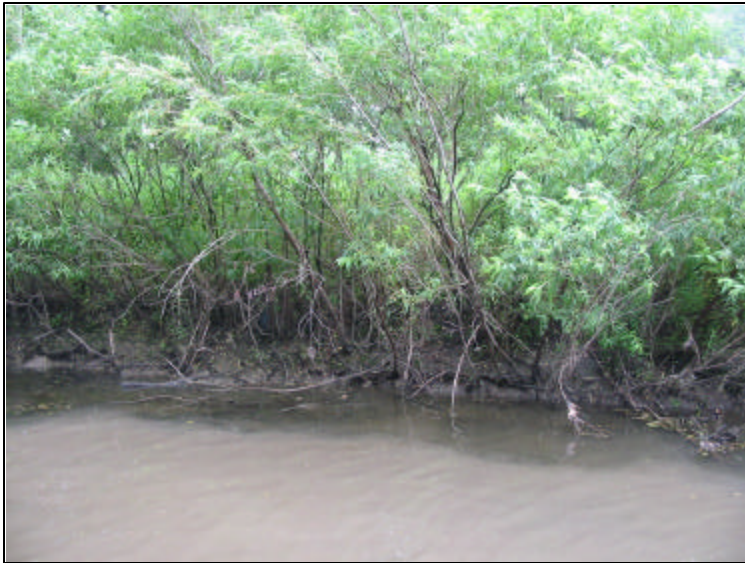
Broad view of the brush layer and willow stakes on the left bank (installation 2). Willow survival was good.

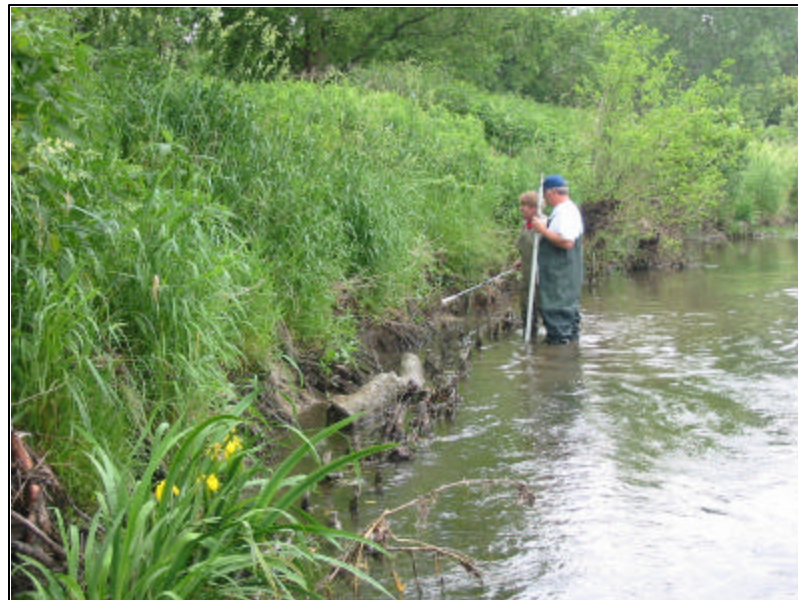
This photo was taken of an undercut, collapsed left bank about 15 feet downstream of installation 3 (the coir fascine and stakes).

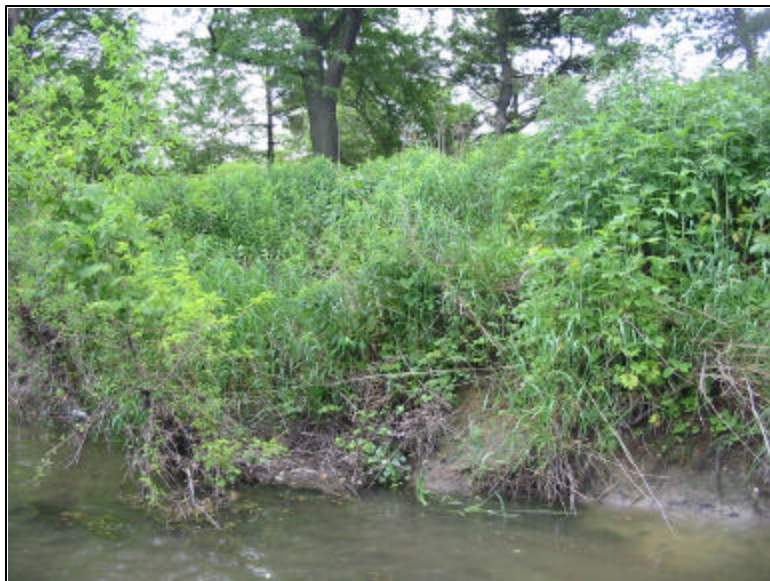
Close up of collapsed bank showing that the cordgrass was not able to root in the soil; the roots are exposed and dried out.

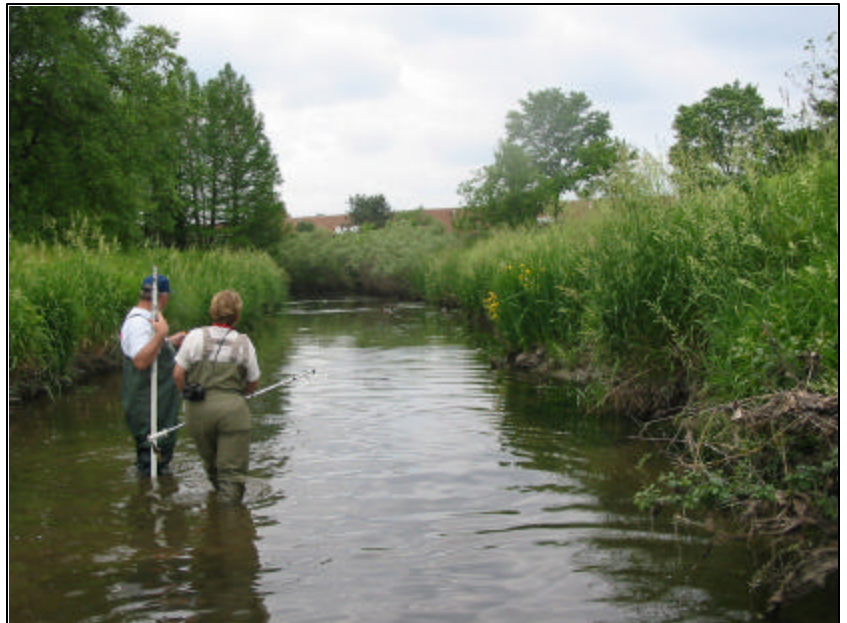
Slab failure; the slab toe was eaten away.

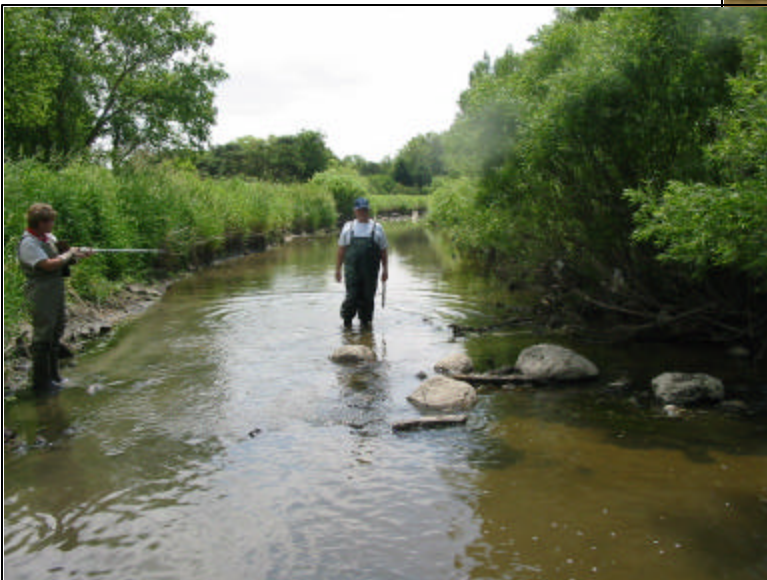
An inverted vortex weir (part of installation 9). Notice the rocks which have moved out of position.

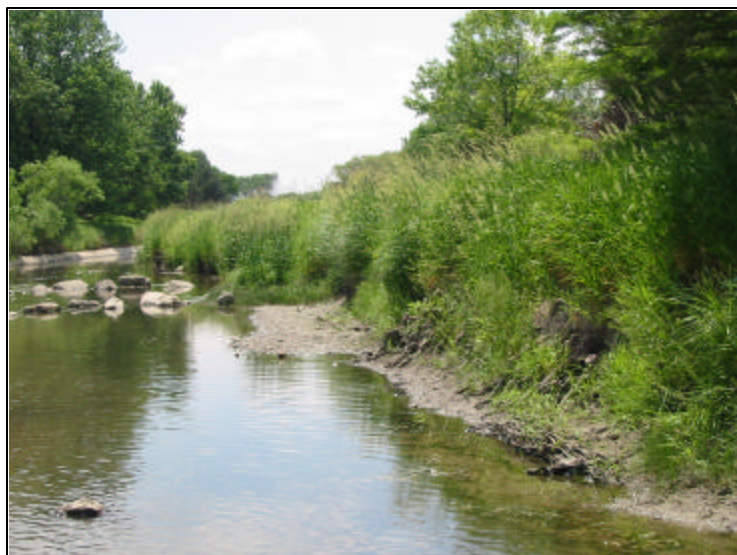
A long view looking downstream at the reach where no restoration has been done. A sandbar has formed in the center and the channel is eroding with undercutting of both banks. Two spawning beds were seen side by side, possibility made by blue gill.

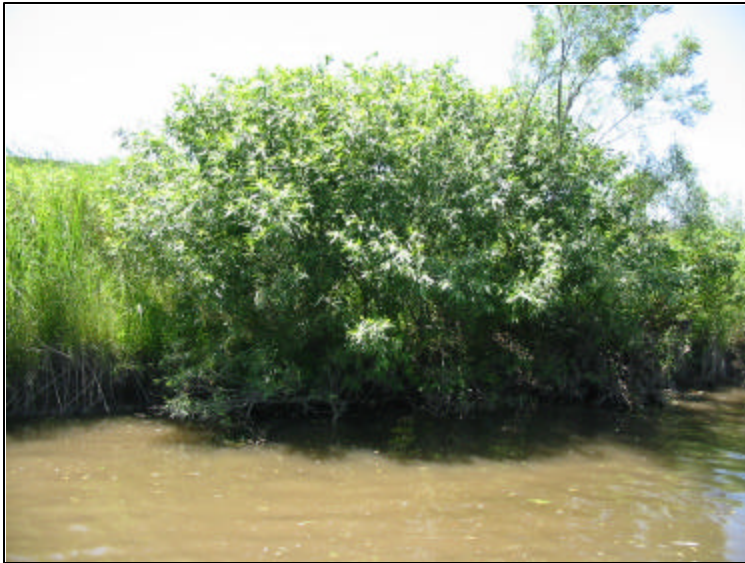
This photo was taken of installation # 17, where the willows have held but the fascine is washed out.

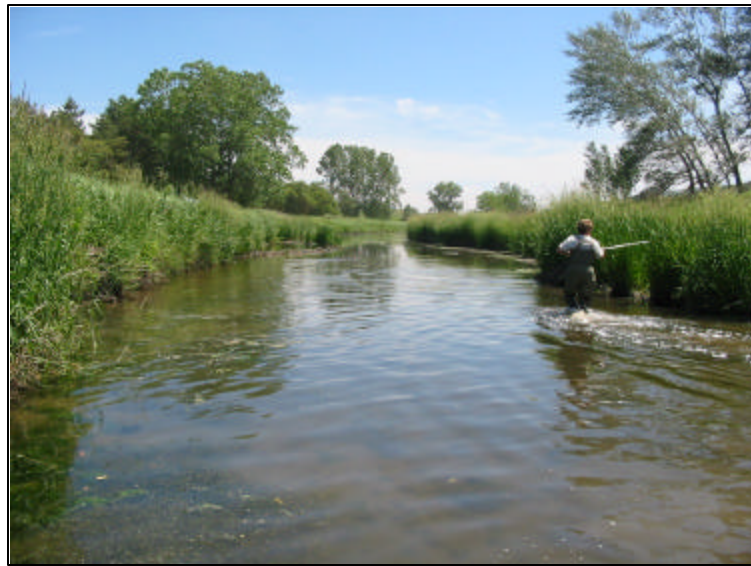
This photo was taken of meander #2 of installation 21 on the right bank. This installation is doing very well. You can also see installation #3 on the left bank which is not doing so well.

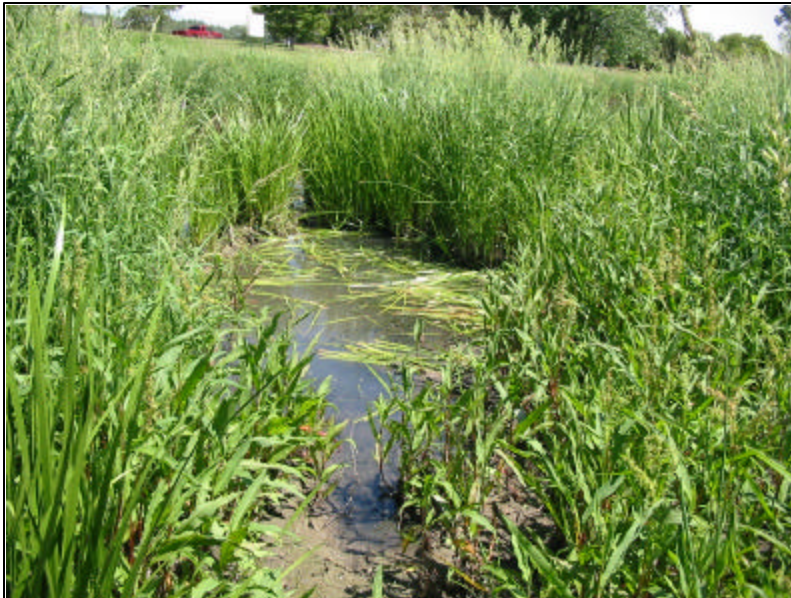
A hole behind the fascine of meander #2.

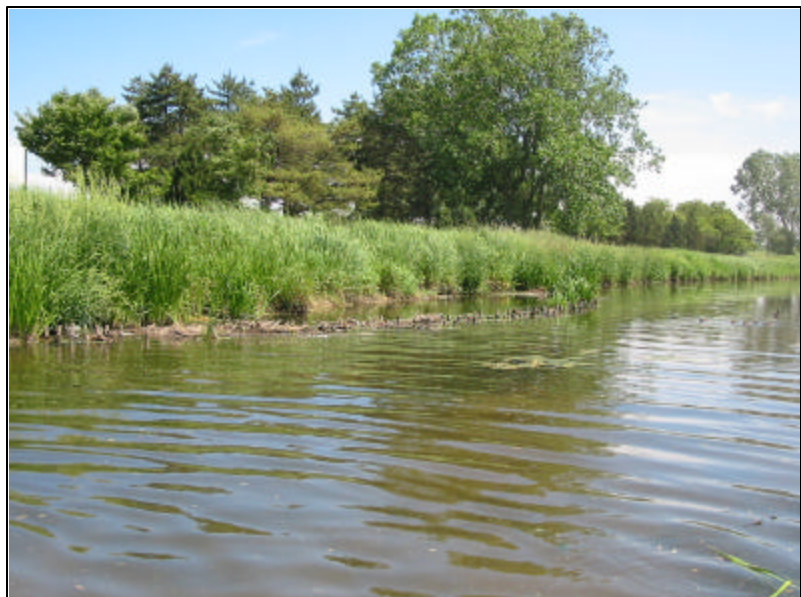
Looking downstream at meander #3 where nothing is growing.

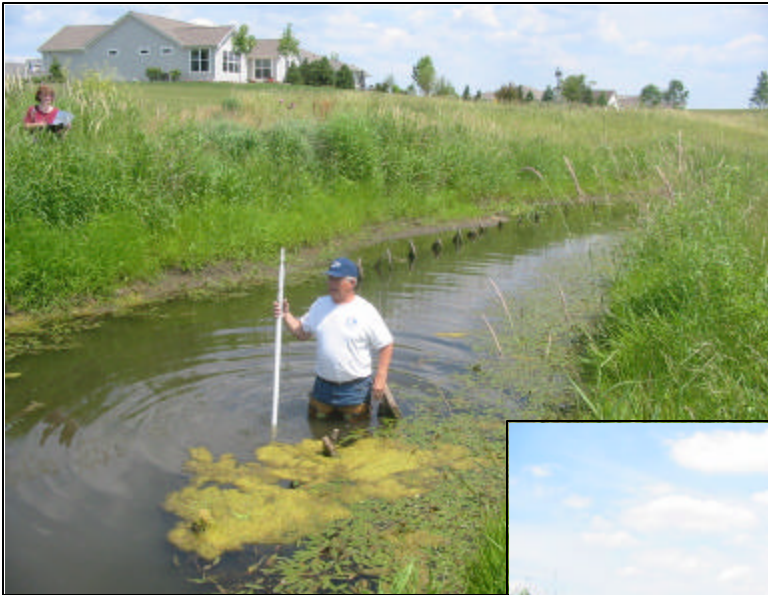
Don measuring pool depth. The substrate throughout the streambed is firmish peat, with pool depth reaching not more than 2 ft.
