Stream Restoration Inventory, Phase 1 Final Report

Prepared for Chicago Wilderness by the Northeastern Illinois Planning Commission

October 2002

Stream Restoration Inventory / Phase 2 Report of Restoration Field Verification

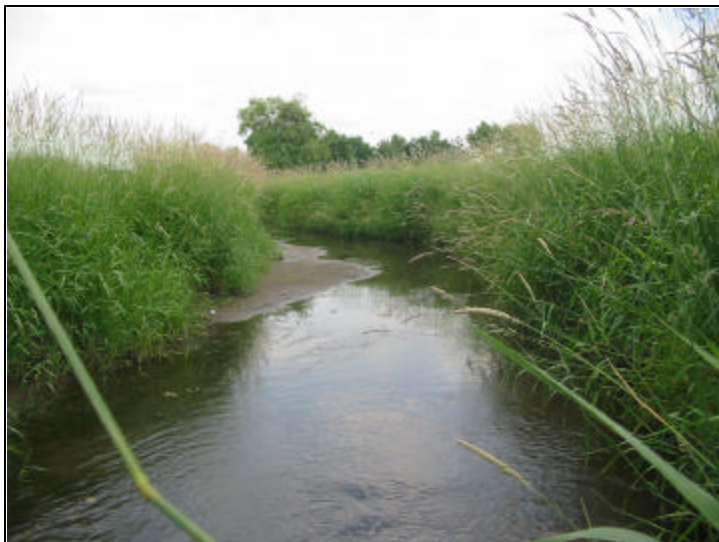
Looking downstream from the lunker installation. There was a pile of rip rap along the left bank that can be seen in this picture.

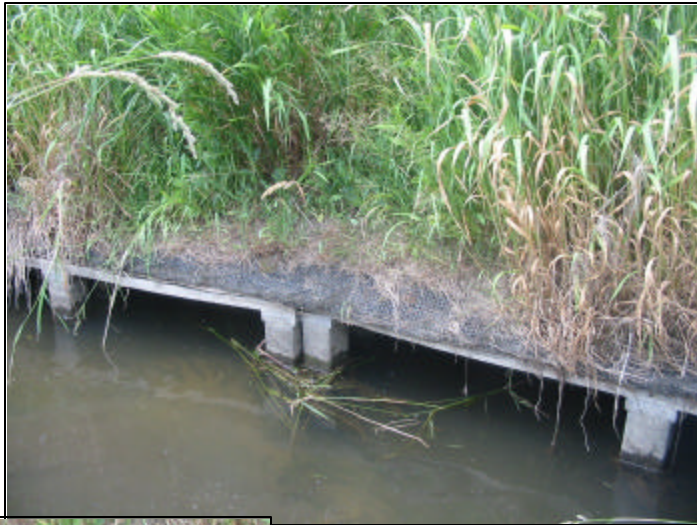
View of the lunkers and mattress (the fabric above the lunkers).

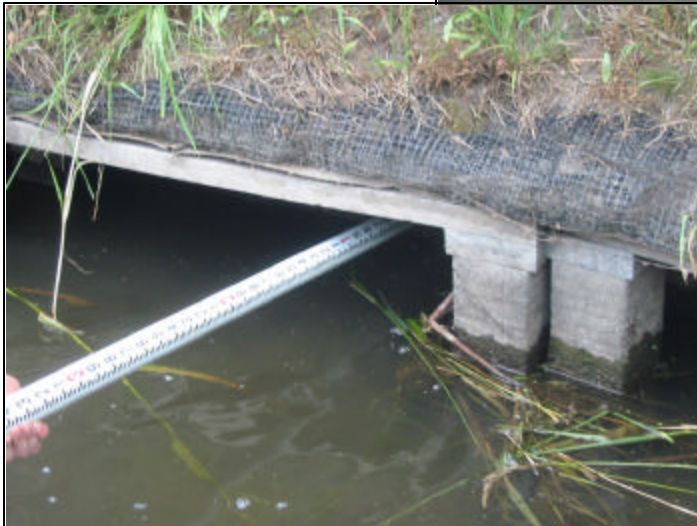
The lunkers were open to a depth of about 1.2 feet

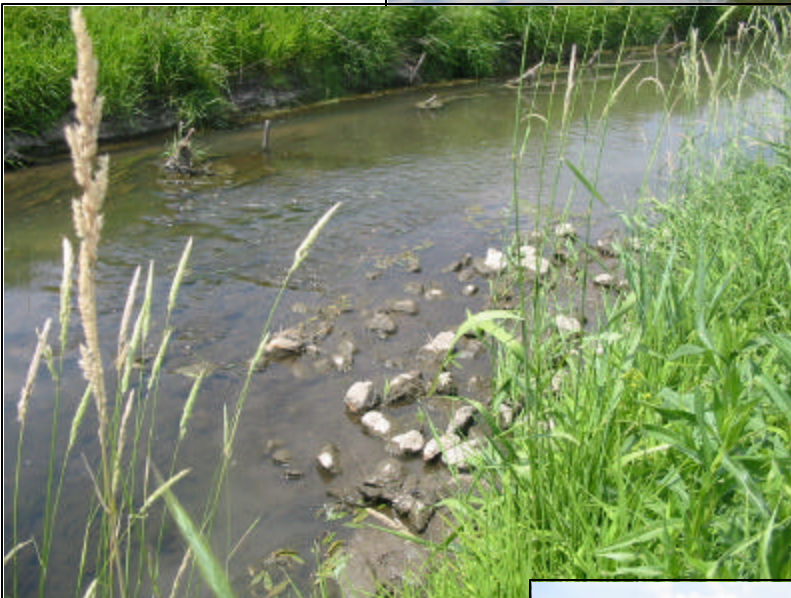
Scour on the left bank just below the first riffle. This scour is caused by the riffle.

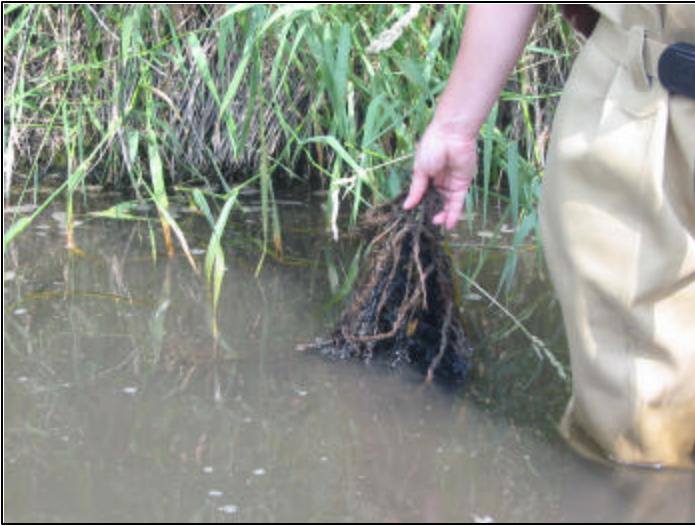
Laura holding up a part of the biolog on the left bank which was submerged under water at the upper end of the biolog installation.

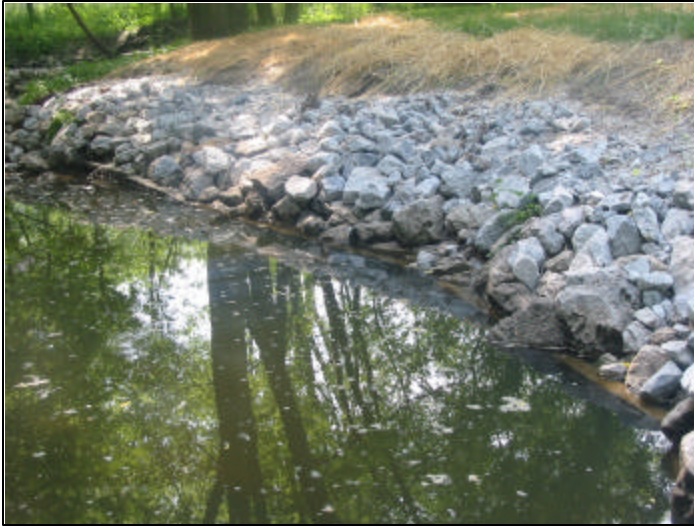
Wooden lunkers on the right bank covered with rock on North Branch channel. At the upstream end the lunkers were halfway filled with sediment; farther downstream the lunkers were more open. The native plantings above the lunkers appear to have been trampled.

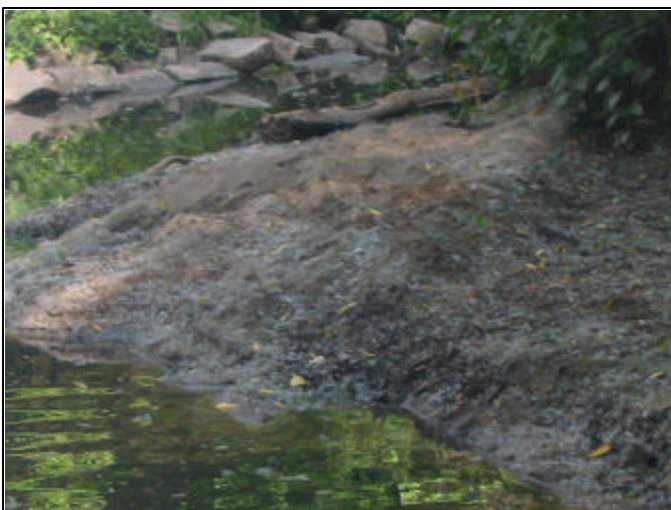
Ajacks on the left bank of the North Branch channel, downstream of the lunkers. The ajacks were completely buried and not visible.

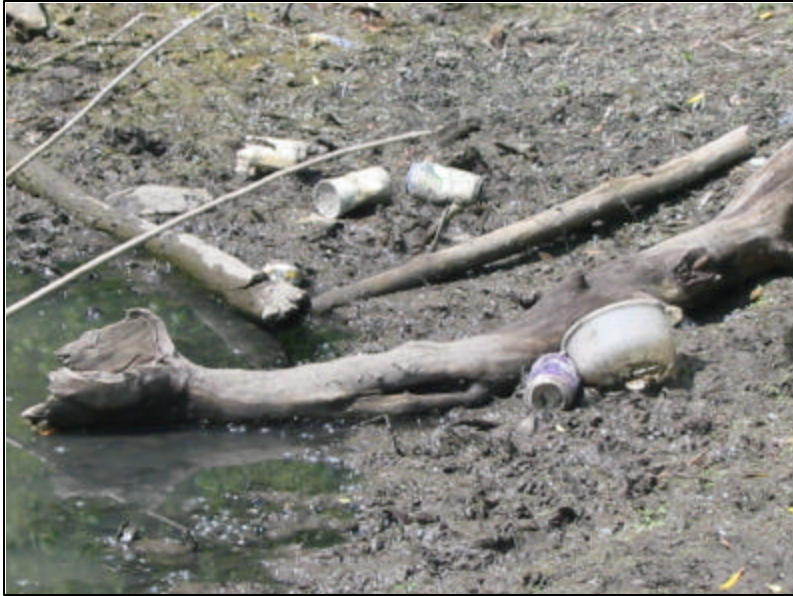
This final photo was taken of trash in the wetland forebay that floated in when flows were high. Water enters the forebay before flowing into the wetland.

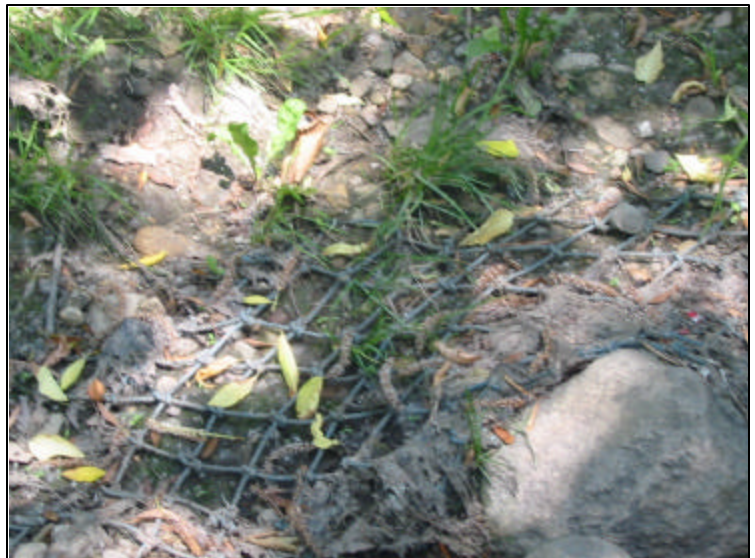
The remains of a biolog put in to stabilize the bank since the weir was not keyed into the bank.

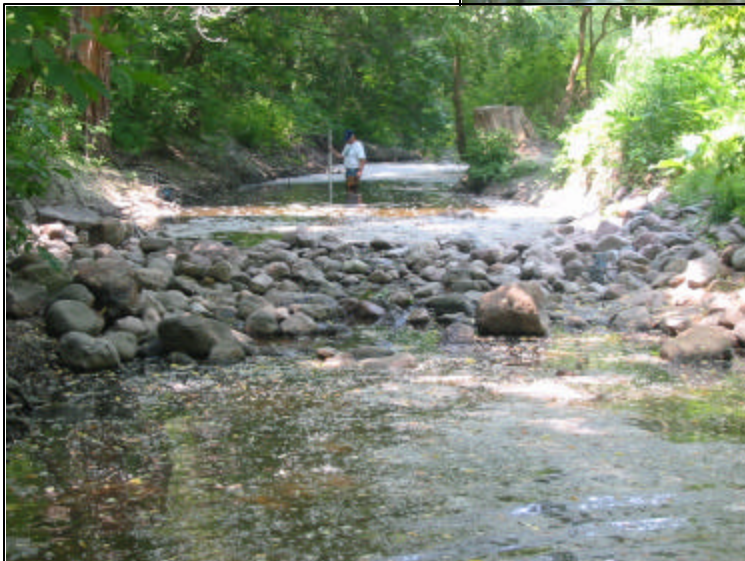
A broad view of Don measuring the water depth near the third Newbury weir. Depth upstream was 1-1.5' and downstream was 2'. Bed material was gravel

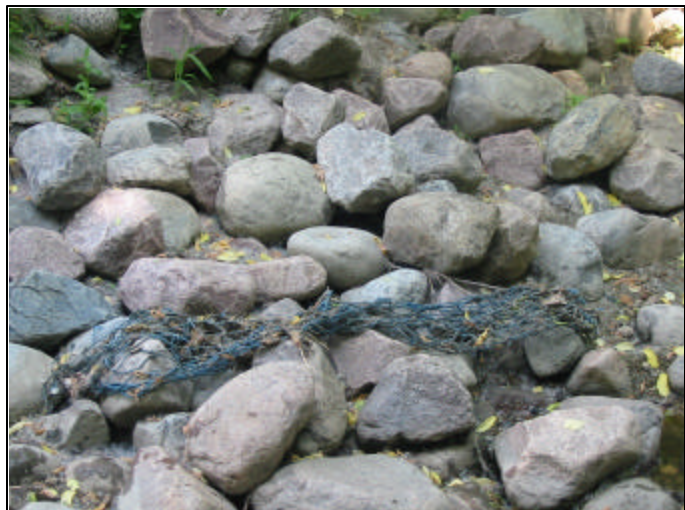
Remnants of a biolog on the third Newbury weir.

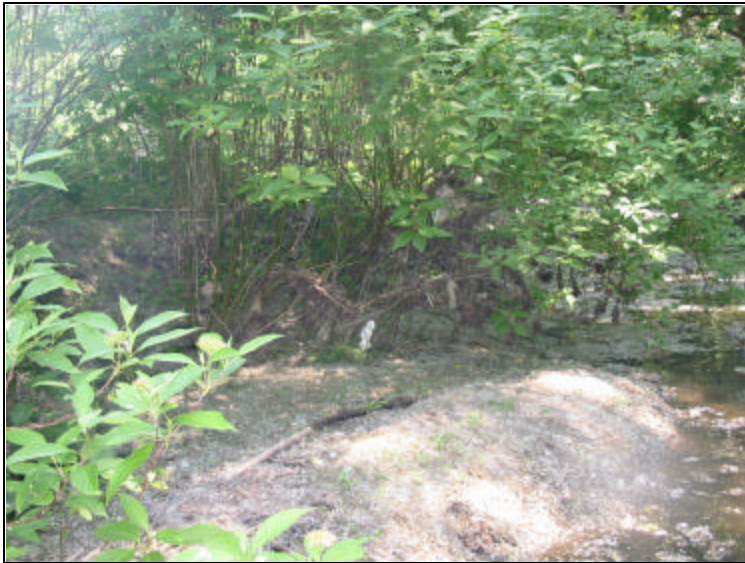
Dogwoods growing on the left bank between the third and fourth Newbury weirs. There are buried ajacks stabilizing the bank here and vegetation growth is good.

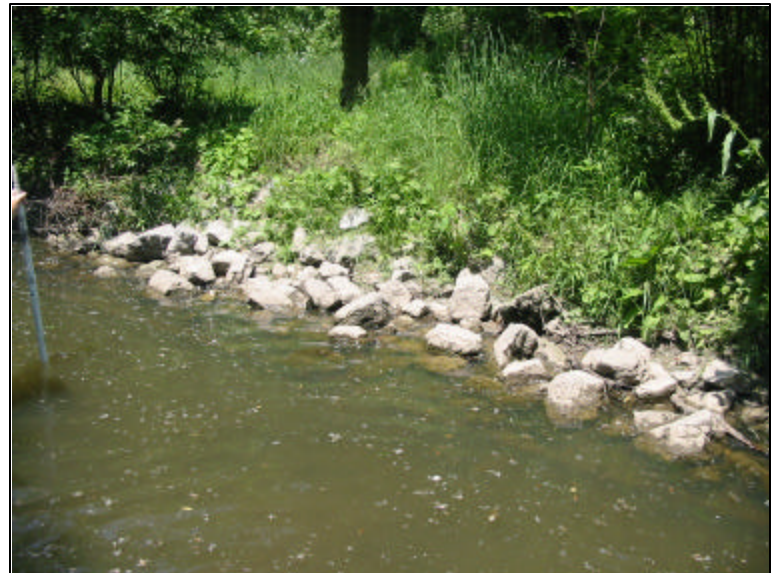
Buried lunkers covered with rock upstream of the fourth Newbury weir. Lunkers were open to a depth of about 1 foot. There was some erosion resulting from the lunkers being put in too deep.

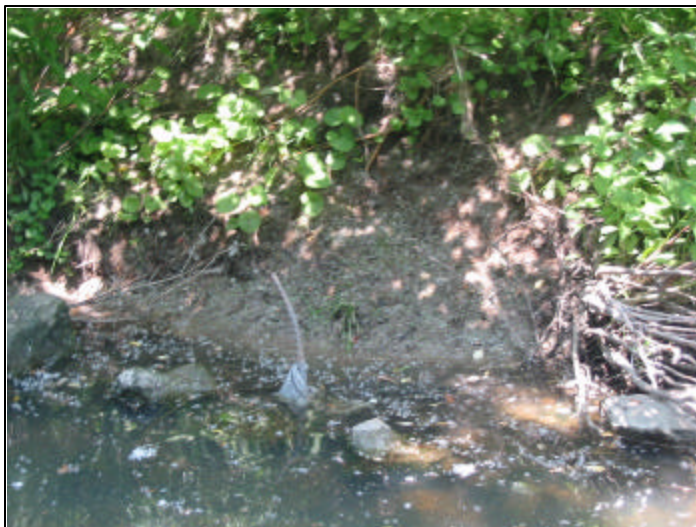
Eroded area just upstream of the lunkers.

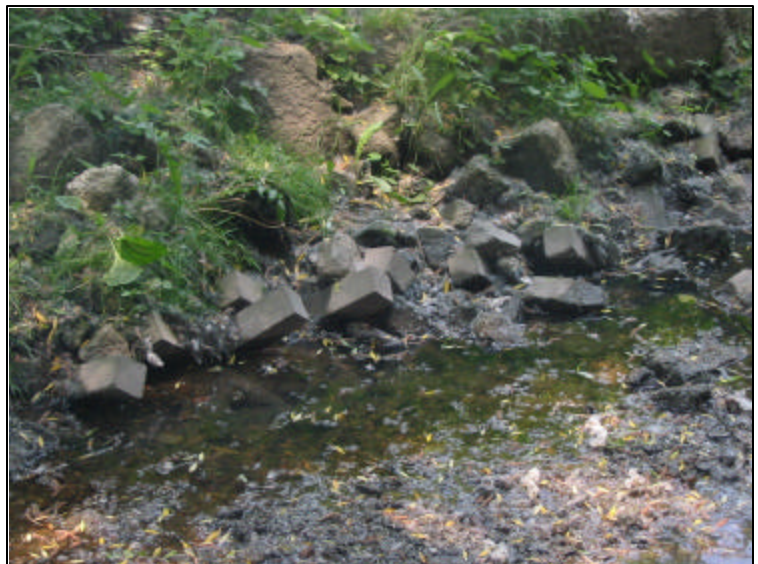
Ajacks exposed by erosion just upstream of the partial weir.

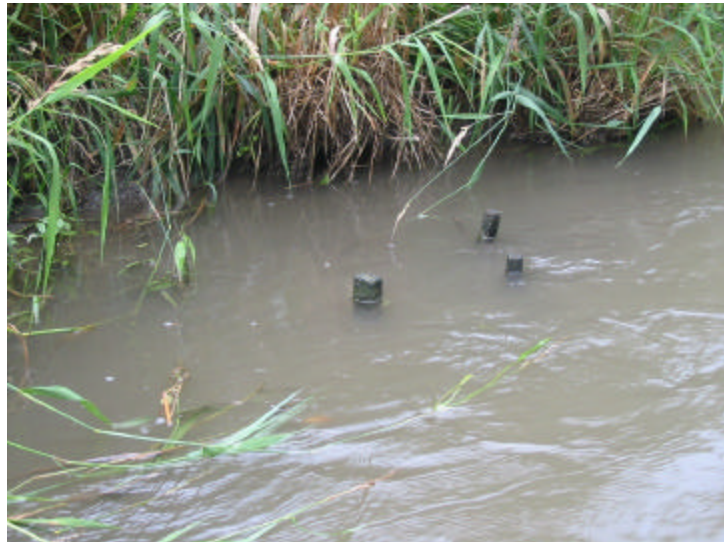
Looking upstream at the lunkers on the right bank (installation 1). Approximately 2/3 of these were open, with the other 1/3 being partially filled. Broad leafed potomagetum and curley leaf were growing in the channel at the downstream end of these lunkers.

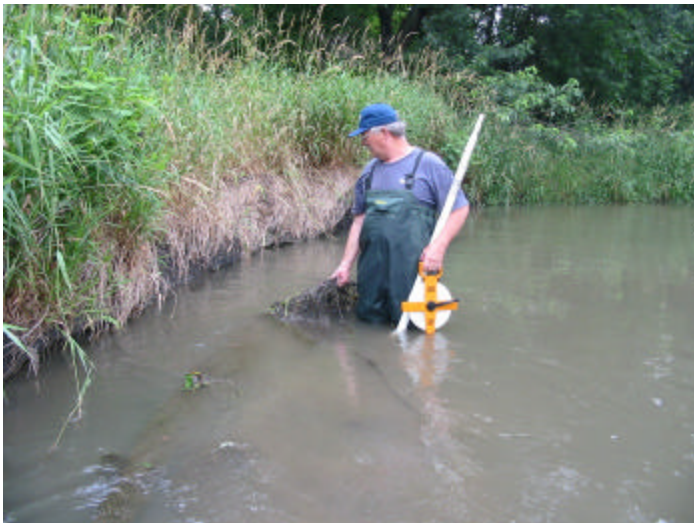
Area where fiber rolls washed out (installation 2). The stakes can be seen in the water with no fiber rolls behind them.

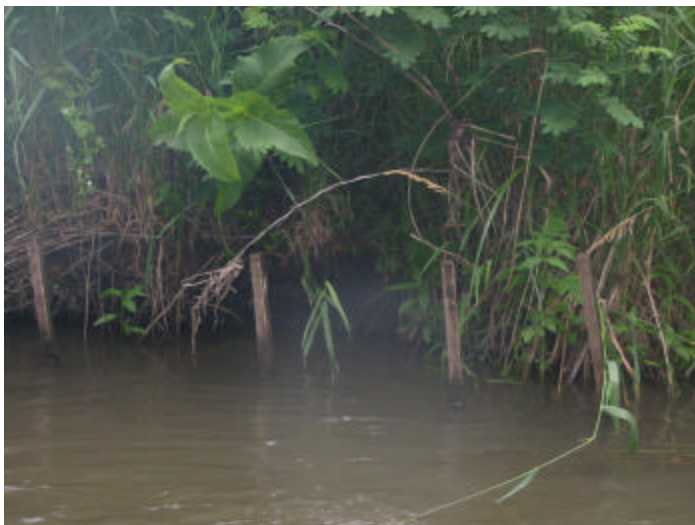
Stakes at installation 8, which is made up of 175' of fiber rolls and stakes. The pool depth varies a lot along this practice and the "islands" pictured above have formed in the channel. Pool depth was 3.5' at the upstream end of this practice.

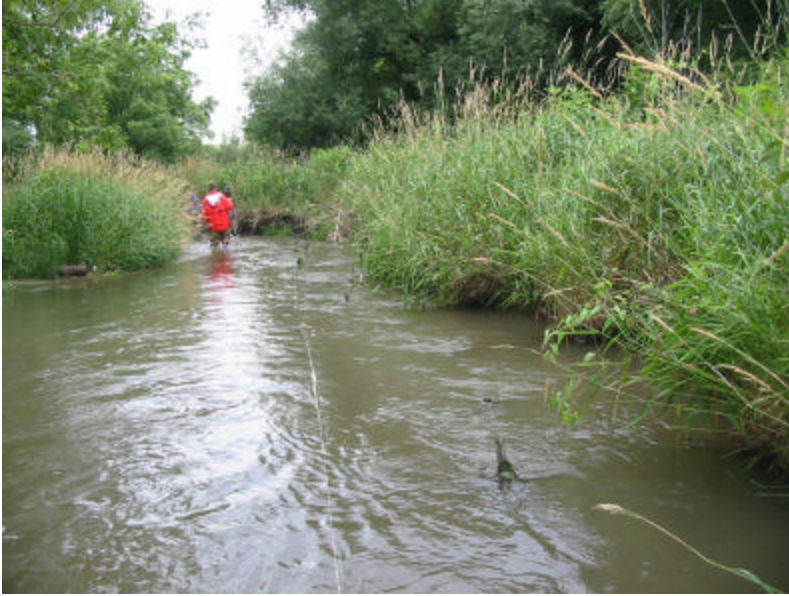
View looking downstream at stakes and fiber roll on the right bank (installation 10). There is about 20' of good fiber roll and then it disintegrates.

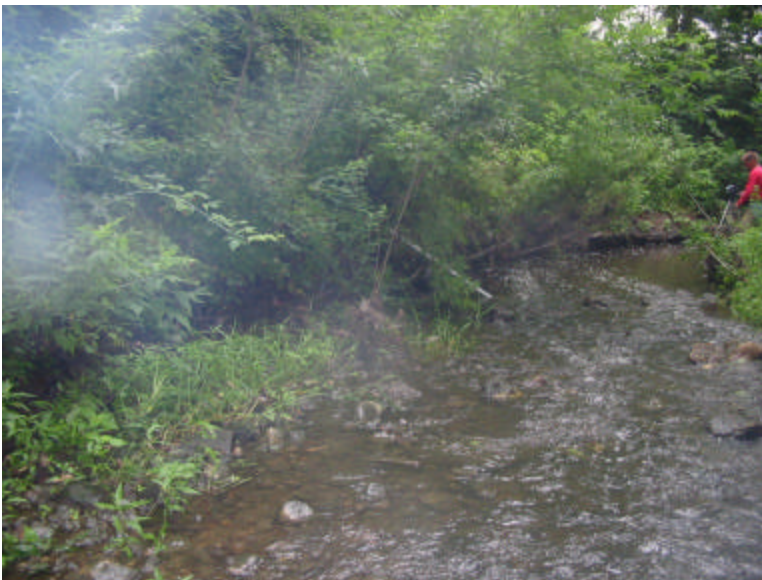
Looking downstream at the outside bend with the ajacks and geogrid of installation 2. At this installation the stability was pretty good, although there was some undercutting of the bank. The maximum pool depth was 2.5 feet, and the substrate was concrete with some larger 4 inch rock and cobble.

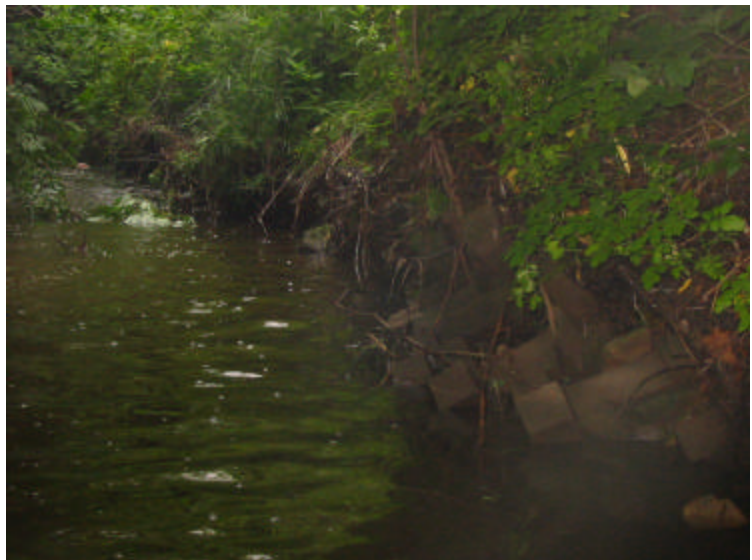
A view looking upstream along the left bank at installation 3. The ajacks here were basically intact and stability was pretty good. Pool depth was 0.6 feet, the substrate was cobble and 4 inch rock and the gradient was steep.

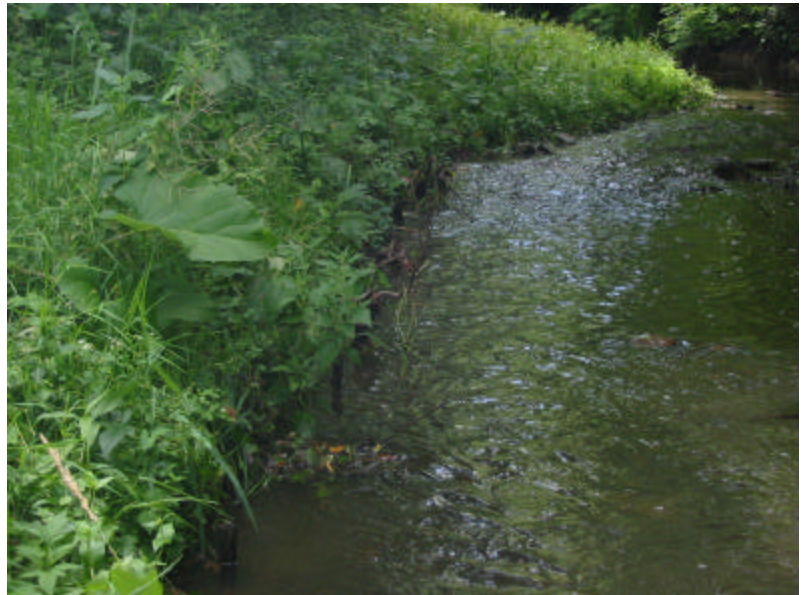
Looking upstream at the channel in the area of installation 1. There are willows and fiber roll on the left bank, and the substrate is small cobble. The willow plantings are doing pretty well, stability is very good and the practice looks good with floodplain developing with low depositional areas in the channel.

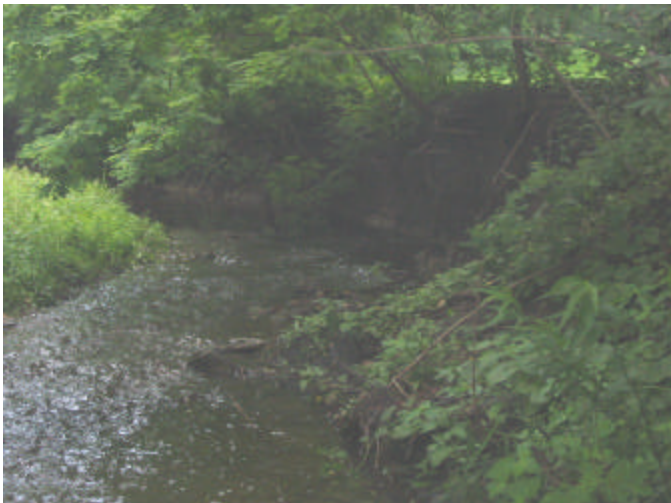
An upstream view of the stakes and fiber roll of installation 2 on the right bank. Stability was not good at this installation and fiber rolls were washed out at the downstream end.

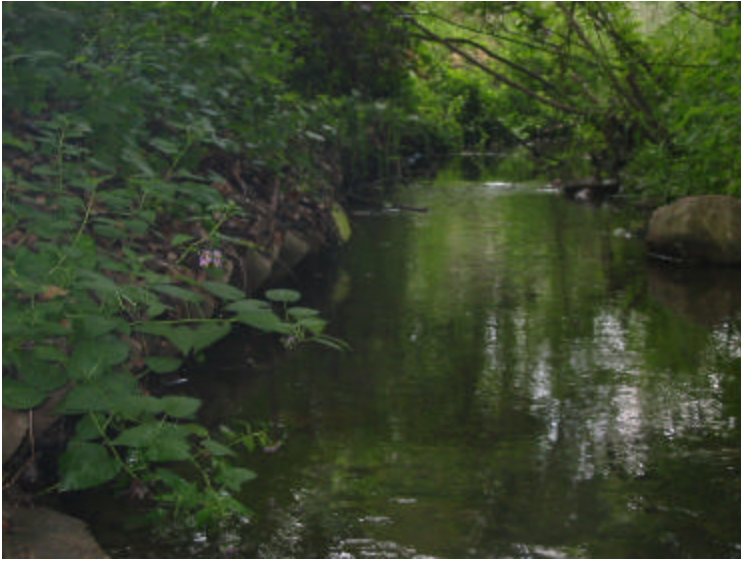
Erosion on the left bank across from installation 2.

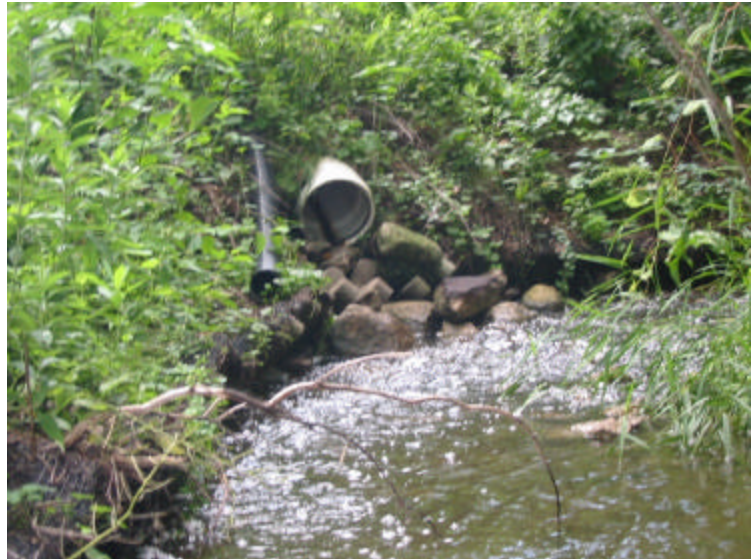
Looking upstream at the row of ajacks and fabric on the right bank. Syability is pretty good here, but these ajacks limit the flow in the reach.

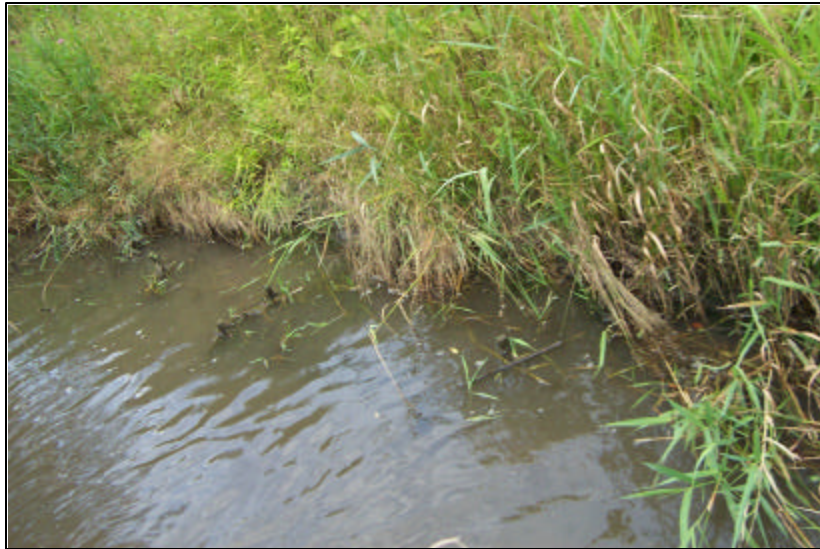
The biolog washout on the right bank at installation 6. Note the stakes with nothing behind them.

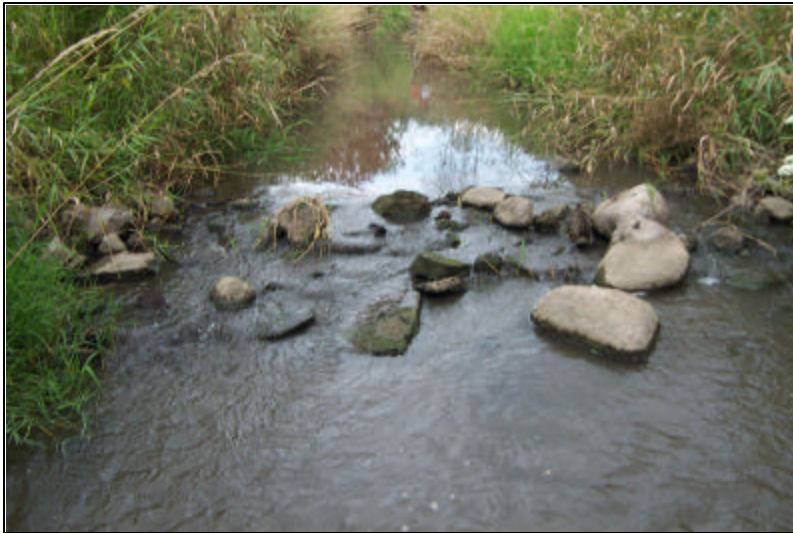
This photo was taken of the stakes at installation 7. The biologs were gone.

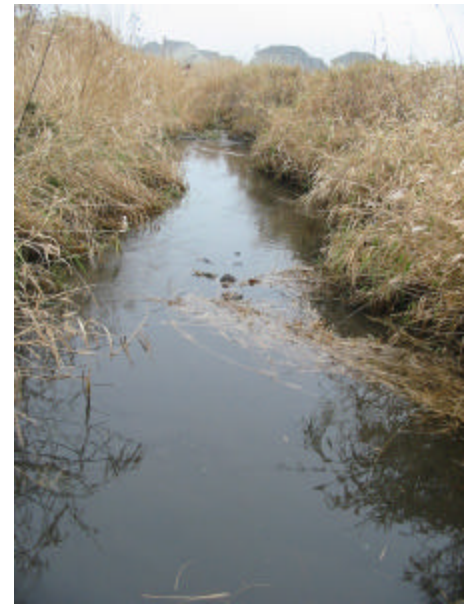
Close up of a slumping, undercut bank near the upstream end of the project where the gradient was steep and stability was not very good. Buffer species were dominated by reed canary grass.

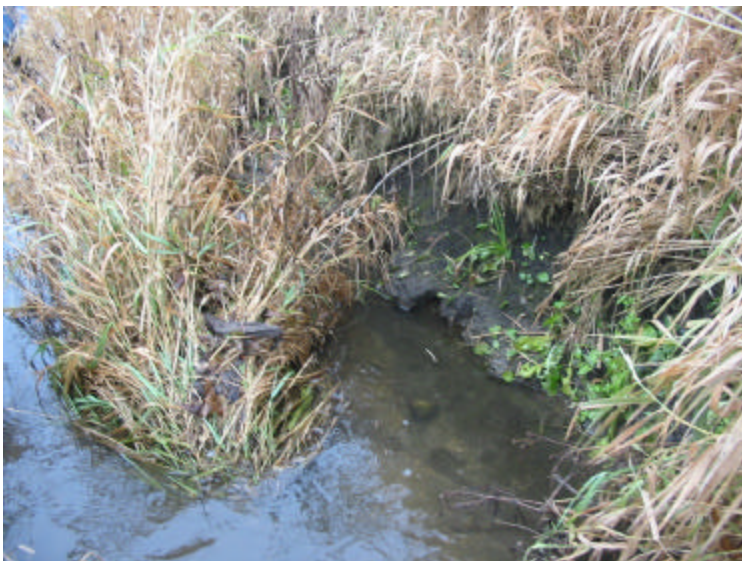
Looking downstream at the first riffle (installation 4). This riffle was about 250 feet downstream from the start point and pool depth was about 1 foot in the vicinity of the riffle. The bank gradient was steep in this area, and the banks unstable.

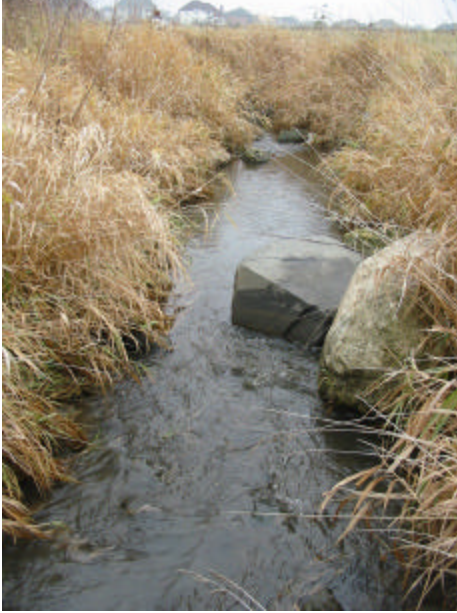
25 feet of severe slumping on the right bank just downstream of the riffle pictured above.

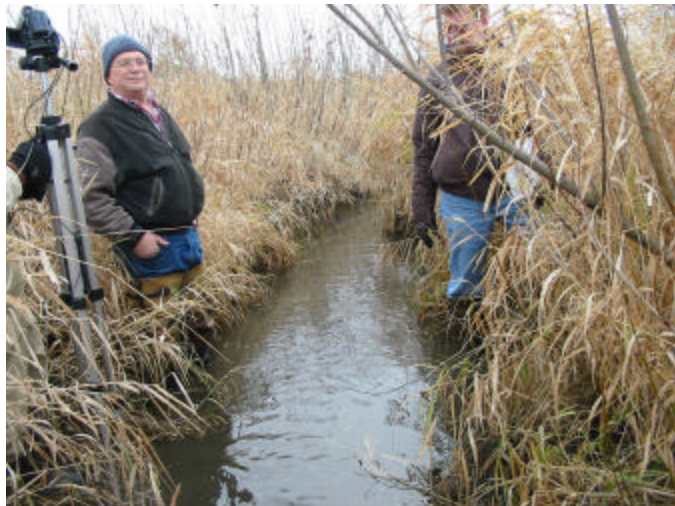
Looking downstream at riffles and fish rocks from installation 9. Bank stability began to improve in this area and continued to be good farther downstream. Bank gradient transitioned from steep to medium and continued to be medium to low farther downstream. Some willows could be seen growing on the banks.

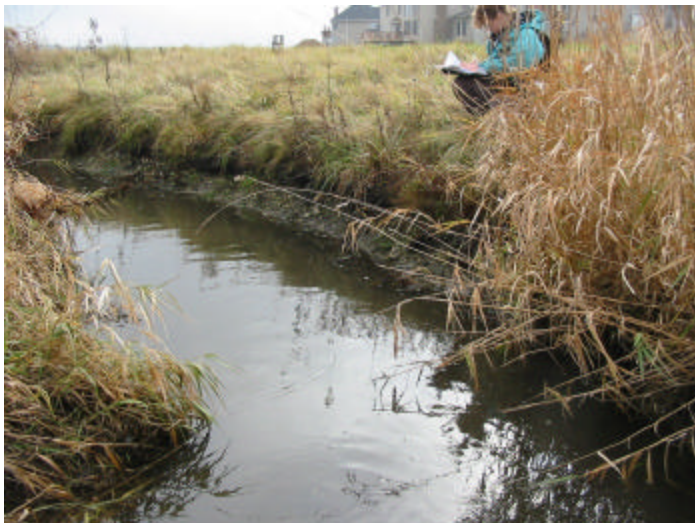
Downstream end of installation 9. Stability was good.

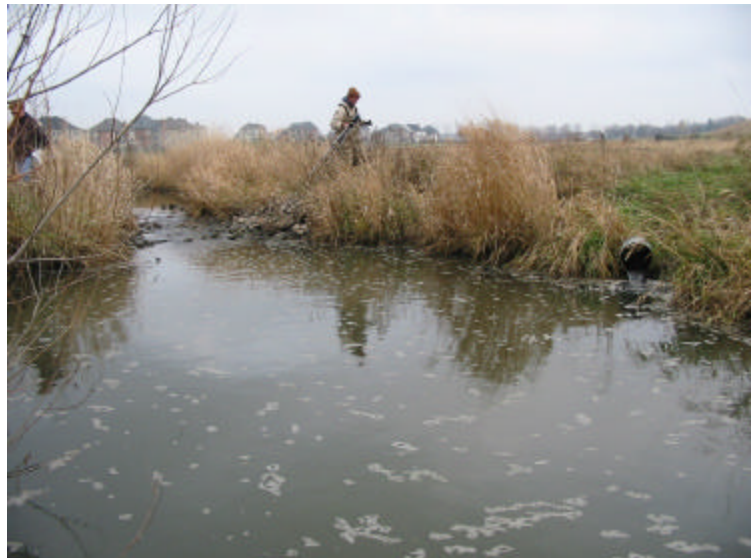
Near the downstream end of the project the buffer appeared to be mowed closer to the shore, but the plant species seen were of higher quality. Jeff Mengler noted that the entire reach had pond weed and other aquatic vegetation in the stream but that this instream vegetation is covered in silt and probably will not survive for this reason.

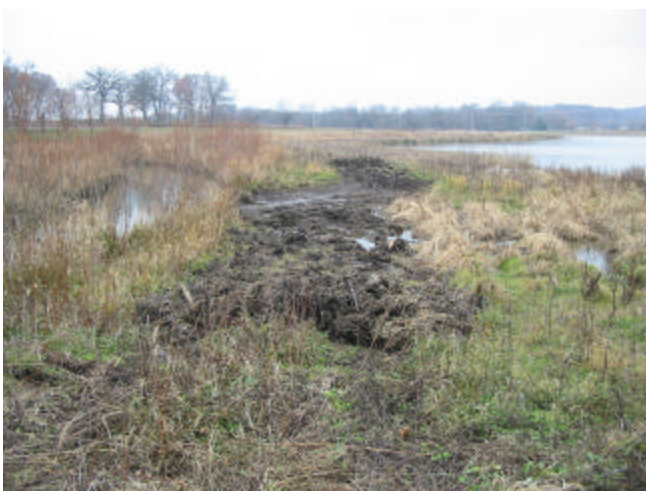
Near the far downstream end of the project, the stream widened out into a pool. Depth was about 2 feet next to the bank and was doubtless deeper near the middle. Switch grass was seen in the buffer in this area.
